# Accuracy of SUAS Photogrammetry for Use in Accident Scene Diagramming

Drew A. Jurkofsky  
Unmanned Experts

**CITATION:** Jurkofsky, D., "Accuracy of SUAS Photogrammetry for Use in Accident Scene Diagramming," *SAE Int. J. Trans. Safety* 3(2):2015, doi:10.4271/2015-01-1426.

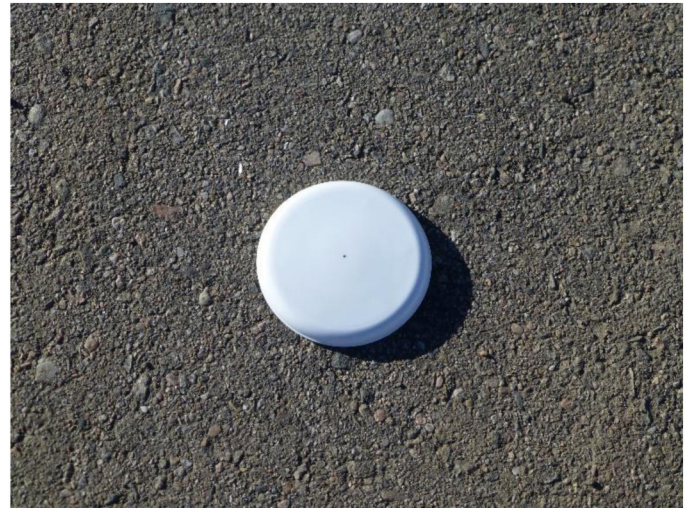
Figure 1. Circular plastic target with a dimple drilled in the center.

Circular white plastic targets were used to mark fixed objects and specific physical evidence in each accident scene for a quantitative comparison. The targets were 12 cm in diameter with a small dimple drilled in the center (Figure 1). The targets were fixed to the roadway using double-sided tape so they could not be easily moved. Targets were placed at all four corners of the test area for ground control and subsequent orientation of the photogrammetric measurements (Figure 2). The simulated light poles were placed at the corners of the accident scenes along the main road and were used as two of the ground control points.

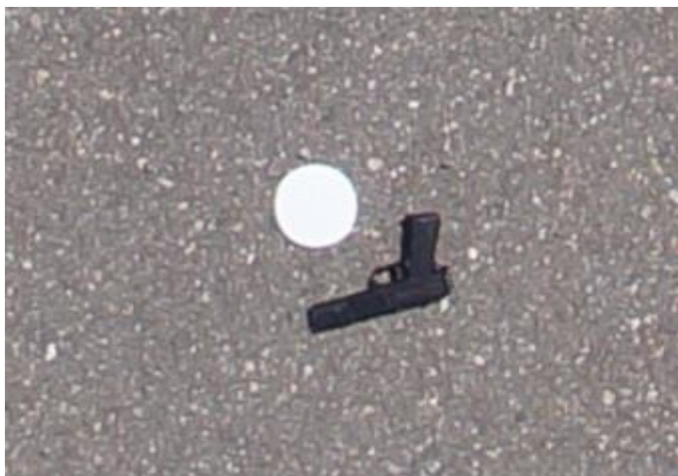
Figure 3. Image of a circular plastic target next to a handgun taken by a 24-megapixel camera at 20 meters flying height.

An assortment of items, each marked with a comparison target and used to simulate physical evidence, were included in each accident scene. The items were chosen to replicate evidence commonly seen in both accident and crime scenes. Items included a pen, shoes, clothing, handgun, cellphone, keys and coins. An upside down bucket with a circular target on top was added to determine the accuracy of the vertical or z-axis measurement. The purpose of the objects was to add realism to the scene, determine the resolution of individual items from the aerial imagery and add context to the circular targets (Figure 3).

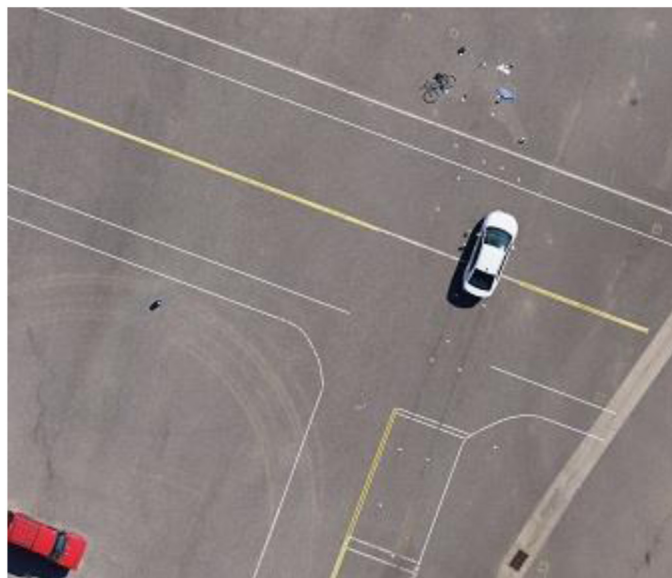
Figure 5. Car versus bicycle mock accident scene.

The second mock accident was between a Chevrolet Malibu and a bicycle. In the scenario, the Malibu was traveling on the secondary road and disregarded the stop sign at the main road. The bicycle was coming from the right of the sedan and traveling in the bicycle lane closest to the secondary road. The front of the Malibu contacted the left side of the bicycle and threw the bicycle in the direction of the sedan. The Malibu was skidded through the T-intersection to rest so

actual skid marks were present. There were 31 targets placed throughout the scene to mark ground control, physical evidence, the fixed objects and skid marks (Figure 5).

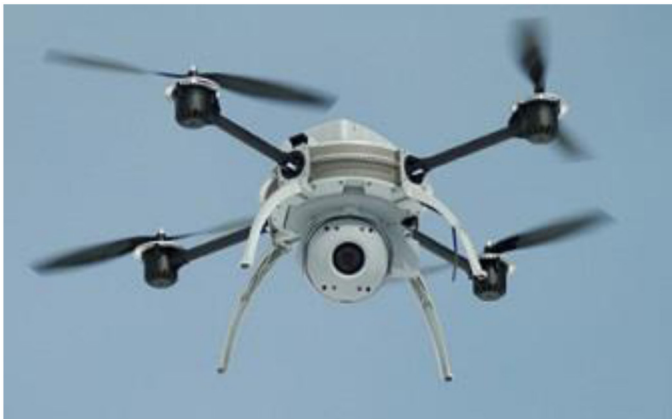
Figure 6. Aeryon Scout with 4-megapixel integrated, stabilized camera. Manufactured by Aeryon Labs, Inc.

low-resolution integrated camera and a high-resolution consumer grade camera. The Aeryon Scout, manufactured by Aeryon Labs, Inc., was powered by 4 rotors (Figure 6). It had an integrated, stabilized camera with a 4-megapixel resolution and 11.9 mm focal length. The DJI S800, manufactured by DJI, was powered by 6 rotors (Figure 7). It was equipped with a Zenmuse brushless gimbal and a Sony NEX-7 24-megapixel camera with a 24mm Zeiss lens.

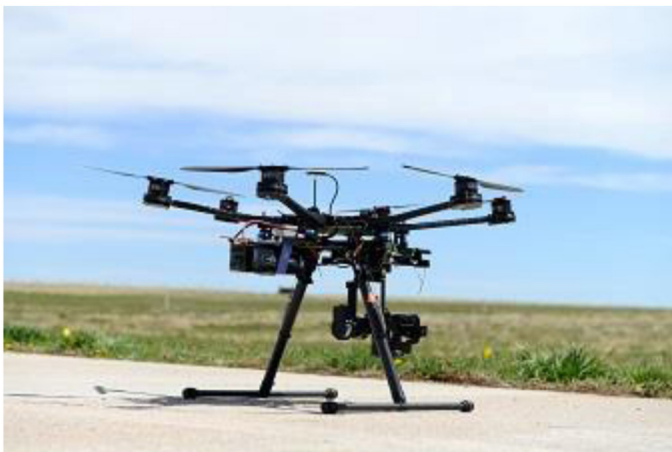
Figure 7. DJI S800 with Zenmuse brushless gimbal and Sony NEX-7 24-megapixel camera with 24 mm Zeiss lens. Manufactured by DJI.

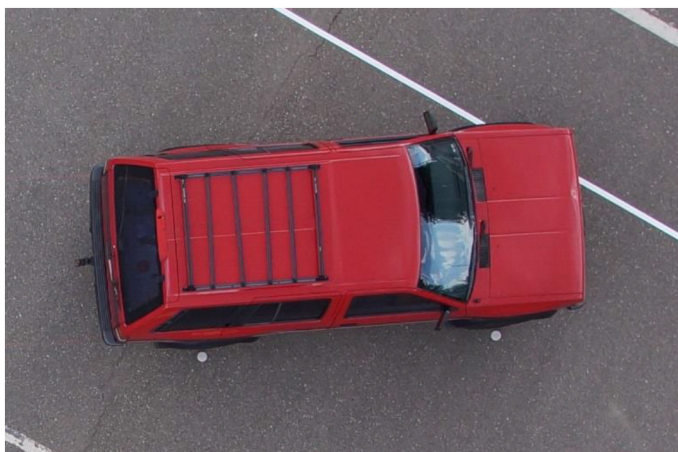
Figure 9. Circular markers used to mark vehicle rest location.

To measure the vehicle rest locations, markers were placed next to the vehicle wheels and centered at the hub (Figure 9). This was done for each flight mission except for the aerial imagery from the Aeryon Scout of the two vehicle accident.
