# Occupant Kinematics and Injury Response in Steer Maneuver-Induced Furrow Tripped Rollover Testing

Michelle Heller, Sarah Sharpe, William Newberry, Alan Dibb, John Zolock, Jeffrey Croteau, and  
Michael Carhart  
Exponent Inc

**CITATION:** Heller, M., Sharpe, S., Newberry, W., Dibb, A. et al., "Occupant Kinematics and Injury Response in Steer Maneuver-Induced Furrow Tripped Rollover Testing," *SAE Int. J. Trans. Safety* 3(2):2015, doi:10.4271/2015-01-1478.

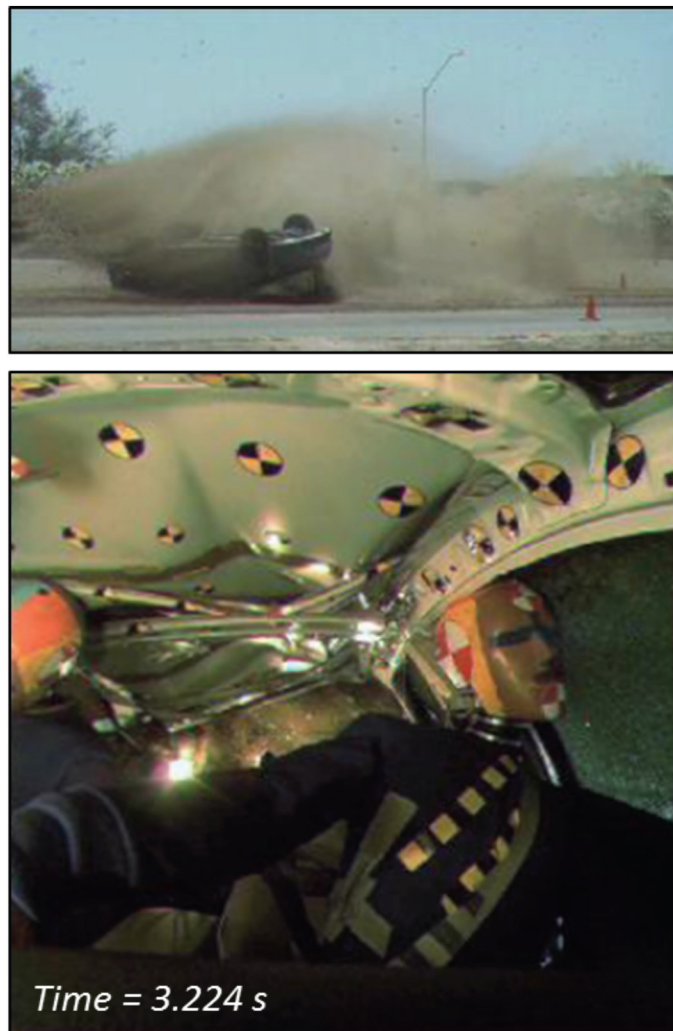
Figure 7. Exterior view of sedan position (top) and interior driver ATD position (bottom) that corresponds to neck loading event during the first roll (roll angle = 190°, roll rate = 404°/s).

An overview of the sedan driver kinematics during the steer maneuver, soil furrowing, and at each 1/8<sup>th</sup> roll position of the rollover sequence is provided in the [Appendix](#) (Figures 39, and 41, 42, 43, 44), with the latter illustrated in the context of the vehicle dynamics (roll angle, roll rate, and vehicle acceleration). As the sedan began to steer towards the right, the driver ATD moved slightly outboard relative to the vehicle interior and the torso belt moved closer to the ATD's neck. As the vehicle steered towards the left, the driver ATD moved rightward (inboard), and the torso belt moved towards the ATD's left shoulder. As the vehicle furrowed into the soil, the driver ATD leaned inboard and the torso belt moved off of the ATD's left shoulder. As the vehicle began to roll through the first quarter roll and into the inverted position, the ATD moved outboard relative to the vehicle, and the torso belt once again moved into a position over the outboard shoulder towards the ATD's neck. The ATD head became positioned against the underside of the roof rail and against the glass. The driver's side roof rail and front window glass made contact with the ground and onboard video showed that the glass had fractured by 3.220 s. The glass likely fractured due to a combination of occupant loading and contact with the ground. The ATD peak compressive upper neck load of 4972 N (1118 lbf) occurred shortly thereafter at 3.223 s with the vehicle roll angle at 190 degrees (0.53 revolutions) ([Figure 7](#)). A transient negative (upward) head acceleration of 21.7 g occurred at 3.224 s due to the release of the head from the constraint of the window glass as it fractured. The compressive neck load associated with this event was in excess of Injury Assessment Reference Value (IARV) of 4000 N and resulted from the torso's continued motion towards the head when the vehicle was oriented just past the 1/2-roll position. The loading of the neck due to motion of the torso toward the head after the head's motion has been arrested is referred to as "torso augmentation" and has been well described in previous rollover literature (e.g., [Raddin et al., 2009](#)). The peak  $N_{ij}$  associated with this event was 1.13 in compression-extension ( $N_{ce}$ ) with a compressive force of 4964 N (1116 lbf) and an extension moment of 42.8 N-m (378.8 lbf-in). The peak extension moment was 44.0 N-m (389.0 lbf-in) and occurred 3.9 ms after the peak compressive neck load. The peak lateral neck moment in rightward bending was 104.5 N-m (926.3 lbf-in) and occurred 9.2 ms prior the peak compressive neck load. The vertical roof displacement, measured at the left B-pillar, was 4.4 cm (1.7 inches) downward at the time of the driver ATD peak compressive upper neck load ([Figure 8](#)), and the lateral deformation was 7.3 cm (2.9 inches) inboard at the same time. The peak

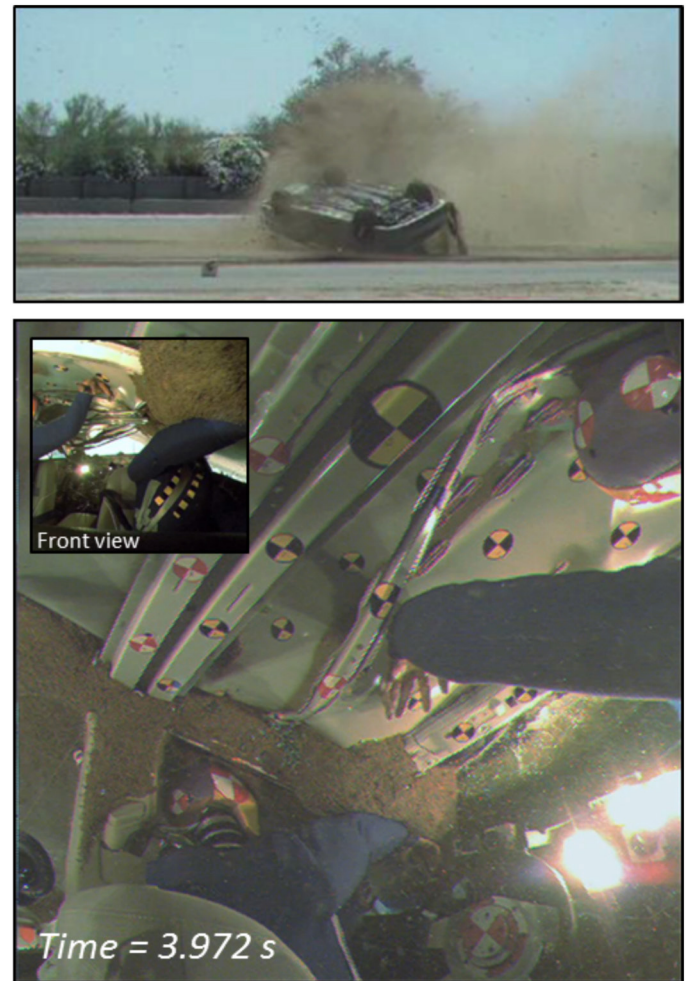
Figure 10. Exterior sedan orientation (top) and interior view of driver ATD position (bottom) that corresponds to neck loading event during the second roll (roll angle =  $360+200^\circ$ ,  $461^\circ/s$ ).

During the first roll, the vehicle traveled approximately 11.6 m (38 ft) with an average roll rate of 333 degrees per second. Following fracture of the driver door window glass, the ATD's head moved outside the plane of the driver side window. As the vehicle completed the first roll, it became airborne until the passenger-side wheels made contact with the ground at approximately the 1 1/8-roll position. Just beyond the 1 1/2-roll position, the ATD head stopped due to direct contact with the ground and the torso continued to move, resulting in a compressive neck load that also exceeded the IARV. The ATD's upper neck was loaded to 5984 N (1345 lbf) at 3.970 s (Figure 10). The peak  $N_{ij}$  associated with this event was 1.01 in compression-flexion ( $N_{cf}$ ) with a compressive force of 5978 N (1344 lbf) and a flexion moment of 10.7 N-m (94.6 lbf-in). The peak flexion moment was 32.4 N-m (286.8 lbf-in) and occurred 16.5 ms after the peak  $N_{ij}$ . The peak lower neck compressive load was 4607 N (1036 lbf). The maximum  $HIC_{15}$  during the second roll was 54.2. The torso belt was located over the ATD's shoulder, adjacent to the neck, throughout this contact and loading event.

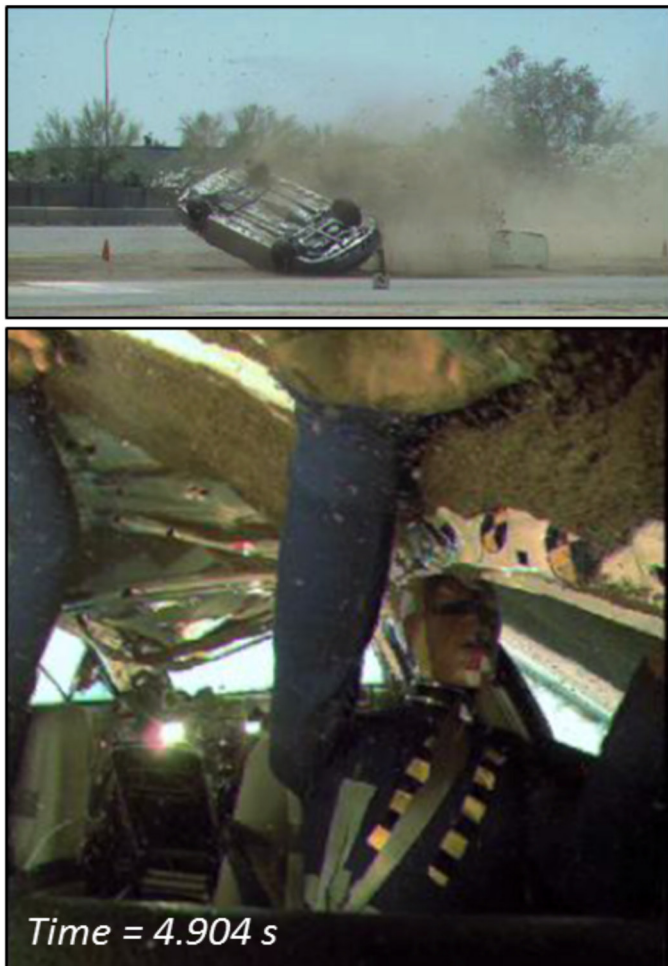
Figure 12. Exterior view of the sedan orientation (top) and interior view of the driver ATD position (bottom) that corresponds to the neck loading event during the third roll (roll angle =  $720+212^\circ$ , roll rate =  $315^\circ/\text{s}$ ).

During the second roll, the vehicle traveled 6.4 m (21 ft) with an average roll rate of 470 degrees per second. As the vehicle completed the second roll, it again became airborne until the right rear wheel made contact with the ground. The windshield separated from the vehicle as the sedan completed the second roll and came to rest in the roll path. The driver ATD maintained an upward and outward position relative to a nominal seated position during the airborne phase of roll 3. As the sedan moved just past the  $2\frac{1}{2}$ -roll position (2.6 rolls), the ATD head was positioned such that it was in contact with pinch weld of the roof rail as the vehicle approached ground contact. The driver head was decelerated by contact with the pinch weld and the ground

as the torso continued to move resulting in a compressive neck load of 2945 N (662 lbf) (Figure 12); however, it was below the IARV. The maximum  $\text{HIC}_{15}$  during the third roll was 5.0.

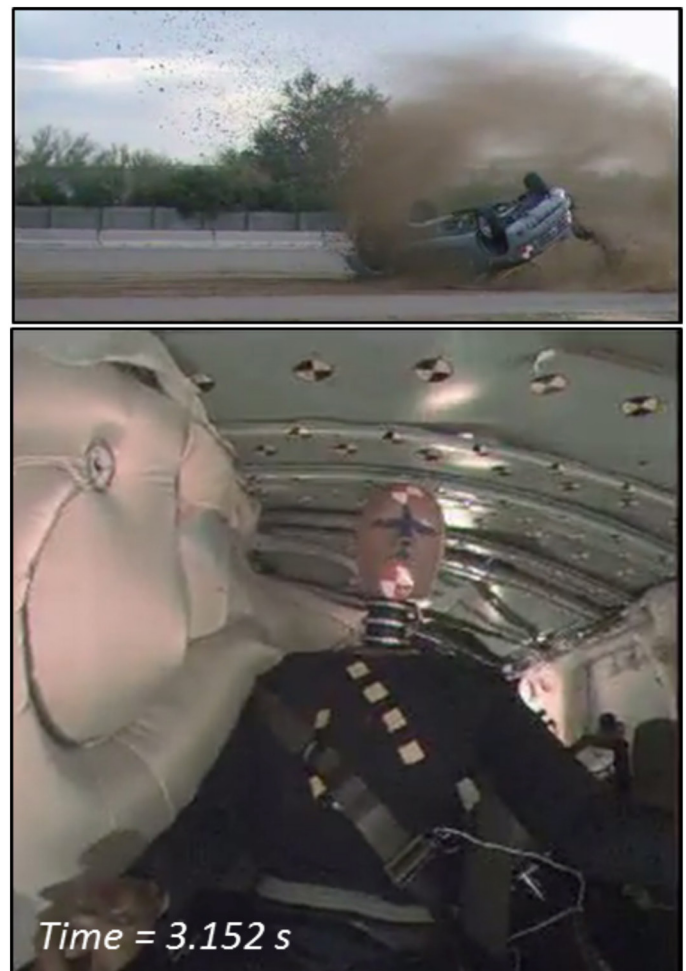
Figure 16. Exterior view of the pickup orientation (top) and onboard view of passenger ATD position (bottom) at time of vehicle-to-ground contact during first roll (roll angle =  $207^\circ$ , and roll rate =  $442^\circ/s$ ).

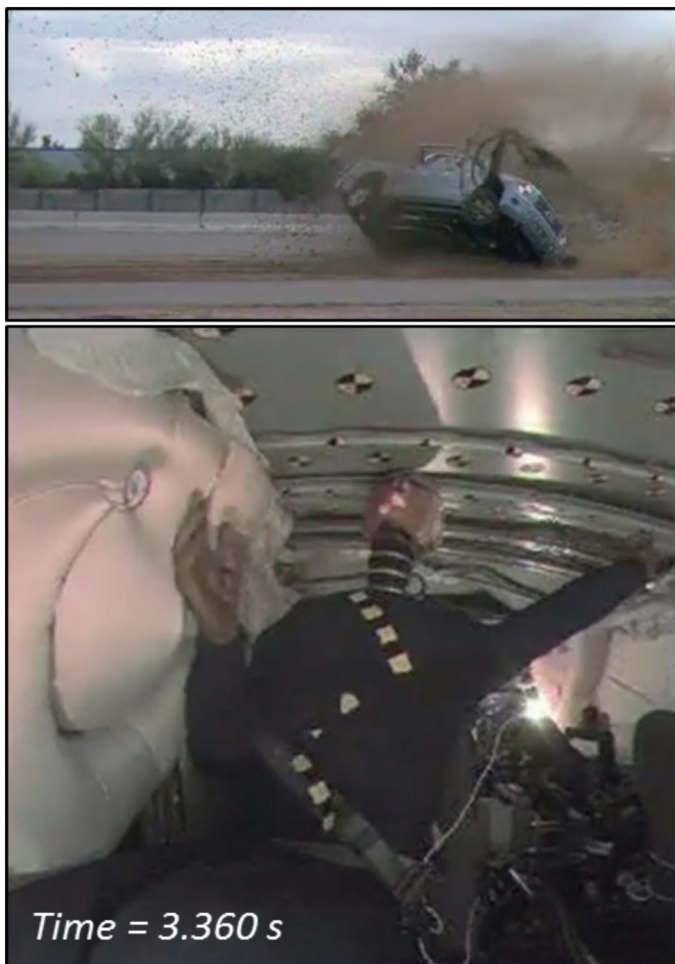
Figure 17. Exterior pickup orientation (top) and passenger ATD position (bottom) after movement of seatbelt relative to ATD shoulder (roll angle = 316°, and roll rate = 535°/s).

The vehicle continued to roll with the passenger ATD maintaining a position upward and outboard relative to the vehicle's center of mass. The vehicle experienced a contact to the driver's side roof rail when the vehicle was inverted that caused the passenger ATD to move towards the driver's side roof rail (Figure 16). This motion resulted in the passenger torso belt slipping off of the passenger ATD's right shoulder during the first roll. The passenger ATD also moved rearward relative to the seat during this contact. As the vehicle moved past the ¾ roll position, the torso belt was located in the right elbow joint of the ATD, and the ATD's head was against the roof, with the face presented to the roof surface (Figure 17).
