# Investigation of the Behavior of Three-Wheel Vehicles When They Pass Over a Low $\mu$ Road Surface

Keisuke Terada, Takayuki Sano, Kenichi Watanabe, Takashi Kaieda, and Kazuhisa Takano  
Yamaha Motor CO.,LTD

**CITATION:** Terada, K., Sano, T., Watanabe, K., Kaieda, T. et al., "Investigation of the Behavior of Three-Wheel Vehicles When They Pass Over a Low  $\mu$  Road Surface," *SAE Int. J. Veh. Dyn., Stab., and NVH* 1(1):2017, doi:10.4271/2016-32-0051.

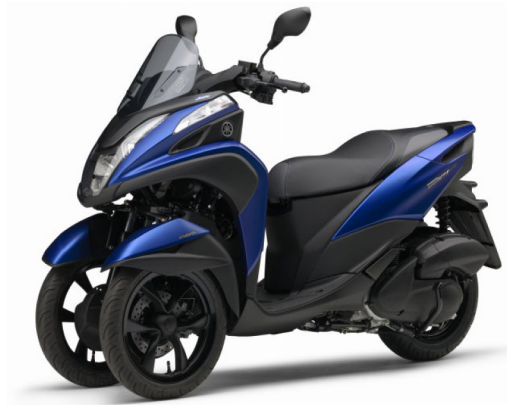
Fig. 1. External Appearance of LMWV

First, an actual measurement test was carried out to investigate and confirm this phenomenon. Fig. 1 shows the LMWV with 155 cm<sup>3</sup> of displacement that was used for the test. Table 1 lists the vehicle specifications. Furthermore, in this paper, in order to focus on the vehicle characteristics, theoretically, when the vehicle is cornering, the examination was carried out using a geometry in which the difference in the left and right wheel steering angles was 0 degrees at the time of roll. The vehicle was equipped with an inertial GPS sensor, a steering torque sensor, and tire six-component force meter wheels on the left and right front wheels. Please see the references for more details about the measuring instruments[3]. The coordinate system uses the ISO

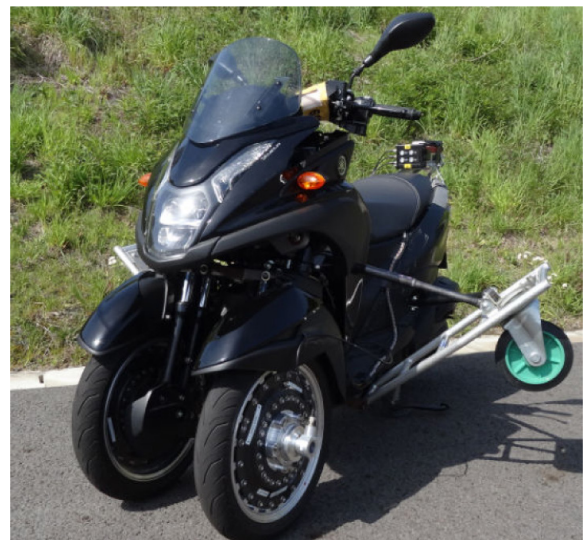
Fig. 4. External View of the Test Vehicle

Outriggers were attached to the vehicle during measurement in consideration of the rider's safety. Fig. 4 shows the external appearance of the test vehicle. A smooth, steel plate (670×670×2.5mm) in a wet state was prepared to be the low  $\mu$  road surface. A skid resistance tester was used to take measurements in advance and as a result it was confirmed that the BPN(British Pendulum Number) was 13.9. The test was then conducted on a circular test course with a radius of 30 meters. The vehicle was driven counterclockwise around the course in a steady state circular turn and only the right front wheel passed over the low  $\mu$  road surface. Rider always keeps a steady circular turn. The vehicle velocity was a constant 30 km/h. Fig. 5 shows the roll angle measurement results. All measurement data was passed through a 10 Hz low pass filter. The area where one wheel passed over low  $\mu$  road surface was determined from the tire force measurement data. The roll angle changed by approximately 1 degree when one of the front wheels passed over the low  $\mu$  road surface. This amount of fluctuation in the roll angle is small in respect to that found during a steady state circular turn and so it was concluded that the vehicle was maintaining its stability. This result matched the comments received from the vehicle's riders. Next, as a distinguishing characteristic of the data measured by using the tire six-component force meter, Fig. 6 shows lateral force measurement data which is shown as  $F_y$  in Fig.3 from the front tires. The graph indicates that when one of the front tires passed over the low  $\mu$  road surface, as the lateral force of the tire on the low friction surface decreased, the other tire appeared to compensate for it. Next, Fig.7 shows the steer angle result. The result shows the steering angle changed on the inside of turn. Consequently, this verification testing and the actual measurement data that was obtained made it possible to confirm that this phenomenon, which occurs when only one of the front wheels of the LMWV passes over a low  $\mu$  road surface while cornering, does in fact exist.
