| AEROSPACE<br>INFORMATION REPORT | AIR1707™ | REV. C |
| Patterns of O-Ring Failures | | |

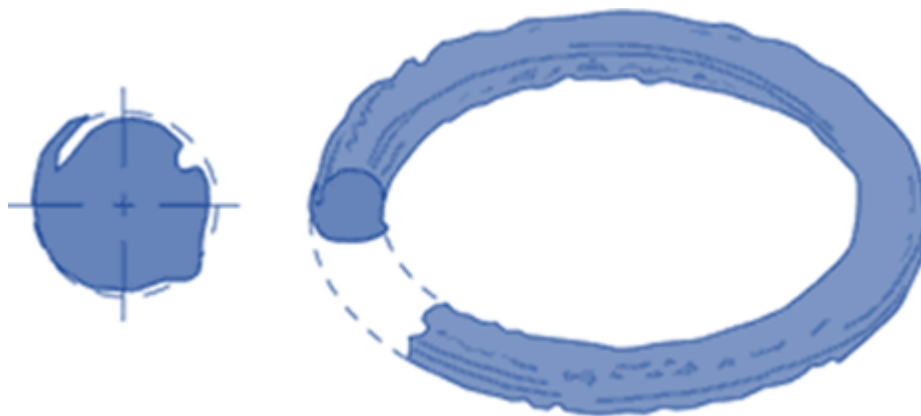
**Figure 1 - Extrusion and nibbling**

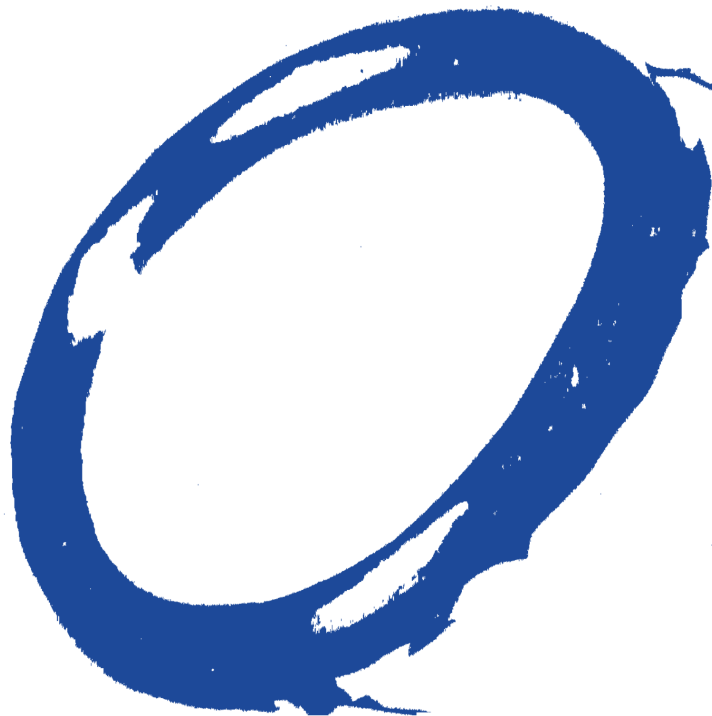
**Figure 3 - Nibbling and skiving**

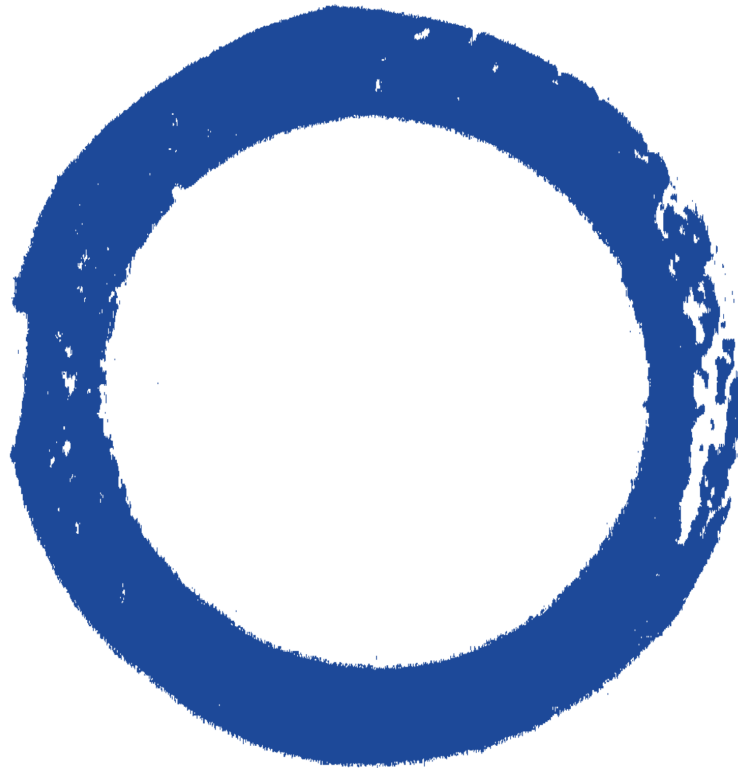
***Figure 4 - Nibbling and abrading***

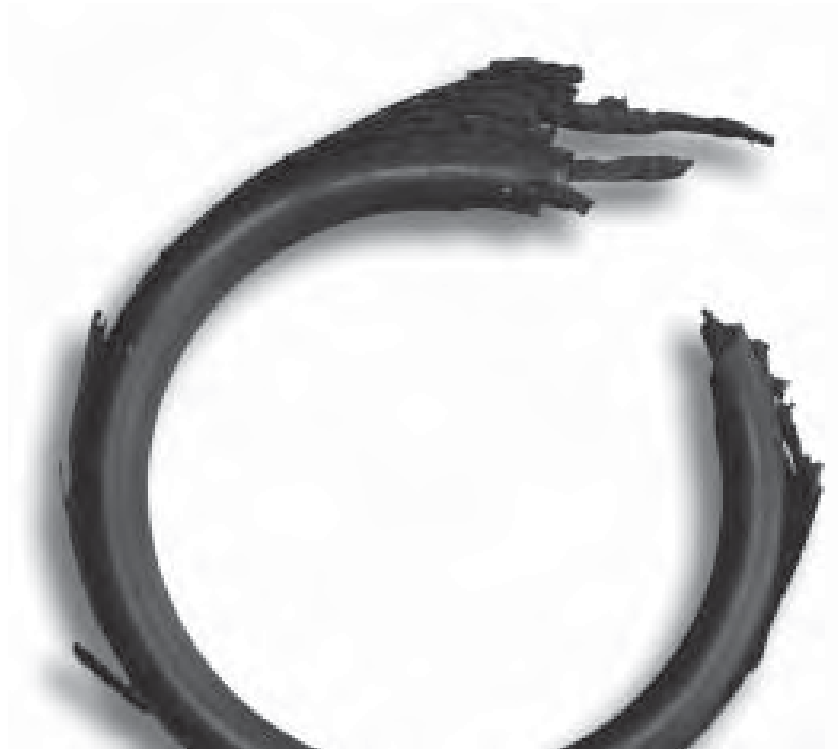
***Figure 5 - Nibbling and extrusion***
