# IN-PLACE PERFORMANCE OF POLYMER CONCRETE OVERLAYS

# **In-Place Performance of Polymer Concrete Overlays**

This paper reports on the condition of a post-tensioned parking garage that was repaired in 1983 using a thin mma polymer concrete overlay. An earlier paper reported on the garage condition, repair methods and materials (1). Comments will be made on the overlay wear, cracking, bonding to the substrate, continued corrosion of embedded reinforcing steel, and surface delaminations after 13 years of service. Comparisons of conditions in 1981 and 1995 are also made. Comments on the success of the application with respect to structural integrity and material durability are made at the end of the paper.

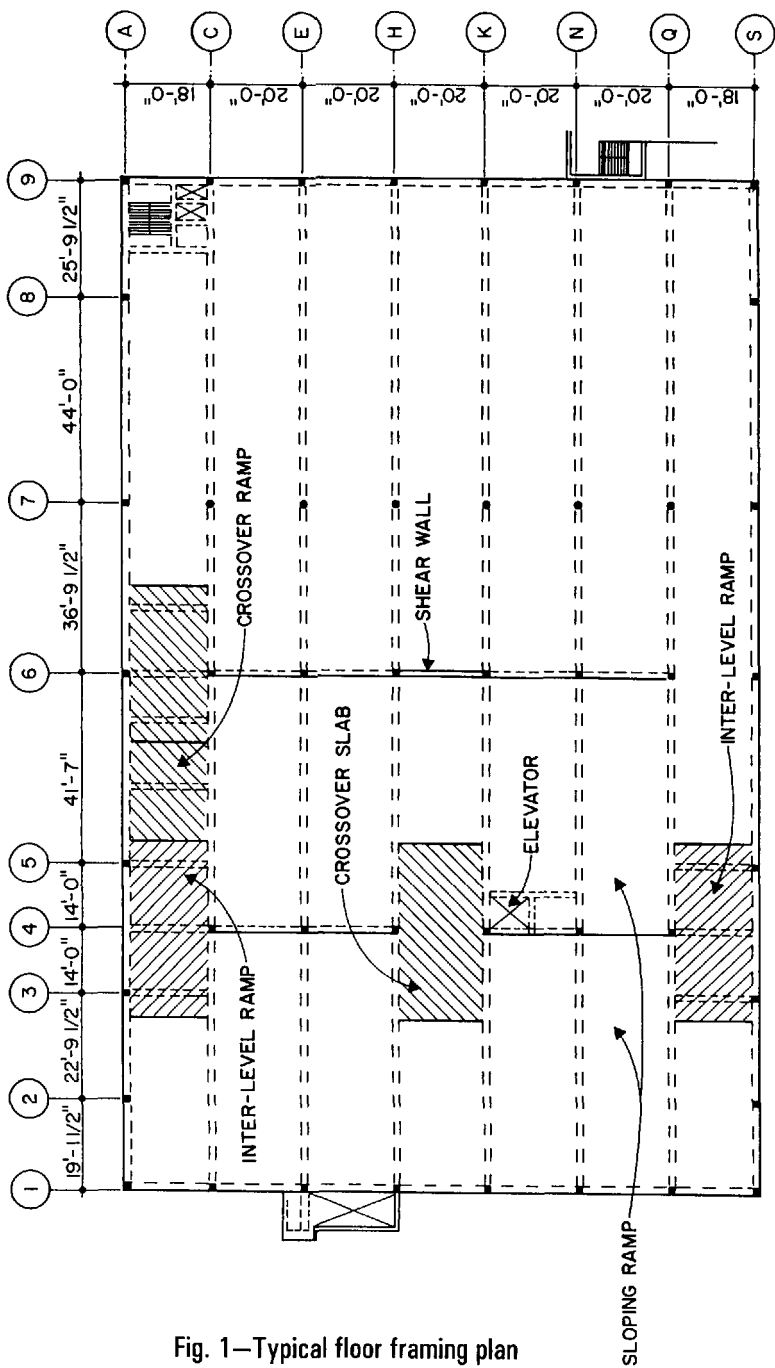
Fig. 1—Typical floor framing plan

Shown in Fig. 1 is a typical floor framing scheme for the eight story parking garage. This parking garage was built in 1975 and is constructed using unbonded post-tensioned concrete slabs and unbonded
