**Seismic Rehabilitation of RC Bridges by Using FRP and SRP:  
Case Study of a Bridge in the South of Italy**

**Synopsis:** The paper deals with a rehabilitation case study on a pre-stressed concrete (PC) bridge (named “Torrente Casale”), located in the south of Italy (on the Salerno-Reggio Calabria highway). The bridge, built in the '70s, was enlarged in 2001 in order to satisfy the new traffic demand. A seismic assessment of the bridge resulted necessary in order to verify its capacity to sustain both gravity and seismic loads. Both destructive and non-destructive tests have been performed in order to evaluate concrete and steel reinforcement mechanical properties. A theoretical analysis was performed, showing that the bridge piers existing cross section and internal reinforcement were not adequate to satisfy the seismic actions. Thus, two rehabilitation systems were investigated: a) an innovative technique based on the combined use of Fibre Reinforced Polymer laminates (FRP) and Steel Reinforced Polymer spikes (SRP), b) a traditional rehabilitation technique (i.e. RC jacketing). The design assumptions and calculations for the rehabilitation as well as the comparison between the

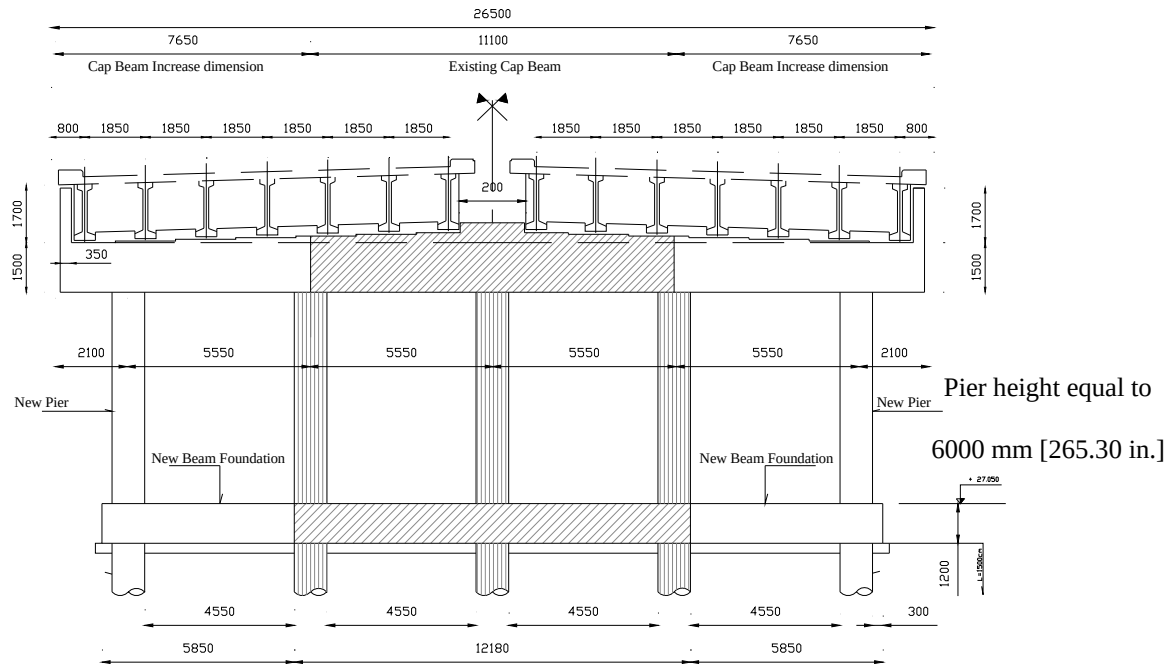
**Fig. 4**—Actual bridge belt configuration after enlargement interventions, (i.e. 2001)

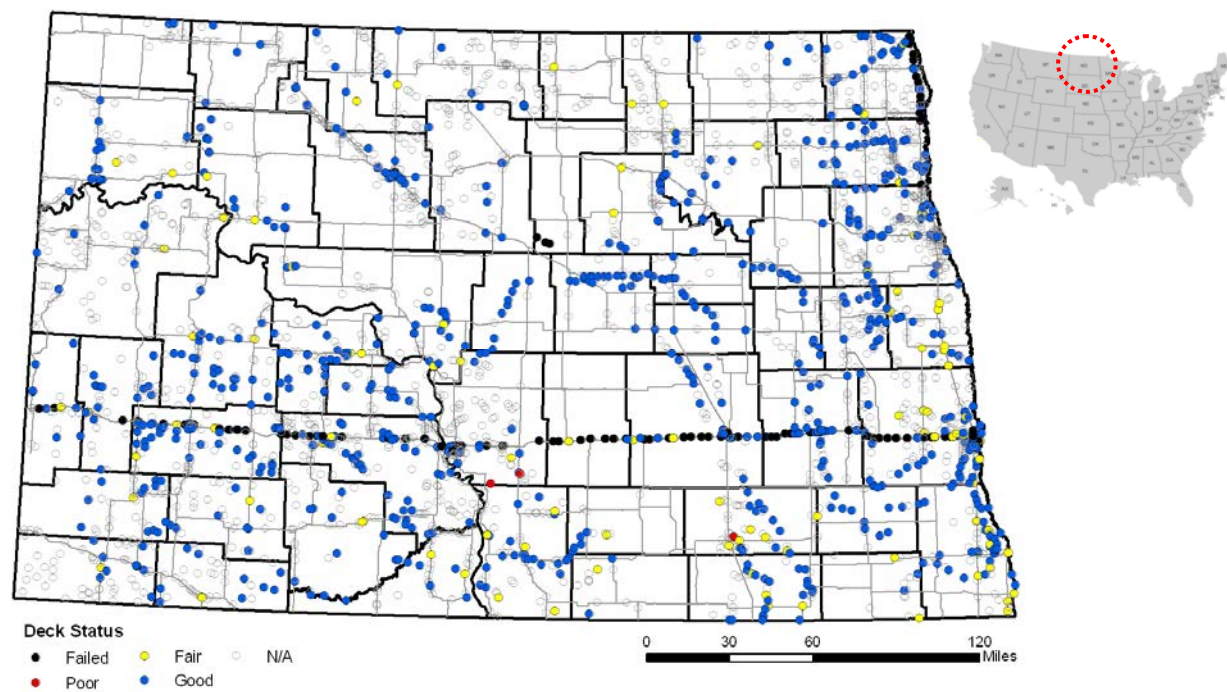
The present status of the 1,126 bridge decks is shown in Fig. 1, including state routes and interstate highways. Although the NBI demonstrated rating factors from 0 (*Failed*) to 9 (*Excellent*), the deck rating for this study was simplified into four categories, namely, *failed* (rating 0), *poor* (rating 1 to 4), *fair* (rating 5 to 6), and *good* (rating 7 to 9). The deterioration level of the bridge decks located in the interstate highways (i.e., I-29 and I-94 shown in the key map of Fig 2) was significantly higher than that of other roads, as shown in Fig. 1. This is primarily attributed to the volume of traffic (Fig. 2), including the operation of heavy trucks transporting commodities produced in the Midwest of the United States and central Canada. Figure 3 shows a typical example of deteriorated decks in the interstate highway of I-29. The relationship between the 104 decks failed (rating of 0) and the constructed year is shown in Fig. 4. Over 73% of the failed decks were constructed in the 1960's and 1970's. This may indicate that the critical year for deck failure would be around 1975, based on the inspection of 2006-2007.

**Fig. 1**—Status of bridge decks

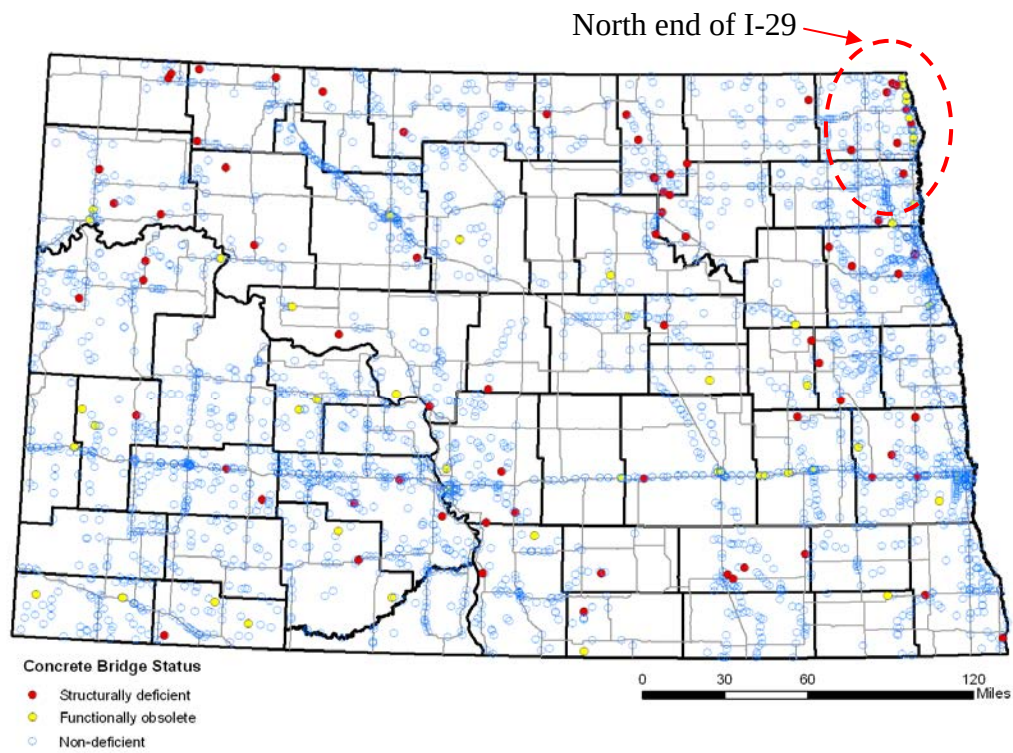
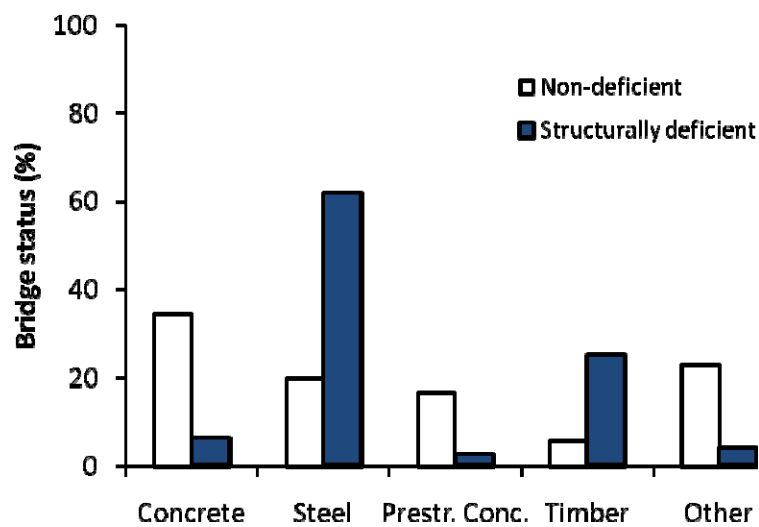
Figure 5 shows a geographical distribution of the bridges sorted by year-built. The interstate highways (I-29 and I-94) involved relatively old bridges that had been constructed before the 1960's, in particular near the north end of I-29. The present status of concrete bridges is shown in Fig. 6. Approximately 93% of the bridges were non-deficient (Fig. 6a) and the level of non-deficiency of the concrete bridges was well lower than that of other types of bridges (Fig. 6b). This observation supports that concrete bridges (including prestressed concrete members) may be an ideal structural type in cold regions. Most of the deteriorated bridges were randomly distributed across the state, whereas some concentrations of functionally obsolete bridges were found at north end of the interstate highway of I-29 (Fig. 6). This may be attributed to the fact that the bridges near the Canadian border were older than other bridges (Fig. 5), implying that the bridges constructed based on the out-of-date design specifications may not adequately accommodate the current traffic needs such as truck size and weight.

**Fig. 6**—Status of concrete bridges: (a) concrete bridges; (b) comparison of concrete bridges with other types of bridges (source from Kim and Yoon 2010)

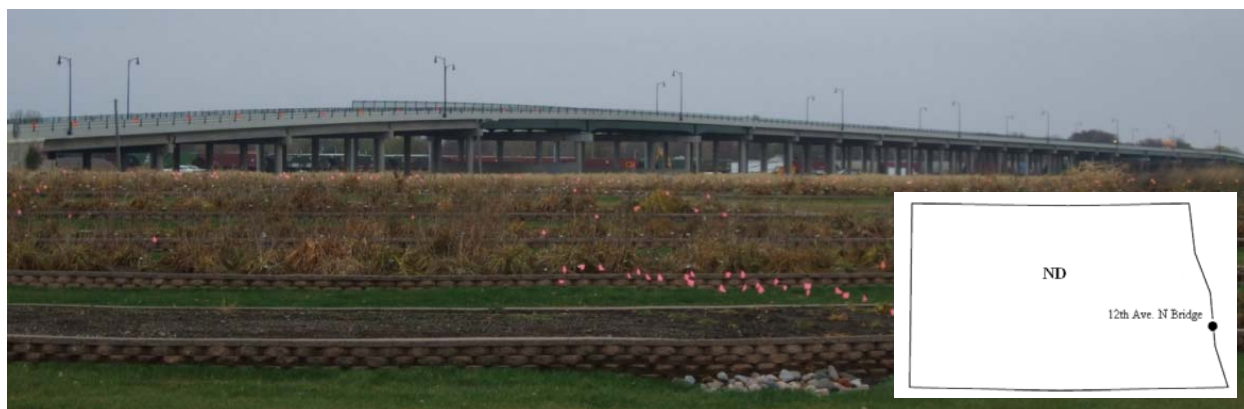
The bridge, 12<sup>th</sup> Avenue North Bridge (ID: 294-000.965) in Fargo, ND, consists of prestressed concrete girders and cast-in-place concrete decks, including steel plate girders near the approach, as shown in Fig. 8. The 29-span bridge was constructed in 1978 and includes two traffic lanes. The length of the bridge is 820 m [2,682 ft.] and the width of the deck is 20.5 m [67.2 ft.]. The estimated average daily traffic is 17,000. The condition rating of the bridge was conducted based on the bridge rating scale of the Federal Highway Administration, as shown in Table 2. Table 3 shows the condition ratings of the bridge over the last 20 years. The superstructure of the bridge showed a significant drop in the rating between 1989 and 1999, whereas the rating was stabilized after 1999. The deck rating gradually decreased from 7 to 5 for 20 years and no significant decrease in the rating was observed for the substructure, as shown in Table 3. It should be noted that regular maintenance and repair have been done to maintain the gradual decrease in deck ratings. The bridge exhibited a failure of the expansion joint and deck drain, and severe chloride penetration resulted from the excessive use of deicing salts. The chloride concentrations drained through the deck joints, over the girders, and down to the pier caps and piers, as shown in Fig. 9. To examine the chloride contents of the bridge, a number of samples were extracted from the deck, piers, and girders, as shown in Table 4. The chloride levels at the girders and piers were higher than those of the deck. This observation explains the rapid deterioration of the superstructure (Table 3) when compared to that of the deck slabs that have been regularly maintained and repaired. Figure 10 shows the deteriorated locations of the deck slab. The *Chain-drag* method was used to identify and map the deteriorated concrete. The primary source of the deterioration was corrosion of the reinforcing steel induced by the intrusion of chlorides into the cracked concrete.

**Fig. 8**—12th Ave. N. Bridge, Fargo, ND
