# Experience of Fires in Concrete Structures

by A. K. Tovey and R. N. Crook

# Fires During Nuclear Power Plant Construction

# Old Flames Speak Well of Young Concrete

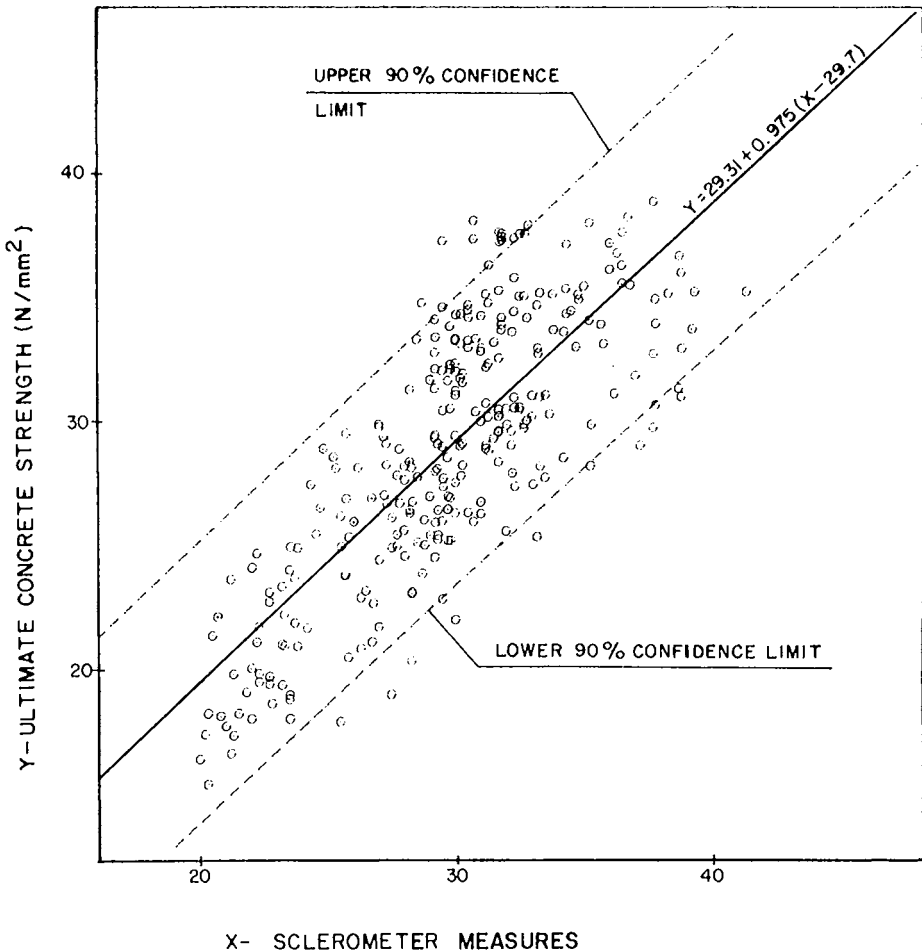
Fig. 3—Correlation between ultimate concrete strength and sclerometer measures in laboratory samples

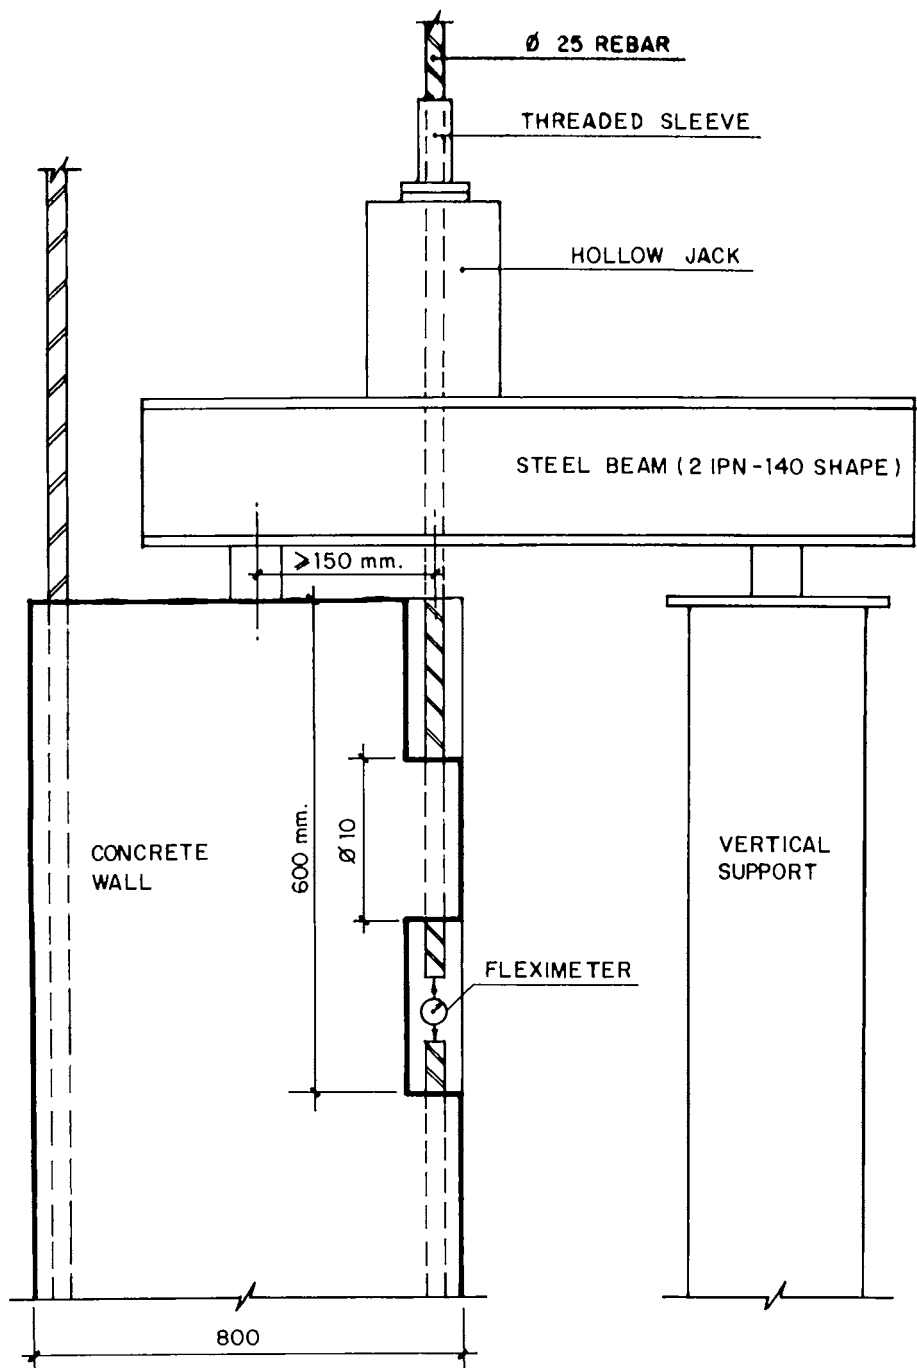
For the bond tests, wall reinforcement bars were chosen (see Fig. 6), and cut or isolated at a certain distance from the upper surface of the wall (60 cm).

Fig. 6—In situ bond test
