# A Crane Gear Failure Analysis – Case Study, Observations, Lessons Learned, Recommendations

by: R.J. Drago, Drive Systems Technology, Inc.

**American Gear Manufacturers Association**

## TECHNICAL PAPER

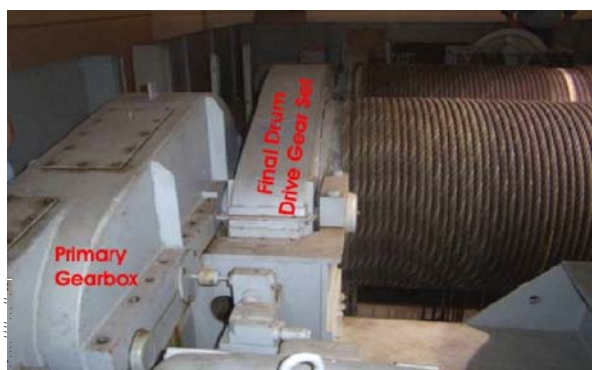
**Figure 1. Primary Gearbox, Final Drive Spur Gear Set Case and Wire Rope Drum**

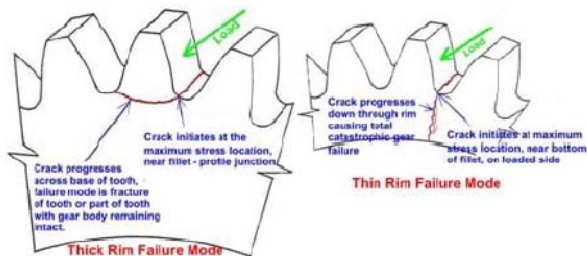
As Figure 4 shows, when a gear blank has a thick rim, if a crack initiates in the tooth root, the progression path is across the base of the tooth, ultimately liberating either a piece of the tooth or, if the face is narrow, the entire tooth.

**Figure 4 - Comparison of Thick and Thin Rim Failure Modes**

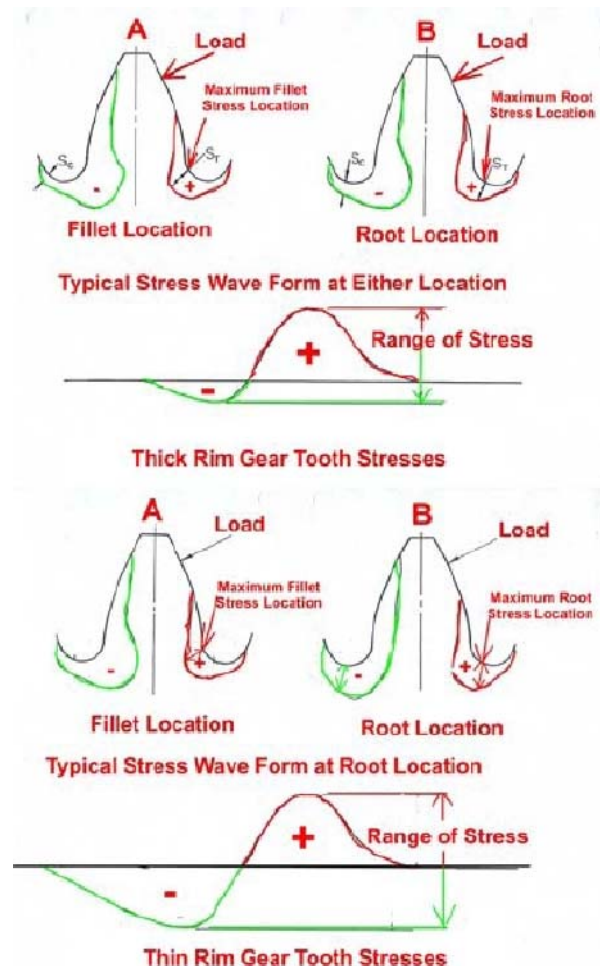
When the gear rim is thin, it “participates” in the tooth bending and the stresses at the tooth root change character dramatically, as Figure 5 shows.

**Figure 5 - Comparison of Fillet Stress Wave Forms for Thick and Thin Rimmed Gears**

Careful examination of the stress wave forms in Figure 5 shows that both the magnitude and the position of the maximum range of stress changes as the rim gets thinner. The results of these changes result in a change in failure mode (i.e. crack propagates through the rim rather than through the tooth base) and an increase in stress level. Considering this scenario, it is easy to understand how the shell pinion failure shown in Figure 3 occurred.
