# The Mechanism of Failure With and Without Titanium Nitride Coating in Roller Tests

by: Jože Vižintin, University Ljubljana

American Gear Manufacturers Association

## TECHNICAL PAPER

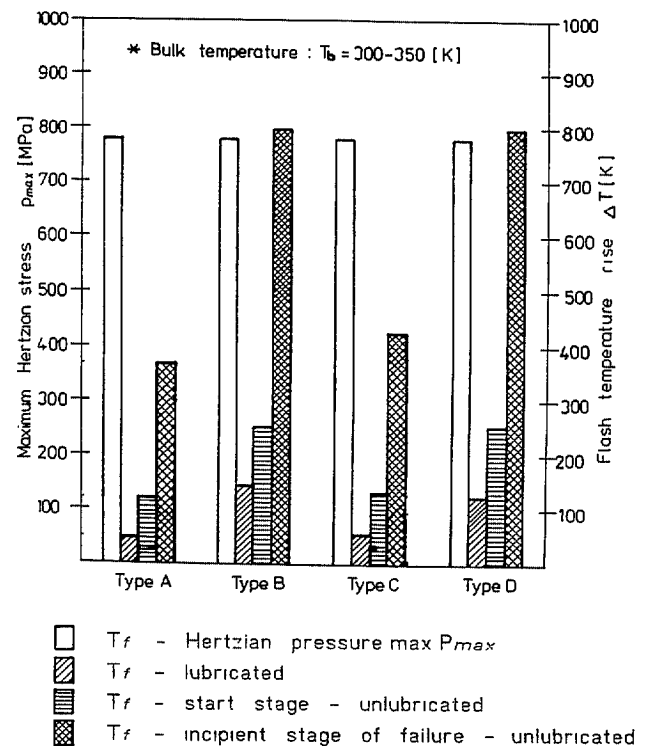
Figure 2 Calculated surface temperature rise and maximum Hertzian stress at the incipient stage of failure and at the initial stage

Figure 2 shows the calculated values of the flash temperature rise and the maximum Hertzian stress  $P_{max}$  at the start and at the incipient stage of failure, unlubricated and incipient stage when lubricated of the roller pairs tested. The flash temperature rise was calculated by the equation given in reference /3/, and the value of the coefficient of friction that was measured just before failure occurred and at the beginning of the roller pair tests. The Hertzian stress was constant during the tests. The flash temperature rise of the roller pairs Type B and Type D unlubricated was approximately 370 to 430 K higher than that Type A and Type C.

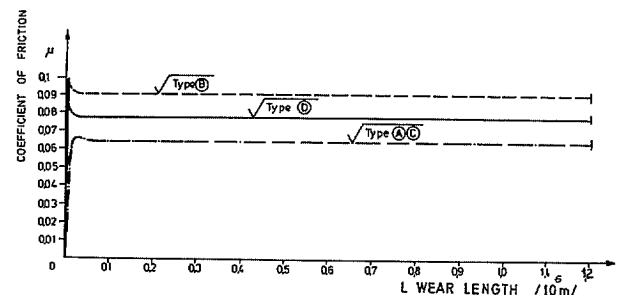
Figure 3 Relationship between coefficient of friction and wear length - lubricated conditions

The relationship between the coefficient of friction and the wear length is shown in Figure 3. The measurement of the coefficient of friction was carried out twice for each roller pair. Since the two values were similar, their mean value is shown.

For all roller pairs, the coefficient of friction just after the beginning of the test had a maximum value. After that, it decreased to a constant value with increasing wear length. The coefficient of friction of the roller pairs Type A and C was 0.065, that of the roller pair Type D was 0.078 and that of the roller pair Type B was highest 0.09.

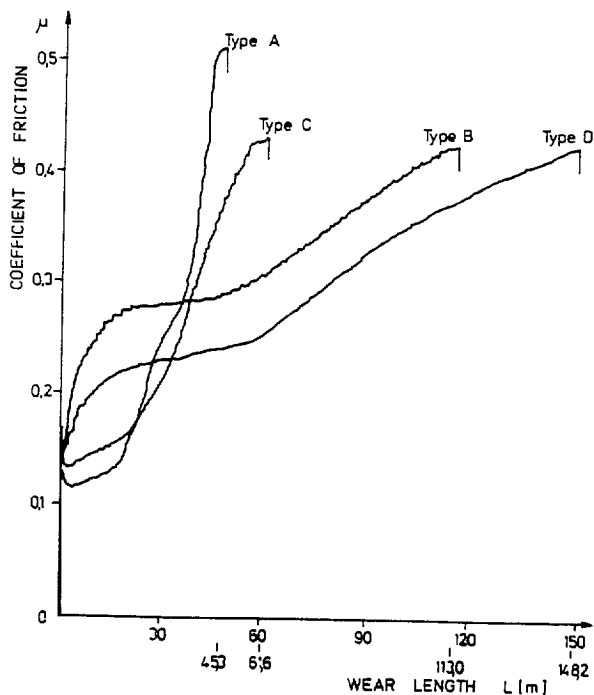
Figure 4. Relationship between coefficient of friction and unlubricated conditions for four roller pairs

The coefficient of friction varied with the difference in the base material and coating on the roller. For all the roller pairs it appeared that the surface was uniformly torn out due to frictional forces and wear; however, the contacting surfaces became smoother as shown in Table 3.

As the failure resistance of the coated and uncoated rollers could not be estimated from the test results obtained under lubrication, the failure test was carried out unlubricated. The testing was stopped when failure was observed. The initial friction coefficients were about 0.12 to 0.16 respectively. The relationship between the coefficient of friction and the wear length is shown in Figure 4.

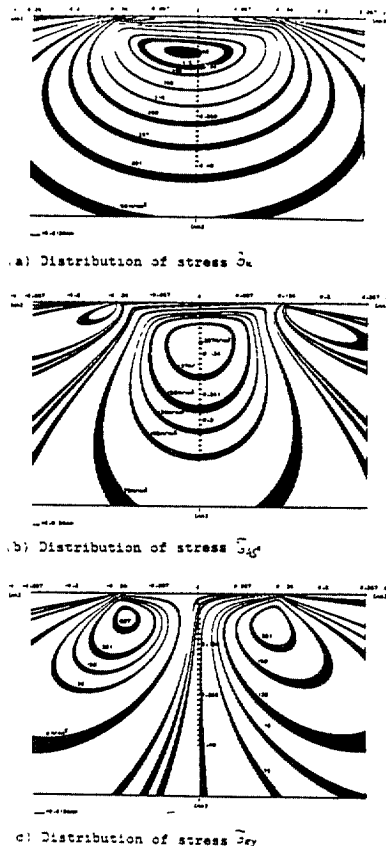
Figure 10 Distribution of resultant stress acting on the upper roller at the incipient stage of failure: coefficient of friction 0.065

As an example, the distribution of the equivalent stress  $\sigma_k$ , shear stress  $\sigma_{45^\circ}$  and reversed unidirectional stress  $\sigma_{zy}$  resulting from the combination of the Hertzian stress field and the frictional force field of the upper rollers are shown in Figure 10 and Figure 11 respectively. The value of the coefficient of friction is given from the measured value just before failure.

In Figures 10 and 11 the ordinate and abscissa indicate the position of the evaluated stress in terms of the parameters  $y$  and  $z$

The patterns show that maximum value of the stresses  $\sigma_k$ ,  $\sigma_{45^\circ}$  and  $\sigma_{zy}$  occurs below the contacting surface, and the profile of distribution of the stresses is approximately symmetrical to the origin for the roller pairs whose value of the coefficient of friction was under 0,1. On the contrary the profile of distribution of the stresses is not symmetrical to the origin for the roller whose value of the coefficient of friction was larger than 0,1. The maximum value of the stresses occurs on or below the surface, as shown Fig. 11.

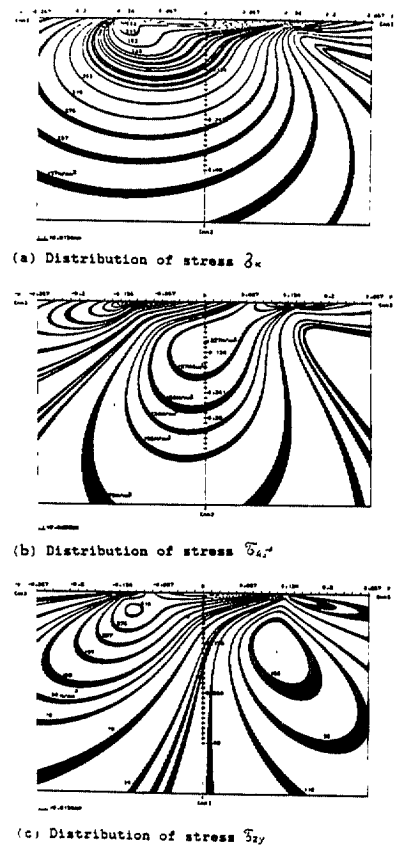
Figure 11 Distribution of resultant stress acting on the upper roller at the incipient stage of failure coefficient of friction 0.5

Figure 11 shows the distribution of the equivalent stresses. The maximum value occurs at a depth " $z$ " beneath the contact surface up to a coefficient of friction of 0,2. When the value of the coefficient of

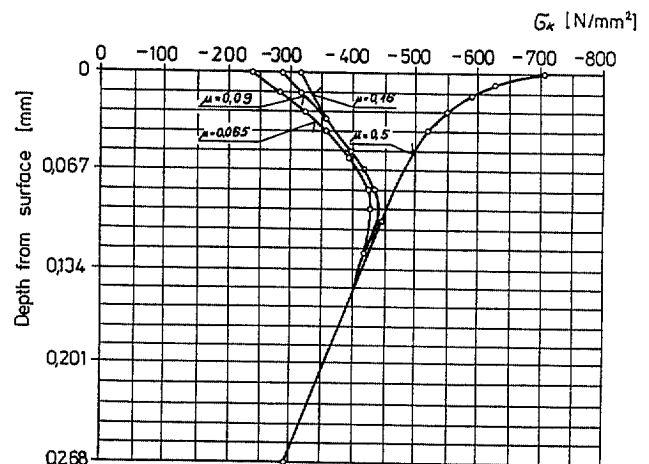
Figure 12. Distribution of equivalent stresses on and below the surface for different coefficient of friction,  $\mu$

Figures 12, 13 and 14 show the distribution of the maximum value of the equivalent stresses  $\sigma_k$ , the positive and negative components of the reversed shear stress  $\sigma$  the positive and negative components of the reversed shear stress  $\sigma_{zy}$  and shear stress  $\sigma_{45^\circ}$  for different values of friction coefficient.

friction is larger than 0.2 the maximum value of the equivalent stress occurs on the contact surface, Figure 12.

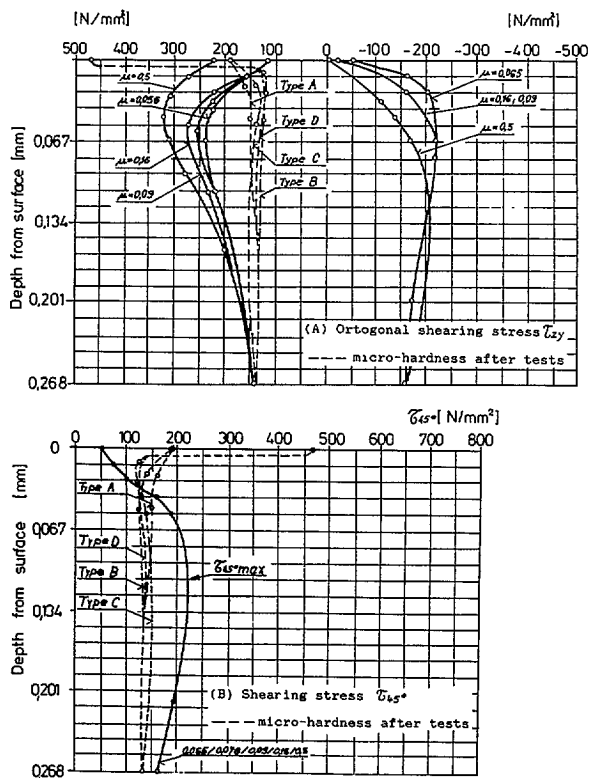
Figure 13 Distribution of reversed shearing stress and flow shearing stress on and below the surface at the incipient stage of failure

Figures 13 and 14 show the distribution of the maximum value of the positive and negative components of the reversed shearing stress and of the shearing stress acting on the upper rollers as a function of depth from surface. The same figures also present the values of the flow shearing stress for lubricated and dry friction conditions calculated from the micro hardness on the basis of equations published in the reference /8/. The reversed shearing stress acting at 5-10  $\mu\text{m}$  below the contact surface of the roller type A and C is equal to the flow shearing stress with lubrication before the test

Therefore this analysis showed that the surface layer of the roller type A and C is work-hardened and the mechanical properties of the layer increased. The surface layer of a thickness of about 15  $\mu\text{m}$  cannot be fractured due to the shearing force acting on the surface of the roller. The reversed shearing stress in the same surface layer of the rollers type B and D is considerably higher than the flow shearing stress before and after the test with lubrication. Therefore, the layer which was deeper than 2-4  $\mu\text{m}$  below the surface can be fractured due to the action of the shearing force on the contact surface of the roller with lubrication.

Under unlubricated conditions the reversed shearing stress below the TiN-layer of the roller pairs type A, B, C and D was considerably higher than the flow shearing stress before and after the tests. Therefore, the structure below the TiN layer can be fractured due to the action of the shearing force on the surface of the roller. As shown in Figures 6-9 the depth of the work-hardened layer and of the plastic deformation of the upper

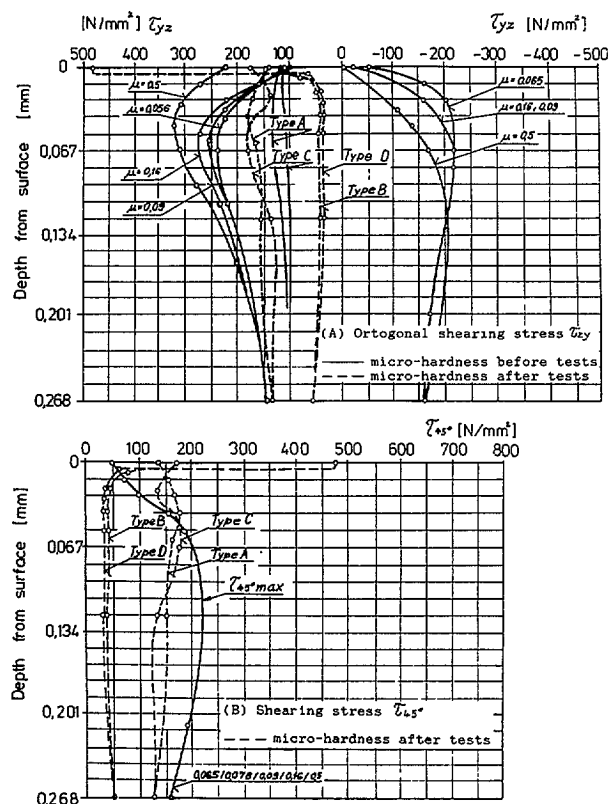
Fig 14 Distribution of reversed shearing stress, shearing stress and flow shearing stress on and below the surface at the incipient stage of failure

The reversed shear stresses acting parallel to the plane of the contact surface and its maximum value occur at a depth "z" beneath the contact surface and are dependent on the coefficient of friction (Figure 14). The maximum shear stress value occurs at a constant depth "z" below the contact surface  $z_2$  at an angle of  $45^\circ$  to the plane at the surface and is independent of the coefficient of friction. Figures 13. and 14
