## Stray Current Induced Localized Corrosion of Stainless-Steel Plates in A Tainter Gate System

Hongbo Ding, Jared Pannell, Dirk van Oostendorp  
Corpro  
7000A Hollister Road  
Houston, TX, 77040  
USA

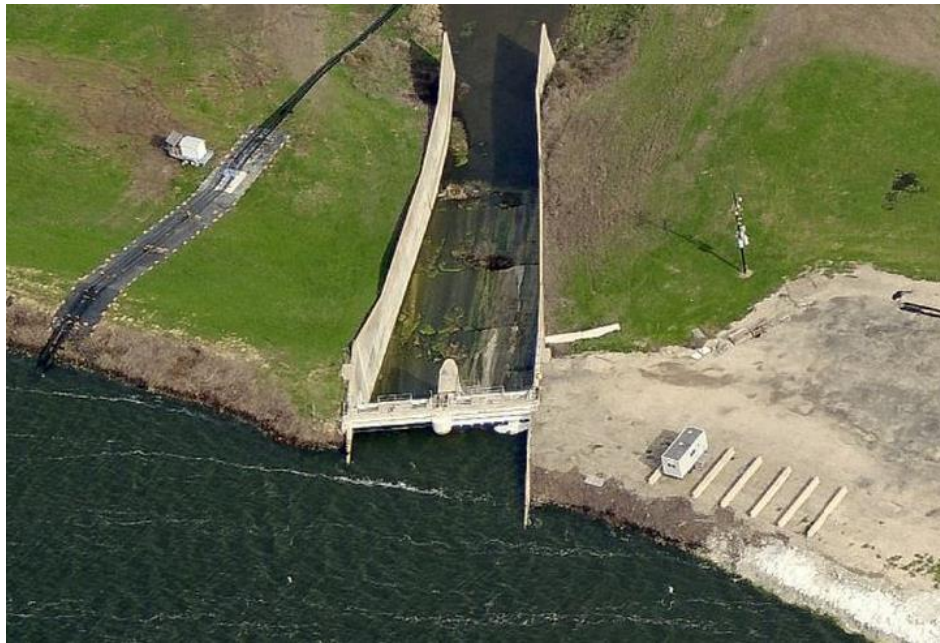
**Figure 1: Aerial View of the Tainter Gate**

There are two gates adjacent to each other, i.e., the South Gate (right in the image) and the North Gate (left in the image), or Gate 1 and Gate 2 respectively. The Tainter gates were installed in 2012. Magnesium anodes were originally installed, known as a galvanic anode cathodic protection (GACP), system for the subject gates. The GACP was replaced with an impressed current cathodic protection (ICCP) system in 2014. Localized corrosion was observed in 2018 on the bottom plate that is not part of the ICCP system. The location of the ICCP anodes are shown in the drawing as dashed line below (Figure 2). The corrosion is observed on the bottom plates that are not protected by the ICCP system.
