**Paper No.**  
**16501**

## **Evaluation of a 60-year old Iron Pipeline in a Corrosive Environment and Flow Test of a 97-year old Cement-mortar Lined Iron Pipeline**

L. G. Horn  
Ductile Iron Pipe Research Association  
P.O. Box 190306  
Birmingham, AL 35219

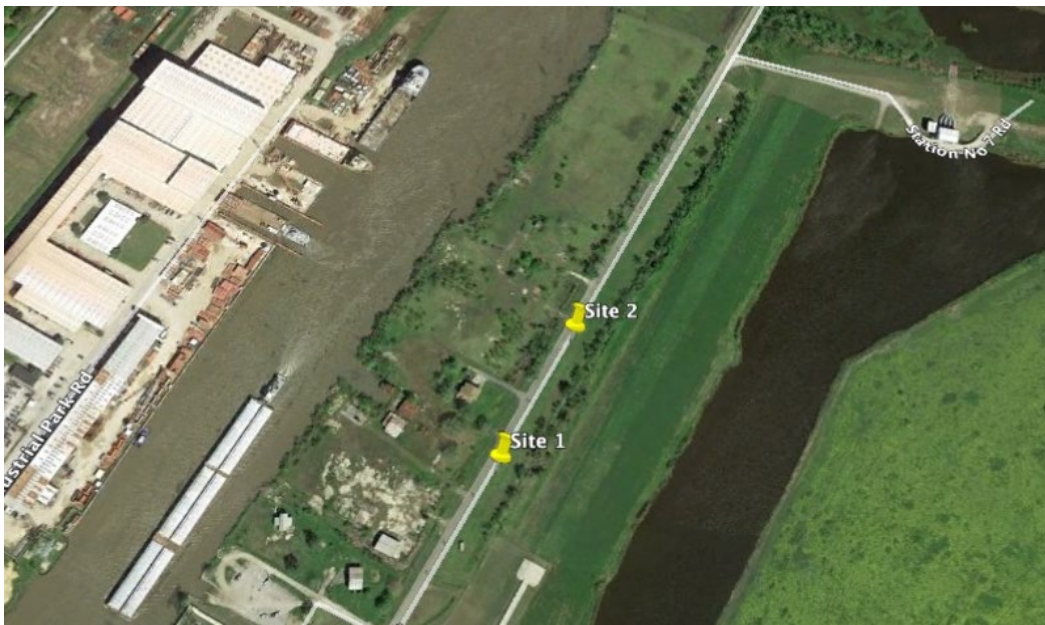
**Figure 1: Overhead view showing the two locations the pipe was examined in 2018. Locations are selected by the water district who conduct the excavation of the pipe.**
