## **Stress-Assisted Corrosion of a Superheater Tube: The Role of Thermal Fatigue Cracking and Crevice Corrosion in the Failure Mechanism**

Ewa Labuda  
Sheppard T. Powell Associates LLC  
Baltimore, MD  
USA

This paper discusses the results of a failure examination of superheater tubes from a boiler. The superheater tubes failed along steamside fissures associated with external surface welds attaching finger bars to adjacent tubes. The morphologies of the fissures were consistent with stress-assisted corrosion (SAC). In addition, cracks typical of thermal fatigue were present on some ID surfaces and at the tips of some fissures. The elemental compositions of corrosion products within the wide SAC fissures, determined using Scanning Electron Microscopy (SEM)/Energy Dispersive X-ray Spectroscopy (EDXS), support the possibility that crevice conditions led to accelerated corrosion during cool down periods, resulting in pit-like areas along the fissures. Failed and unfailed superheater tubes were examined using standard metallographic techniques. The results were used to develop a theory of the role of thermal fatigue cracking and crevice corrosion in SAC fissure initiation on the st

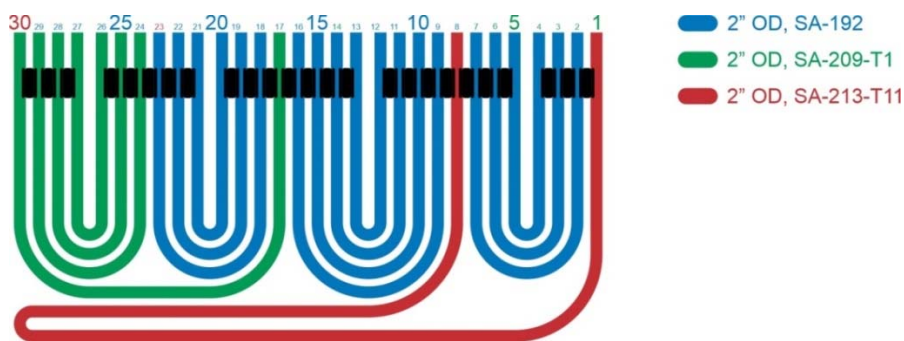
**Figure 3: Schematic of Tubes in the High Temperature Superheater Platen**

The tubes provided for the examination were from the high temperature and intermediate temperature superheaters. As an example, a sketch of the high temperature superheater platen assembly is shown in Figure 3. A schematic representation of finger bar welds between the tubes and the location of the axial fissures are depicted in Figure 4.
