**Paper No.**  
**16553**

## **Stress Corrosion Cracking of a Stainless Steel Vacuum Tower Bottom Line**

Xavier Roumeau  
Total  
Total Antwerp Platform  
Antwerp  
Belgium

Matthieu Devallée  
Total  
Total Port Arthur Refinery  
Port Arthur / Texas  
USA

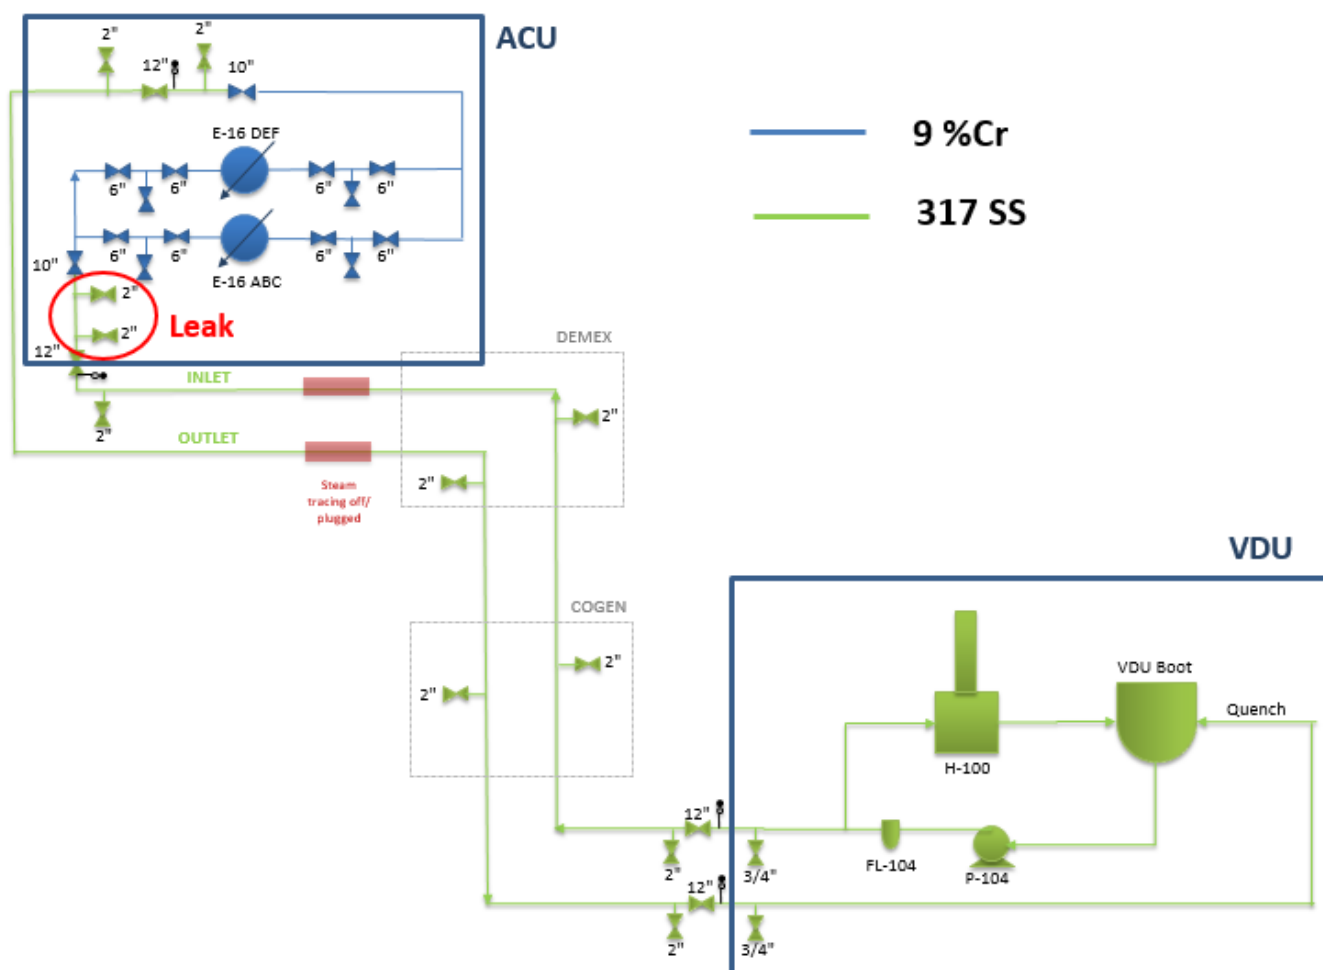
Figure 1: ACU and VDU VTB loop

For heat recovery purpose, VTB is used to heat the crude feed in the Atmospheric Crude Unit (ACU). The VTB circuit is spread between the Vacuum Distillation Unit (VDU), the ACU and the Outside Battery Limits piping (OSBL) in between, as presented in figure 1.
