Paper No.  
16680

## Microbiologically Influenced Corrosion in a Gas Storage Well

Noelle Easter C. Co, Ryan D. Milligan, Ming Gao,  
Rudolf H. Hausler, Ravi M. Krishnamurthy  
Blade Energy Partners  
16285 Park Ten PI Suite 600  
Houston, TX, 77084  
USA

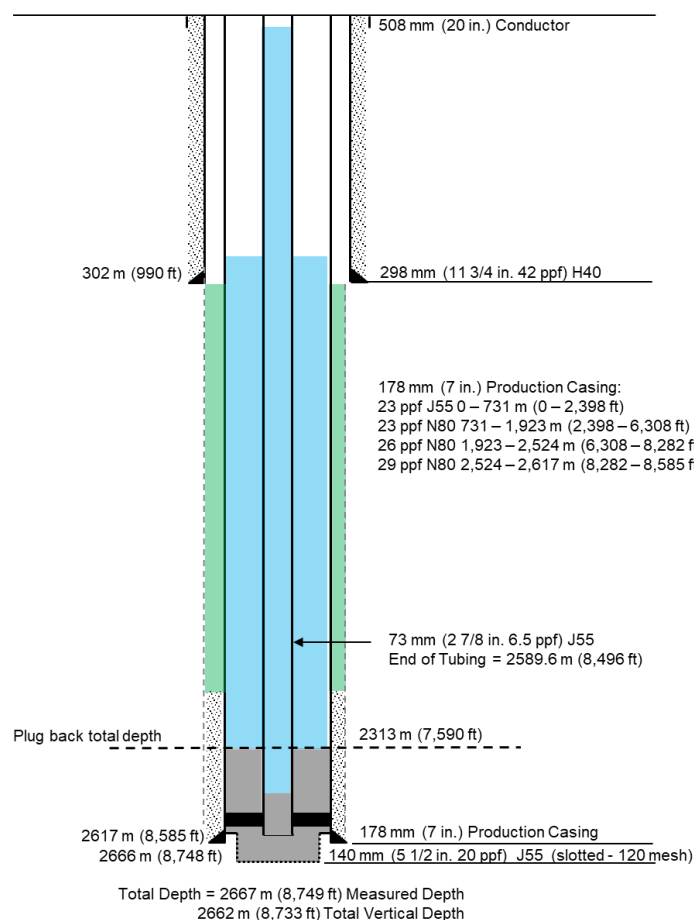
A gas storage well was originally drilled as an oil well in 1954; it was then converted into a gas storage well in 1973<sup>1</sup>. Gas injection and withdrawal occurred through the 73 mm (2 7/8 in.) tubing and the 178 mm (7 in.) production casing, while the 298 mm (11 3/4 in.) casing was used as a surface casing to protect groundwater (see Figure 1). To ensure the integrity of the well for safe operation, pressure measurements were obtained regularly, the temperature was logged annually, and the noise logs were captured occasionally. There was no indication of integrity issues until the well started leaking in the last quarter of 2015. The production casing axially ruptured and circumferentially parted, resulting in a natural gas blowout for 111 days. The well was controlled in early 2016 and permanently plugged in 2018.

**Figure 1: Schematic of SS-25 Well**
