## AC Corrosion at Other Frequencies Part A: Field Investigation and Mitigation

### ABSTRACT

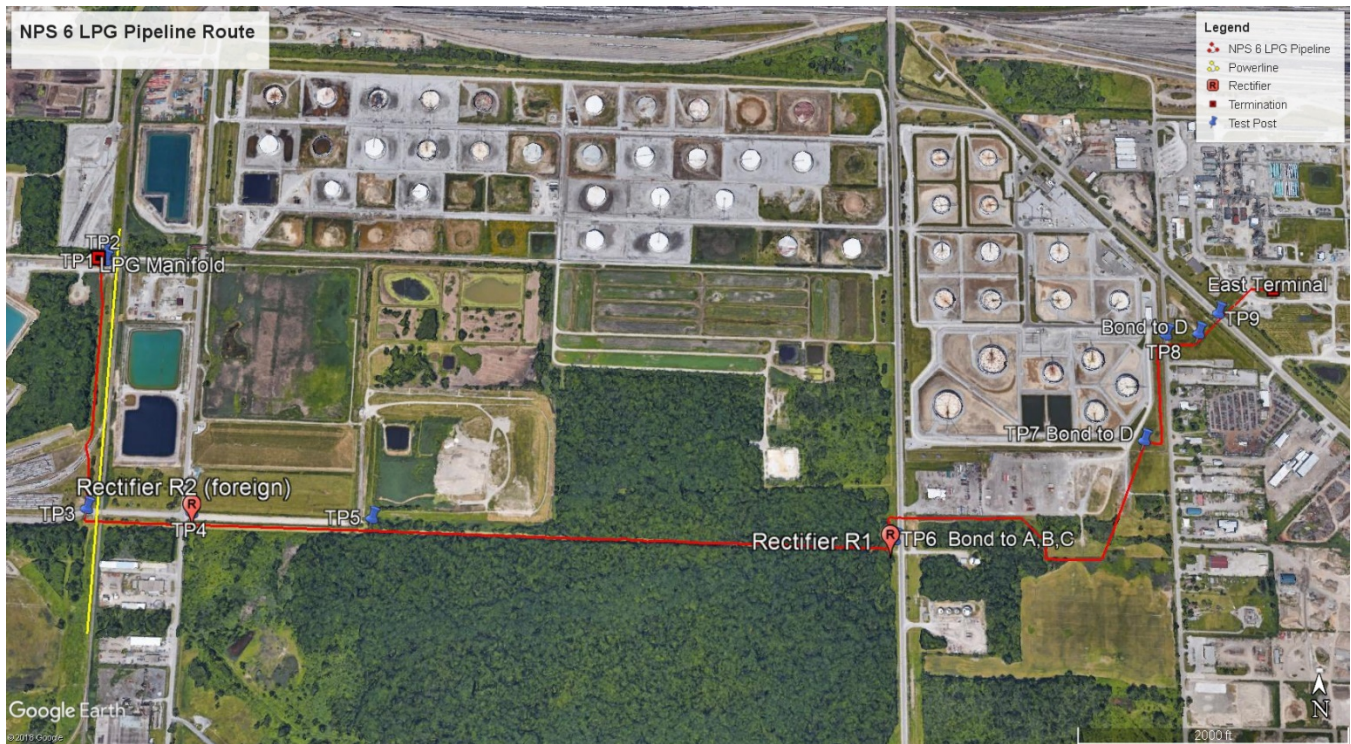
Figure 1: Pipeline Route (Source: Google Earth<sup>†</sup> 2018)

A high voltage AC (HVAC) powerline parallels the pipeline for approximately 600 m between the LPG manifold at the west end and test post TP3. Figure 1 shows an overview of the project area.

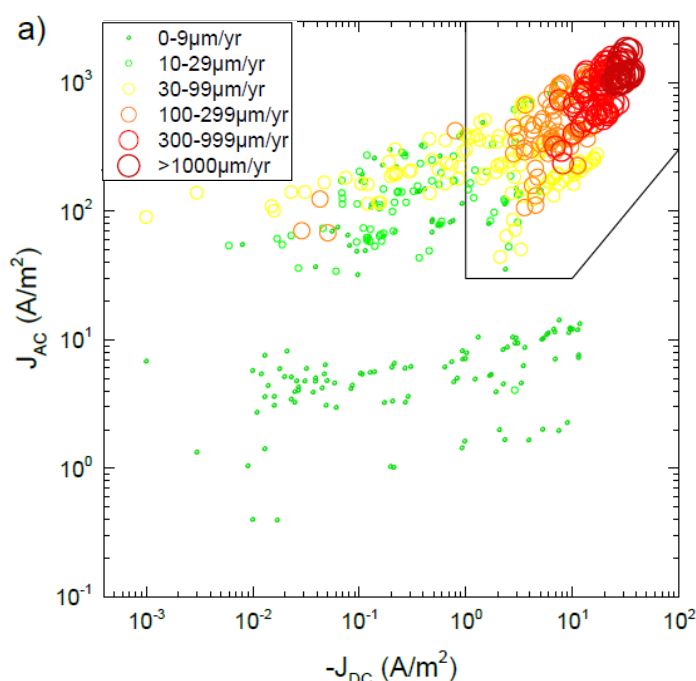
Figure 3: Corrosion Rates Measured on ER Probes Installed at Various Sites<sup>5</sup>

Data from extensive laboratory testing on  $1 \text{ cm}^2$  corrosion rate probes is summarized in Figure 3, and has been used to assess the combined effects of DC and AC current density ( $J_{\text{AC}}$  and  $J_{\text{DC}}$ ) on the AC corrosion rate.

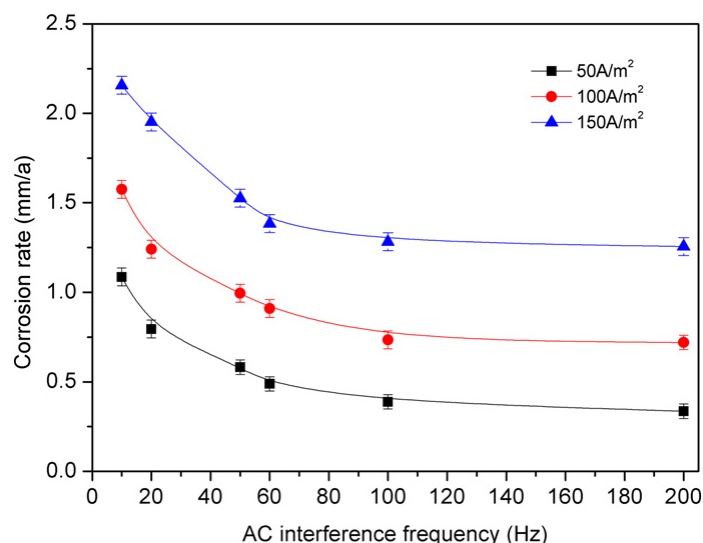
**Figure 4: Corrosion Rate for X60 Pipeline Steel in Simulated Soil Solution versus AC Interference Frequency<sup>6</sup>**

As shown in Figure 4 for steel samples tested in simulated soil solution, the AC corrosion rate decreases with an increase in the AC signal frequency. This change is particularly evident for frequencies less than 60 Hz. The corrosion rates in this study are significant for a frequency of 120 Hz, and only marginally less than those for 60 Hz. However, these tests were performed in liquid solutions on samples with no cathodic protection and may not be representative of the conditions in this case study. No previous literature was found on the effects of frequency on AC corrosion rates of cathodically protected steel in soil.
