## **Slurry Abrasion Failure Of A Carbon Steel Pipe Carrying Bitumen Froth In Oil Sands**

In this paper, the premature failure of a carbon steel pipe carrying bitumen froth (60 to 90°C; 1,040 kg/m<sup>3</sup> density) from oil sands primary extraction is analyzed. The leak developed at approximately 1,000 m downstream the pumps' discharge on an underground sloped section of the pipeline and was due to the thinning of the pipe wall. An extensive investigation was conducted including detailed visual and microscopic examination, mechanical testing, froth and solids abrasivity characterization, and hydraulics analysis. Various laboratory tests were performed to simulate different wear and corrosive-wear conditions in order to replicate and better understand the failure. Results showed that despite slurry erosion to be the expected damage mechanism, the failure was actually caused by a slurry abrasion process. This can create thickness loss rates much more aggressive than those expected by an erosive process under similar conditions. A new wear mechanism is proposed to explain the observed results.

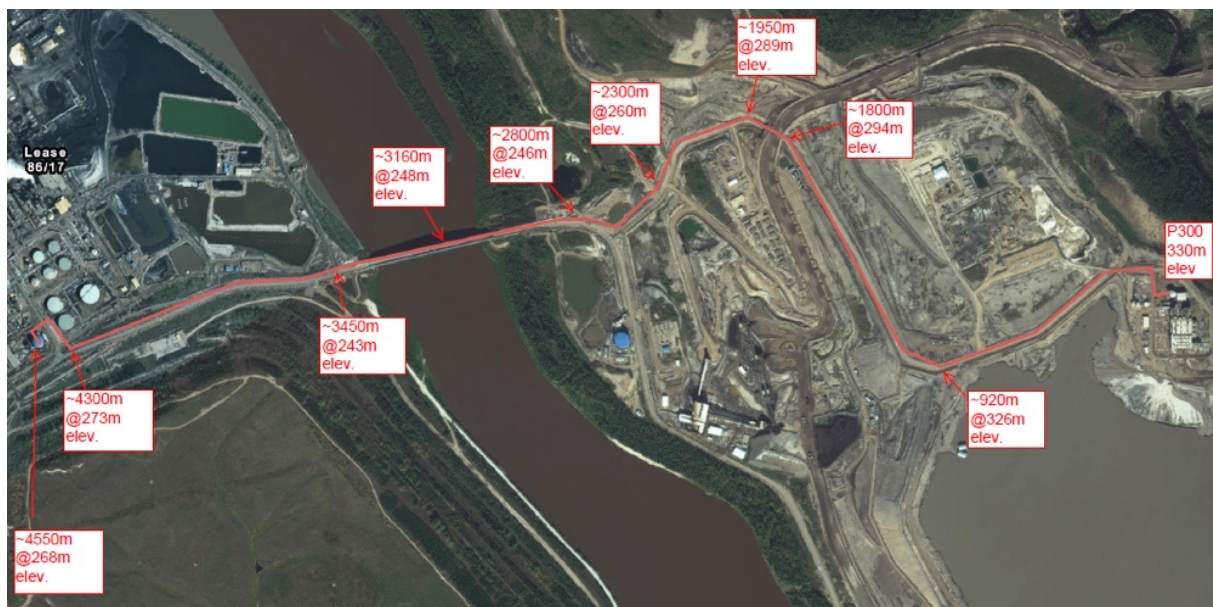
**Figure 1: Steepbank primary froth line routing and elevation changes.**

The failure location was in a sloped section between 900 m to 1,100 m from the Steepbank Plant, and exhibited severe wall thickness loss with a split over 12 m long (Figure 2), which resulted in 600 m of pipeline to be replaced due to thinning. In order to understand the thinning mechanism(s) leading to such premature failure, an extensive failure investigation was conducted including detailed visual and microscopic examination, mechanical testing, froth and solids abrasivity characterization, and hydraulics analysis. Various laboratory tests were performed to simulate different wear and corrosive-wear conditions in order to replicate the damage and better understand the failure.
