## Black Powder Results in NGLF Interruptions

Yahya T. Al-Janabi, Noktan Alyami, Matteo Leoni,  
Anaam Al-ShaikhAli, Eid F. Al-Helal, Taib B. Abang  
Saudi Arabian Oil Company,  
Dhahran 31311, Saudi Arabia

### ABSTRACT

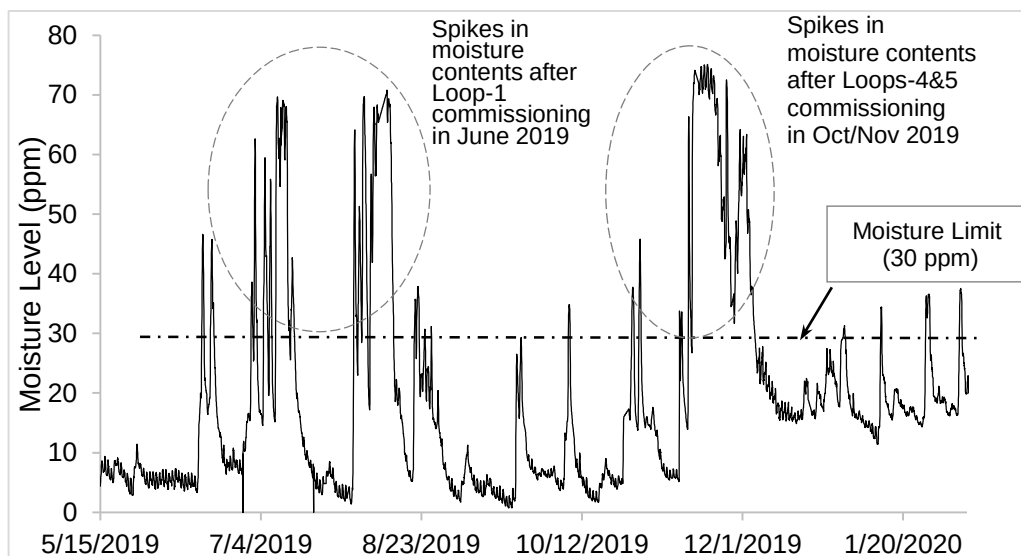
By studying the operational data of gas plants and crude processing facilities, it was concluded that both were not the source of these solid contaminants. Pipeline loops were the remaining potential source of these contaminants. Spikes of moisture level were observed in the moisture data of the NGLF feed over time, Figure 4. The NGLF had experienced high moisture contents exceeding 70 ppmv following commissioning activities of loop-1 in June 2019, and loops-4&5 in October/November 2019. The moisture upper limit is set at 30 ppmv. This observation further indicated that pipelines could be the source of these contaminants.

**Figure 4: Moisture level over time in NGLF C<sub>2</sub>+NGL feed.**
