## **After 30 Years of Duplex Stainless Steel Experience in Oil & Gas - Do we still face challenges?**

Janardhan Rao Saithala, Amjad Kharusi, Mohammed Ghafri, Talal Nabhani  
Manish Kulkarni, Nasser Behlani,

Petroleum Development Oman  
PO Box 81, Muscat  
Sultanate of Oman

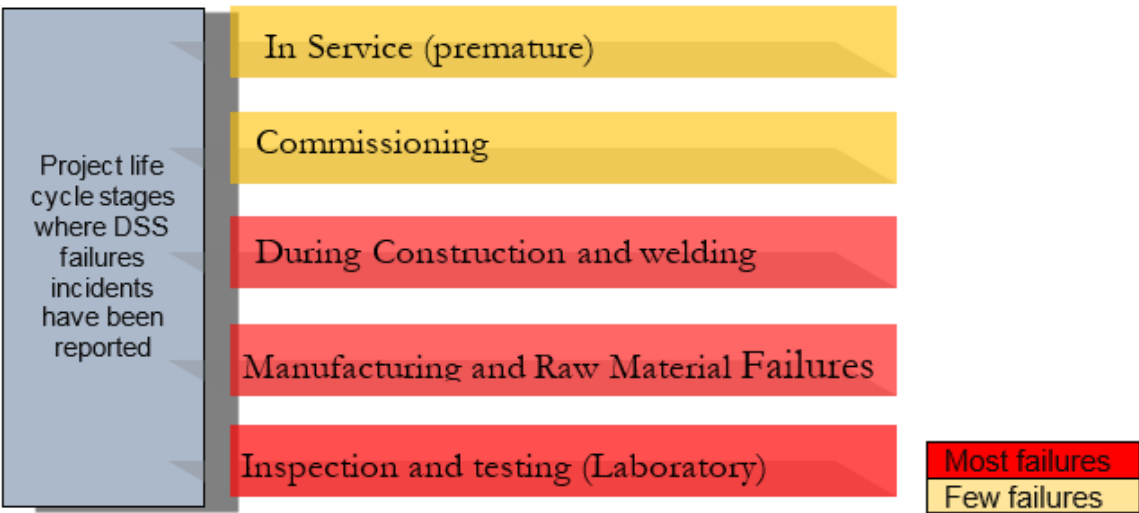
Figure 2: Key stages of DSS failures occurrence

Unanticipated failures have a major impact on Oil & Gas business operations, people and assets. In addition DSS failures had significant effect on project delivery, project costs (both capital and operational). Many failures and challenges in DSS products have been captured during the last 30 years of operations, and their occurrence can be divided into five key stages as shown in Figure 2.
