## **Failure Analysis of a Pulsation Dampener Using Statistical Fractography**

### **ABSTRACT**

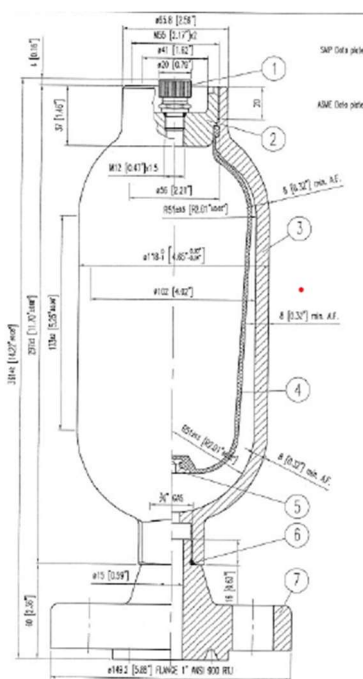
Figure 1: Dampener design

The basic design of the dampener is shown in Figure 1, whilst the location where the dampener was located is shown in Figure 2. The site is situated offshore in the Gulf of Guinea. Figure 3 shows the retrieved fractured part.
