## **Failure Analyses On A Super Duplex Stainless Steel Tube Material Before And After Slow Strain Rate Testing In Sour Conditions – Part 2: A Case Study On Local Corrosion**

### **ABSTRACT**

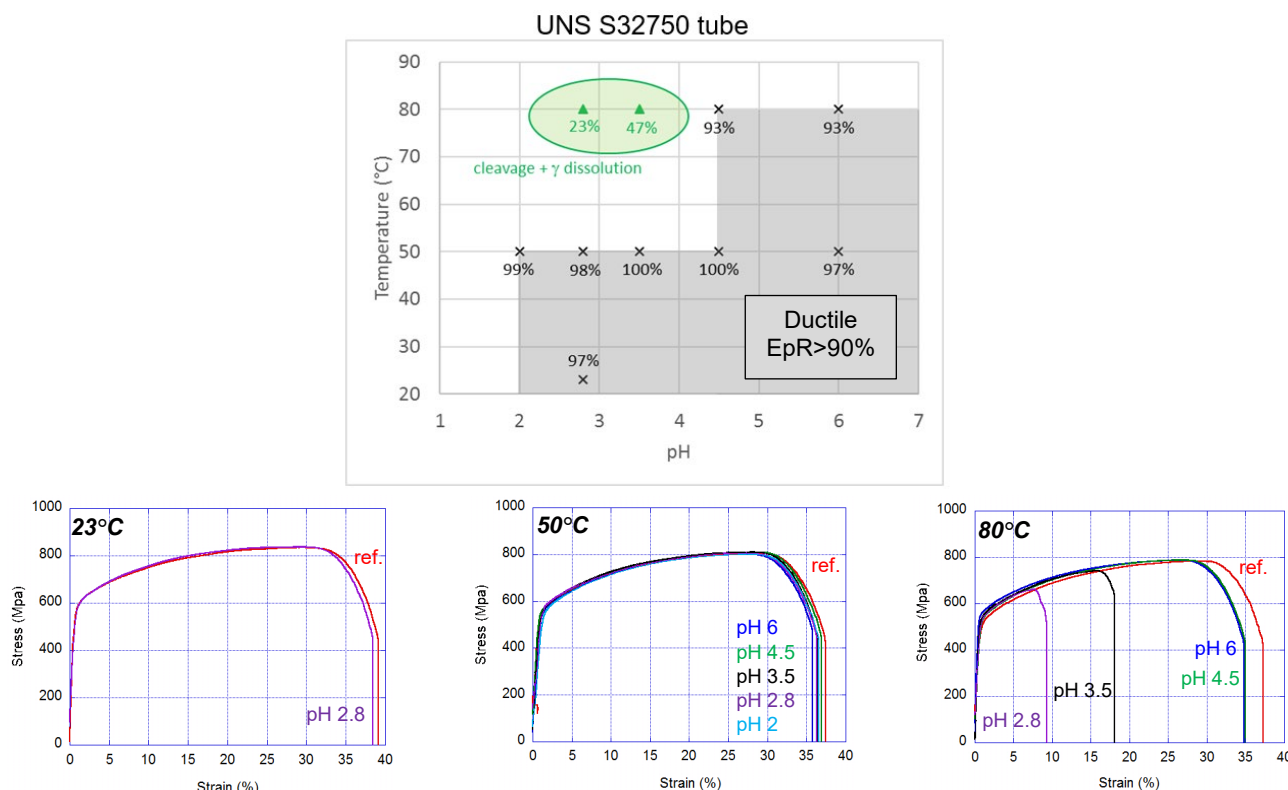
**Figure 1: T-pH domain (upper picture) for a UNS S32750 tube material by SSRT in NACE Solution A: 50 g/L NaCl, 5 g/L NaCH<sub>3</sub>COO, acidified by HCl for reaching the specified pH, 0.5 bar (7.25 psi) H<sub>2</sub>S. Plastic elongation ratio (EpR > 90%) in the grey condition area; SCC and austenite SD were observed in the green condition area. Stress-strain curves in lower pictures.**
