| Ref: | NR/GN/SIG/17902 |

# Guidance Note

## SSI Program and Data Problems

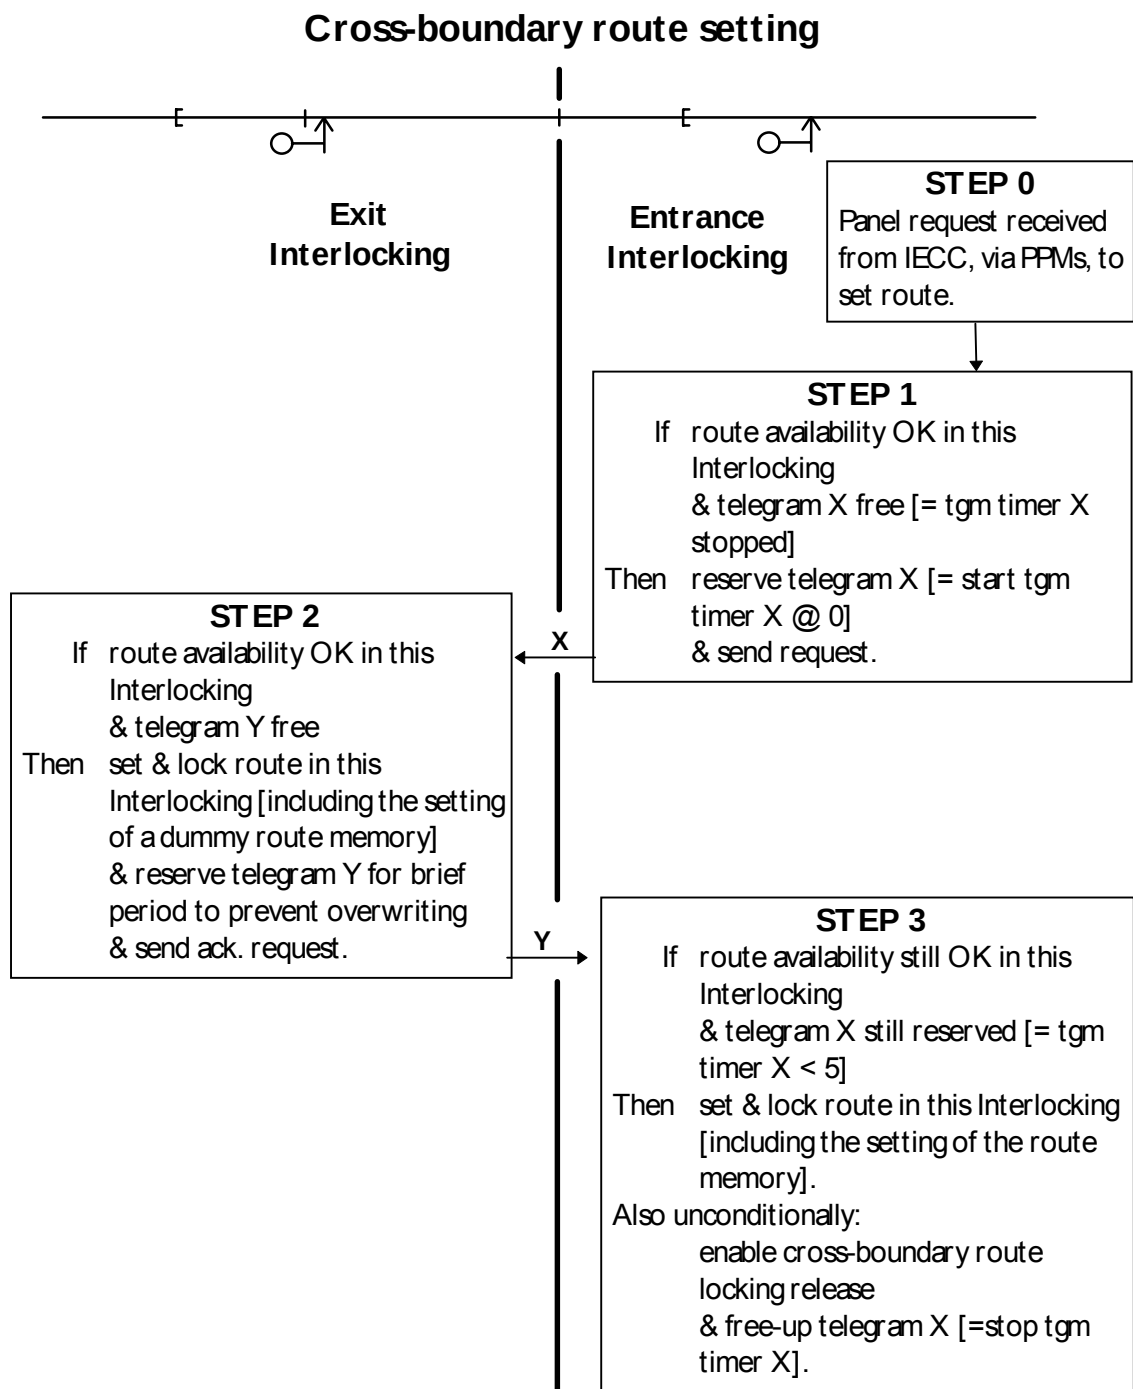
Figure 12

Once the Entrance Interlocking has received a panel request to set a cross-boundary route, then a three step hand-shaking process takes place, as shown in Figure 12. A

In Step 3 of the route setting process, the cross-boundary route locking release is unconditionally enabled. If the route is successfully set at this point then the release of the route locking in the Exit Interlocking is inhibited until the sectional route locking in the Entrance Interlocking is released up to the boundary (see Figure 13). If the route fails to be set in the Entrance Interlocking at Step 3 (e.g. because route availability in the Entrance Interlocking has changed between Steps 1 & 3) then route locking release is initiated in the Exit Interlocking in order to cancel the route setting that took place at Step 2.

Chained alternative routes are expected to be implemented such that if the route availability tests for the preferred alternative fail at either Steps 1 or 2 (but not at 3) then Steps 1 to 3 are repeated for the second alternative.

Because the two Interlockings' major cycle times will usually be different, a "transmit-twice" feature is employed by each sending Interlocking such that each cross-boundary request or acknowledgement is sent twice. This is so that each receiving Interlocking receives each request or acknowledgement at least once, however, this also means it is usually received (and processed) twice. If the receiving Interlocking is running faster (i.e. it has a smaller major cycle time) than the sending Interlocking, then requests/acknowledgements will occasionally be received (and processed) thrice. Any second or third acknowledgements received, although processed, are expected to have no effect because of failure of the "telegram still reserved" test in Step 3, as the telegram timer has already been stopped by the first acknowledgement.

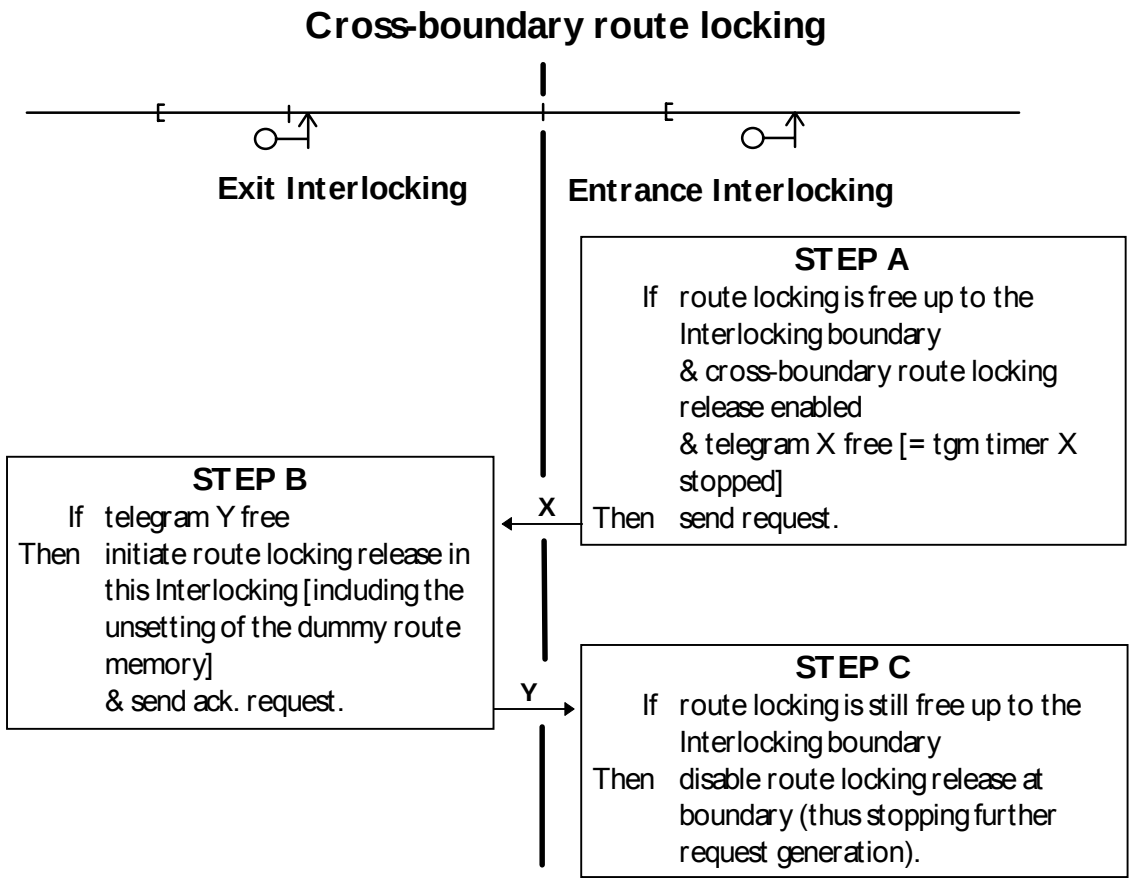
Figure 13

The releasing of sectional route locking across boundaries is done by a similar handshaking method, as shown in Figure 13. The data for Step A is regularly cycled with the resulting cross-boundary request continuing to be generated (i.e. not a "one-shot" request) until the acknowledgement is received in Step C. Because of this it can be treated as a lower priority request and does not need to reserve the telegram as the above higher priority route setting requests do.

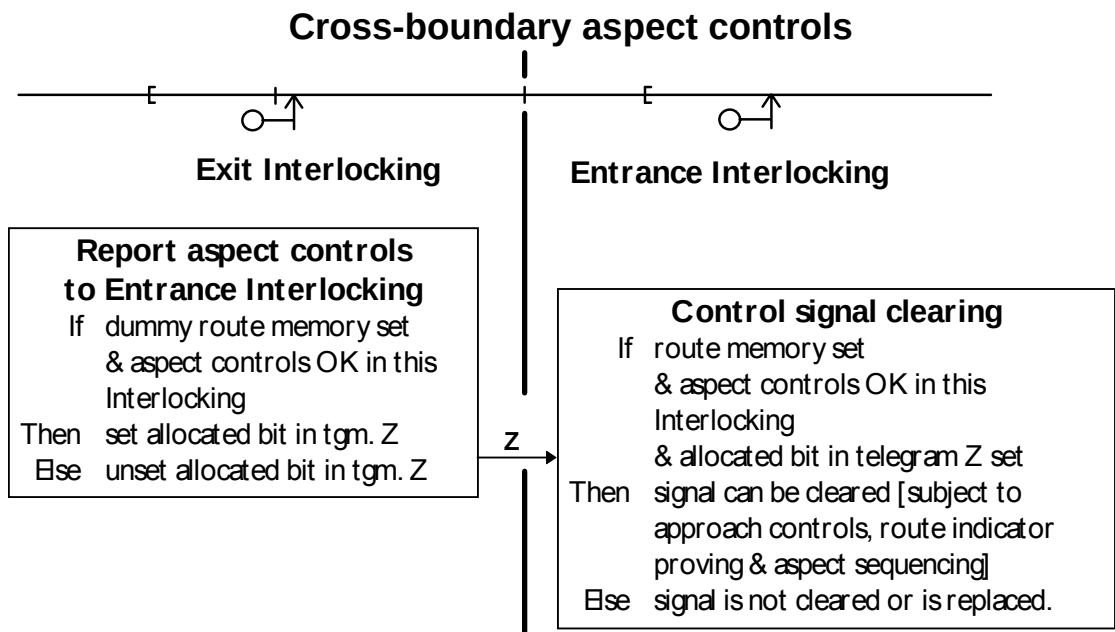
Figure 14

The method of transferring the aspect controls from the Exit Interlocking to the Entrance Interlocking is shown in Figure 14. Unlike in telegrams X & Y above, which are only used to transfer one request at a time in the form of an eight-bit code, up to eight bits of steady state information are transferred by telegram Z. As well as aspect controls, other information such as aspect sequencing and track circuit states may be transferred. Dummy route memories are allocated for each combination of route class and destination, these being used to select which aspect controls are to be transferred. The included dummy route memory test in the Exit Interlocking is also a check that the route locking in the Exit Interlocking is present. A similar arrangement applies to a route crossing a castellated boundary, the aspect controls tested in the Exit Interlocking including those for both parts of the route in this Interlocking.
