| Ref: | NR/L2/ELP/27009/MOD C12 |

## OVERHEAD LINE CAMPAIGN CHANGES – DATA SHEET

### MODIFICATION OF SEIZED MECHANICALLY INDEPENDENT REGISTRATION (MIR) HINGE ASSEMBLIES

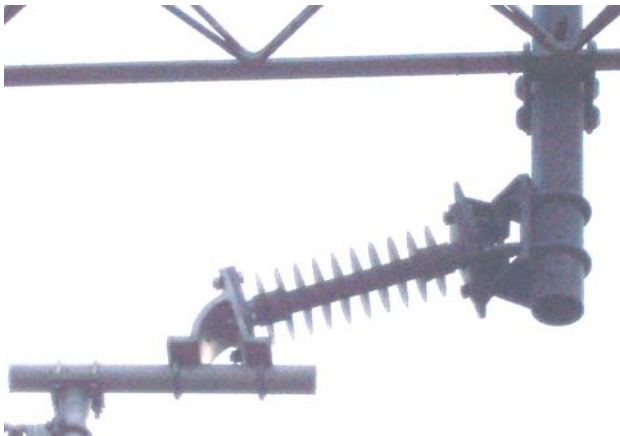
**COMPONENT** Seized hinges in “Mechanically-Independent Registration” (MIR) assemblies on portal structures.

**PROBLEM** Lack of available along track movement at the registration causes mechanical stressing of insulators and other components.

| OVERHEAD LINE CAMPAIGN CHANGES – DATA SHEET | |
|---|---|
| <b>ACTION REQUIRED</b> | <ol style="list-style-type: none"> <li>1. Replace seized hinges with refurbished or fabricated brackets.</li> </ol><br> |
