# The Effects of Surface Texture on Fretting Fatigue between Fastener and Aluminum Structure

2010-01-1854

Published  
09/28/2010Hasim Mulazimoglu  
Alcoa Fastening Systems

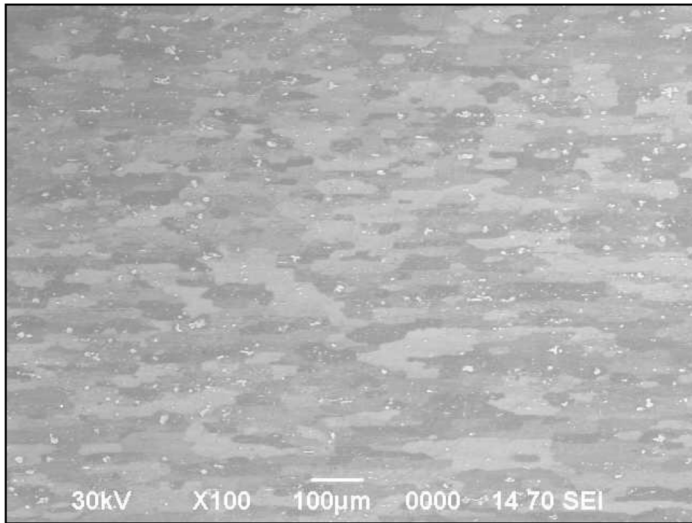
**Figure 3. Optical micrograph showing the general microstructure of the test plates.**

and other microstructure details. The optical micrograph is presented in Figure 3. As can be seen in this figure, the microstructure of 2024 alloys consists of elongated grains and dispersed un-dissolved inter-metallic phases which are typical features of cold finish 2024 plates.
