# Timber Utility Pole Fracture Mechanics Due to Non-Deformable and Deformable Moving Barrier Impacts

2011-01-0288

Jeffrey Croteau, Benjamin Frank, Daniel Peterson and Cleve Bare  
Exponent Inc.

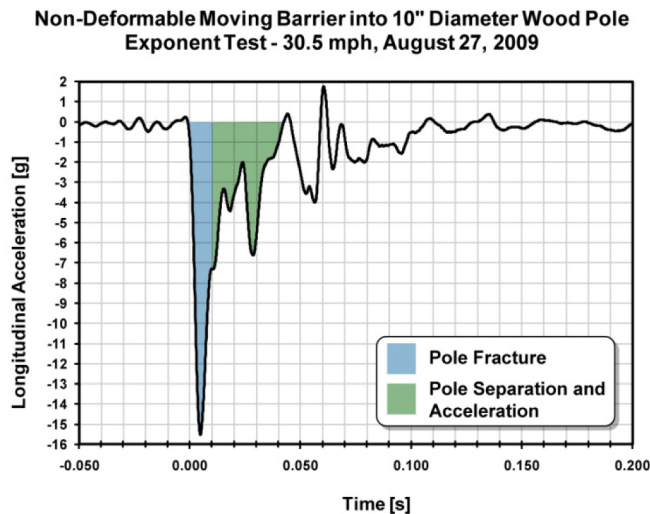
In each of the tests conducted with the non-deformable moving barrier (NDMB), the pole fractured early in the collision and the impact was separated into two distinct regions. These two regions are depicted in the blue and green shaded regions in [Figure 6](#) for the 30.5 mph (49.1 kph) test. In this test, the barrier experienced a peak deceleration of 16 g, which corresponds to the initiation of fracture. Fracture of the pole was complete at 9.7 milliseconds, corresponding with the right edge of the blue shaded region. Once the pole had fractured (after 10 ms), the non-grounded (upper) portion was accelerated by the barrier and separated from the

*Figure 6. Longitudinal acceleration time history for the 30.5 mph NDMB test, annotated with two distinct regions of pole fracture and separation/acceleration.*

The second (green) shaded region in Figure 6 represents what we have termed the “Pole Separation and Acceleration” phase of the upper portion of the pole; in this test, this phase occurred from 10-44 ms. After pole fracture, the intruding barrier tore the wood fibers in the pole and accelerated the pole, transferring kinetic energy to the pole. As a result of this energy dissipation and transfer, the barrier continued to decelerate with a corresponding reduction in barrier energy. The lower structure of the barrier passed over the anchored end after the pole separated and the effect of this interaction can be observed later in the acceleration profile (beyond 44 ms).
