# Eliminating Engine Performance Degradation Over Time Through Compressor Redesign

Eric Krivitzky  
 Concepts NREC

Masashi Yamamoto  
 Mitsubishi FUSO Truck and Bus Corp.

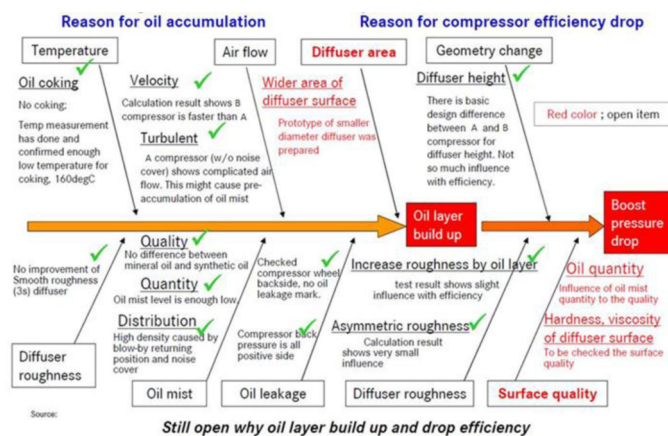
A wide net was cast, as shown in [Figure 5](#), to understand the fundamental mechanisms and address the problem at its source. This paper will cover much of the investigational work and ultimate resolution for boost deterioration from a compressor standpoint, focusing on why compressor A was sensitive to CCV while compressor B was not. The change from compressor A to compressor B represented the only change capable of stemming the boost pressure deterioration without violating the emissions targets via an open crankcase vent. Starting with a comparison of the two compressors, a geometrical analysis will serve to highlight the fundamental differences in the underlying design philosophies, while a comparison of the performance map, oil accumulation regions, and the resulting engine match will indicate operability differences. The discussion will then cover various potential sources of degradation that were identified, including a summary of the suspected source of degradation. A new compressor design, aimed at verifying the final hypothesis, is outlined with test-stand results verifying the approach.

**Figure 5. Outline of the upper-level potential sources for oil deposits and efficiency degradation.**
