# AEROSPACE INFORMATION REPORT

**AIR5913™**
**REV. A**

## (R) Landing Gear Component Heat Damage

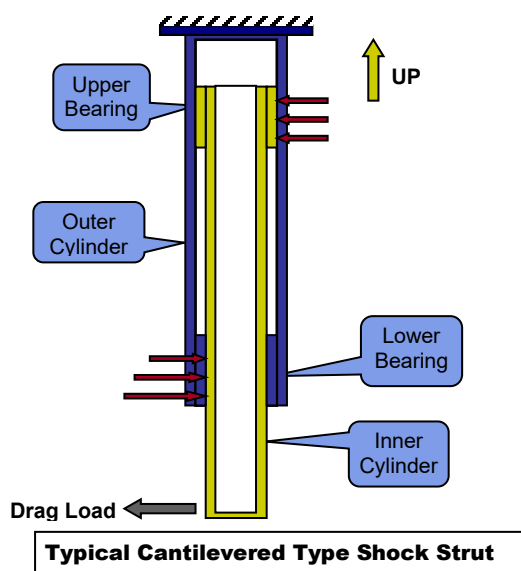
**Figure 1 - Boeing 767 main gear**

Heat damage in landing gear shock struts primarily occurs in cantilever type designs where high lateral bearing loads result from the drag and side loads acting on the gear during typical landing and ground maneuvering operations. A typical cantilever landing gear that encounters this type of heat damage is shown in Figure 1.
