# Guidelines for Resolution of Steel Bridge Fabrication Errors

G2.2-2016

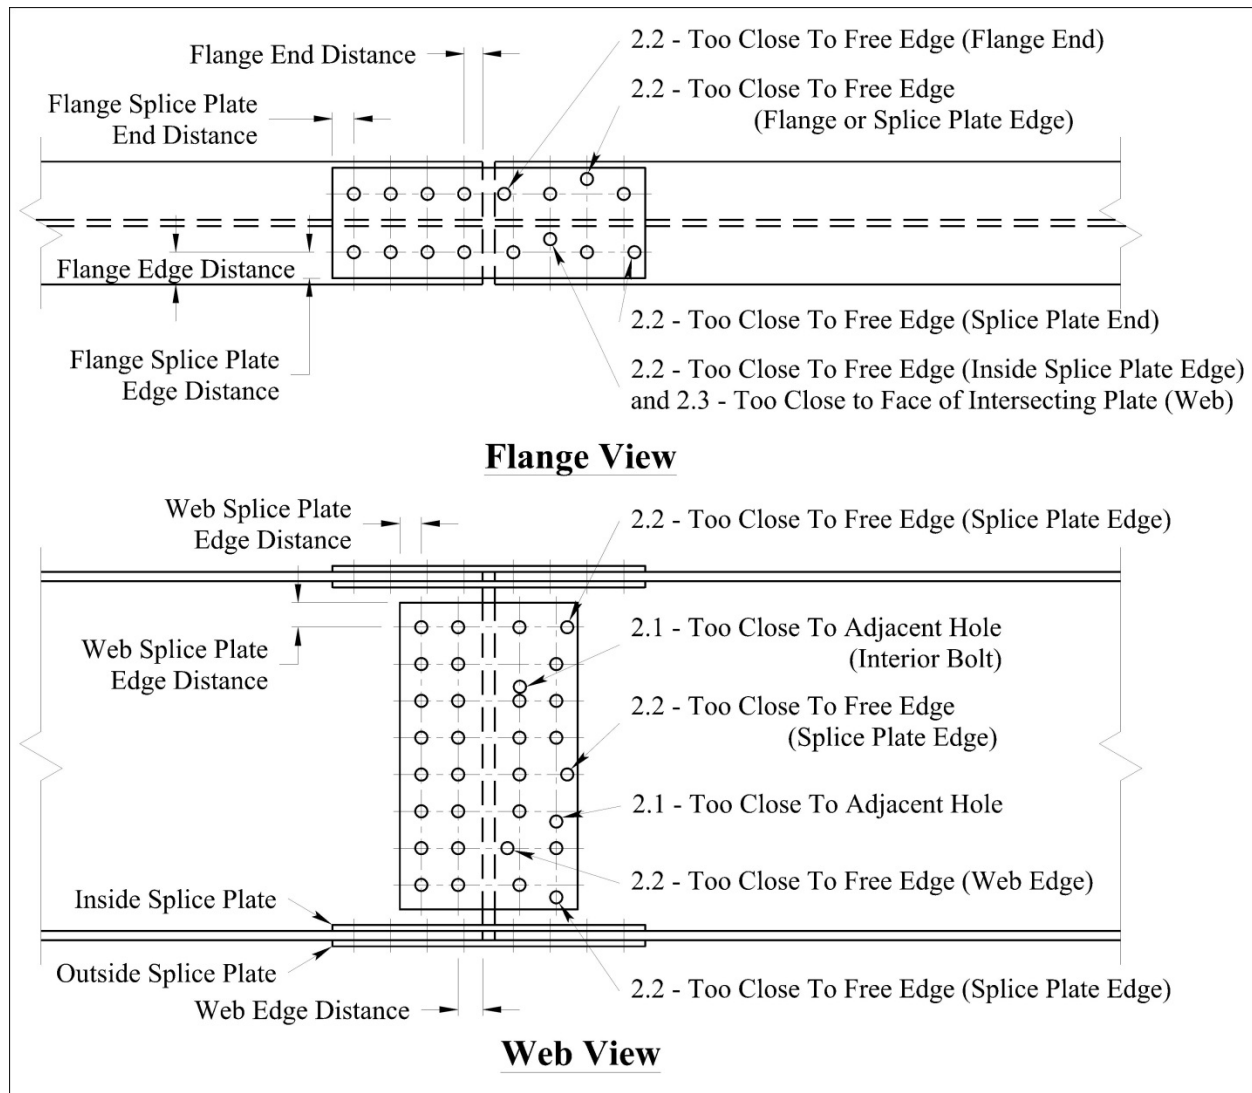
During the fabrication of steel bridge members or components, holes are sometimes misplaced and drilled too close to the ends or edges of flanges, webs, or splice plates; to adjacent holes; or to other components. (See Figure 2-1.) These errors can occur because of shifted templates or layout dimension errors and sometimes due to CNC (computer-numerically controlled) equipment programming errors. When errant or mislocated holes are made in a bridge element, the Engineer should be notified and will determine if repair will be permitted or replacement of the steel member is required.

Figure 2-1—Errant Holes at a Bolted Field Splice

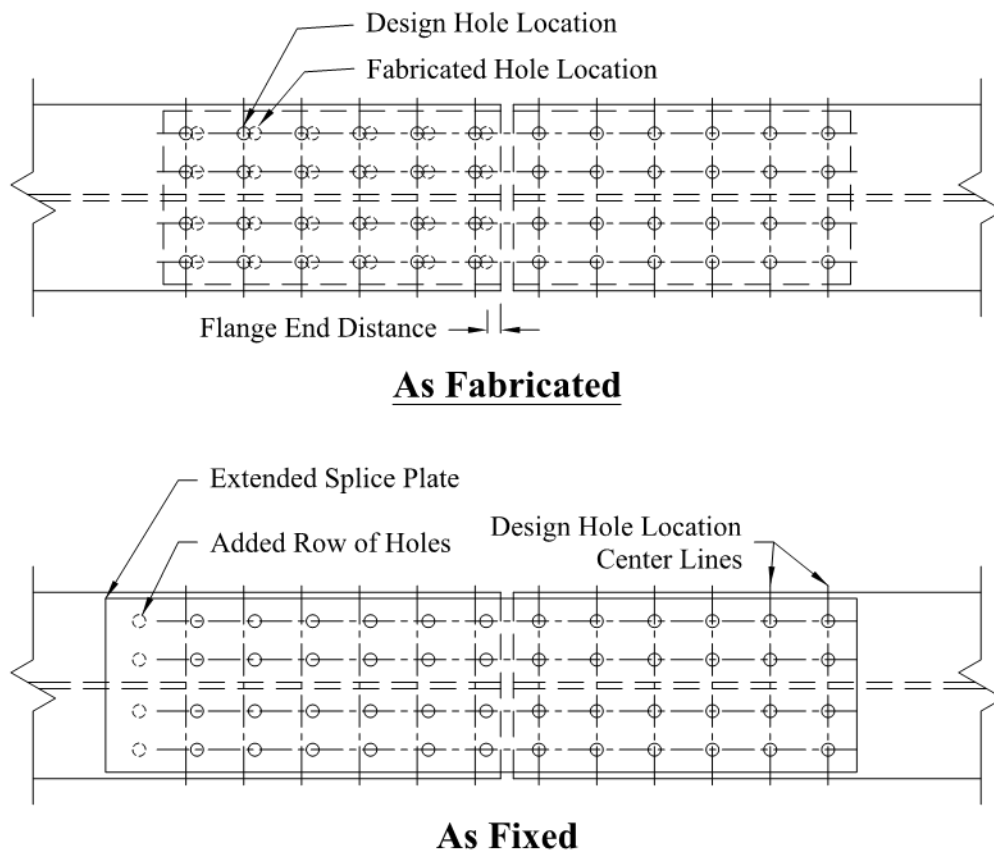
Figure 2.2-1—Too Close to End of Flange

- b. Determine whether larger splice or connection plates with additional bolts could be employed. See Figure 2.2-1. Note that for web splices, increasing the number of vertical rows increases design requirements.

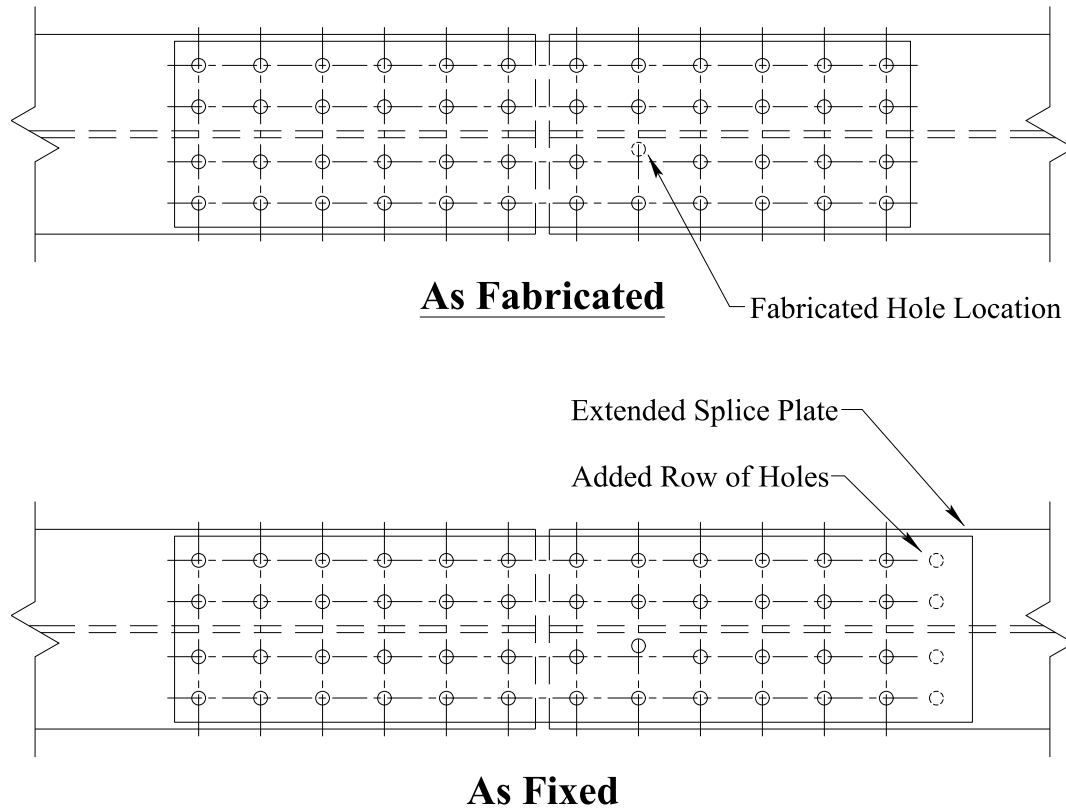
1. If the hole does not cut into the intersecting plate, in order of preference:
  - a. Slot the hole transversely to allow the bolt to be installed further away from the web.
  - b. Determine whether the connection is adequate with the bolt omitted.
    - i. If the bolt can be omitted, fill the hole in accordance with Chapter 3. Filling the hole addresses fatigue concerns and also prevents confusion in the field.
    - ii. If the bolt is structurally necessary, consider enlarging the connection by adding bolts. (See Figure 2.3-1.)
2. An errant hole entering the intersecting plate (e.g., goes through the flange-web fillet and into the web) may be a significant stress riser in a tensile stress area, and an in-situ welded repair would be very difficult. In this case, consider the following:
  - a. At a bolted splice:

Figure 2.3-1—Hole Too Close to Face of Intersecting Plate
