# MANAGING ALKALI-AGGREGATE REACTION EXPANSION IN MASS CONCRETE

**Keywords:** alkali-aggregate reaction; maintenance; mass concrete; repair.

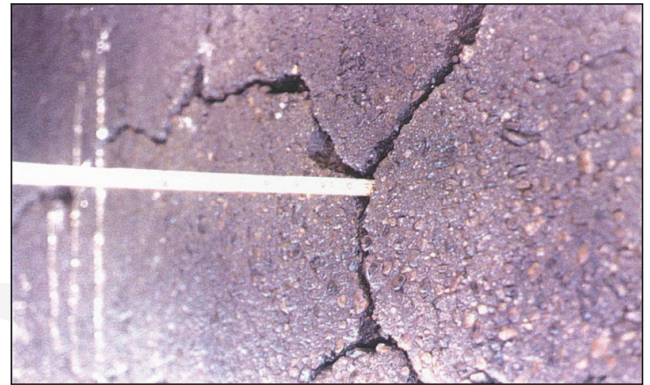
Fig. 1—Wide cracks in concrete as a result of AAR (width of the order of 1 in. [25 mm] in certain areas).

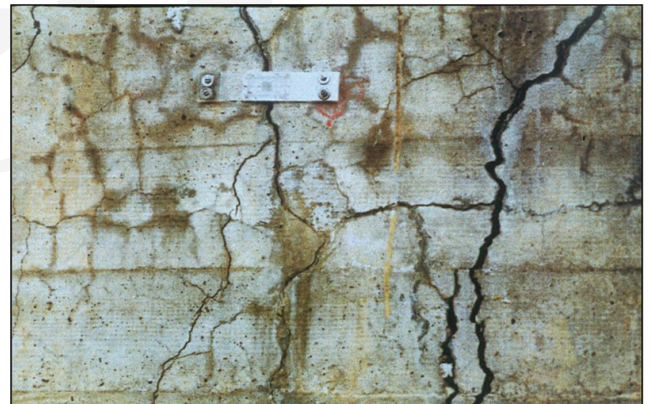
Fig. 2—Monitoring changes in crack width.

There is no universal approach to maintenance or repair of concrete structures affected by AAR, and problems usually are addressed on a case-by-case basis. Maintenance and repair ranges from monitoring the AAR-affected concrete (Fig. 2) to complete removal and replacement.

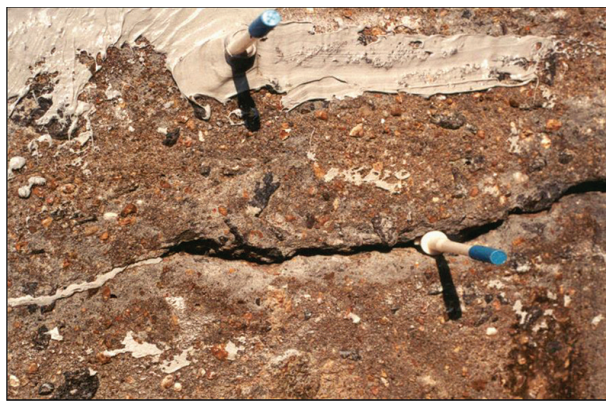
Fig. 3—Crack repair by epoxy pressure injection.

Because AAR in mass concrete sections typically results in extensive wide cracking, sealing the cracks by epoxy injection may be the most obvious repair action (Fig. 3). While crack injection may increase structural stability and minimize ingress of external contaminants, it will also block egress of reaction products, potentially increasing the pressure from internal gel expansion and enhancing the formation of new cracks. Injection with flexible materials may provide some improvement in repair performance. Consider crack sealing and injection only after a careful evaluation of its compatibility with future expansive reactivity.
