# Dual Drive Conveyor Speed Reducer Failure Analysis

by: M. Konruff, Rexnord Geared Products

American Gear Manufacturers Association

Mike Konruff, P.E., Rexnord Geared Products

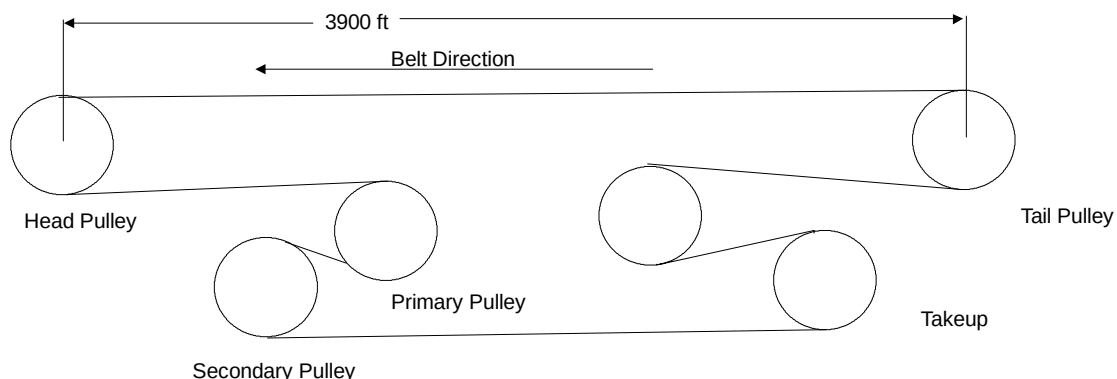
Figure 1. Conveyor Layout

conveyors. Components of the new conveyor system consisted of both used and new equipment. All main line conveyors were dual drive arrangements. Figures 1 and 2 show the conveyor layout of the main line dual drives before the slope belt. The speed reducers were coupling connected to the pulley shaft with grid type couplings. Prime movers were connected to the reducers with elastomeric couplings. The drive base was fabricated from steel plate and structural steel members. The base was welded to the pulley support structure. Information on the speed reducers and prime movers is provided below.

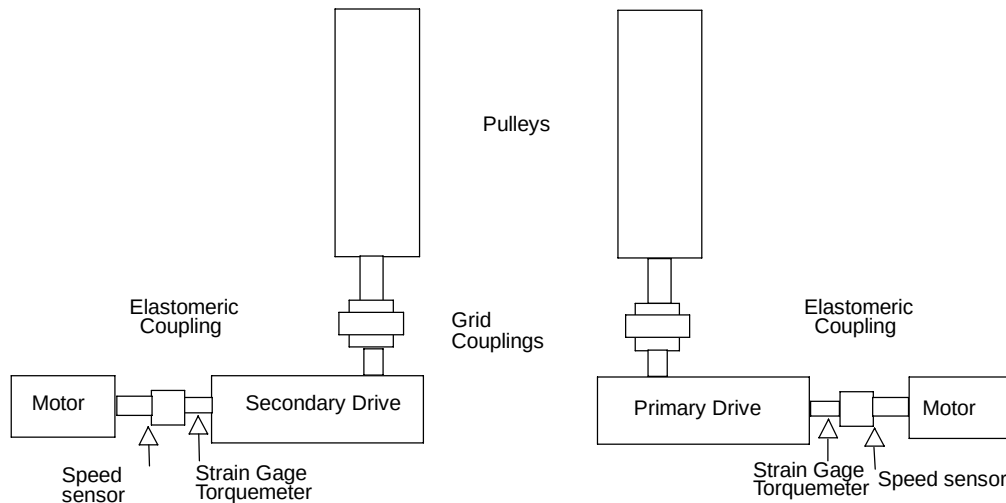
**Figure 2. Drive Arrangement**

To start the conveyor, both motors are energized at the same time with a single solid state starter. The conveyor is brought up to speed, which takes 4 seconds with an unloaded belt. A vacuum bypass contactor engages after the drives are at full speed which puts the motors across the same line and shuts off the solid state circuit.
