12FTM18

# **Analysis of Ripple on Noisy Gears**

By G. Gravel, Hamburg University  
of Applied Sciences (HAW)

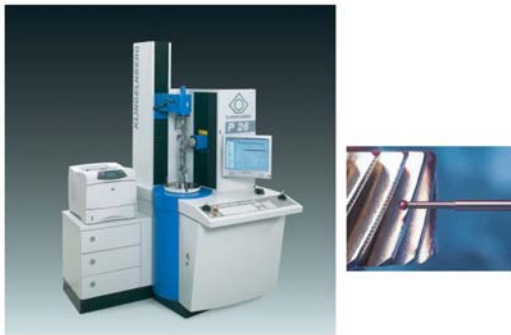
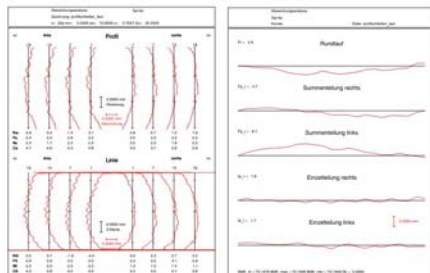
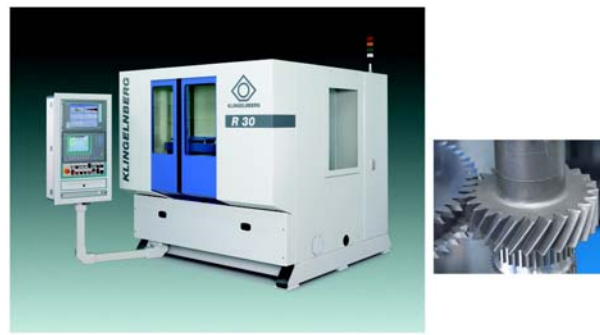
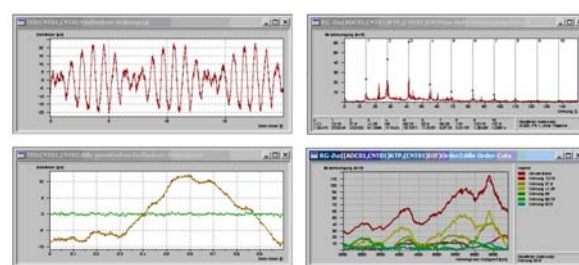
**Figure 2. Inspection procedures when facing noise problems**

## Single error inspection

## Composite inspection / noise inspection

Inspections of gear geometry are generally carried out during production on gear measuring devices that use a probe to trace the tooth flanks at individual points or on curves (Figure 2, left). By conducting such individual error tests, it is possible to arrive at definite conclusions with respect to the quality of the gearing and corrections for the production process [3] [4] [5]. This holds true to the extent that the errors occur over large areas and systematically on a number of teeth, as is the case for a great deal of production errors.

If damage occurs on individual teeth, however, or if the behavior of the gear is to be inspected as installed in the transmission, a working inspection is used. Here, a complete inspection of the tooth flanks is carried out by rolling with a high-quality master gear (figure 2, right). All errors of the gear act as a composite, in the form in which they have an effect when the gear is generated. A spectral analysis of the single flank generating signal reveals vibrations over the angle of rotation, which are caused by ripples on the tooth flanks and are also known as ghost frequencies [6]. Extended outfitting of the measuring device allows noise testing using structure-borne sound sensors and generation at higher rotational speeds and under load.
