**Paper No.**  
**16325**

## **Pipeline Coating Corrosion, Understanding Testing and UV Degradation of Fusion Bonded Epoxy Coatings**

Lake H. Barrett &  
Robert Leggat, PhD

KTA-Tator, Inc.  
145 Enterprise Drive  
Pittsburgh, PA15001  
USA

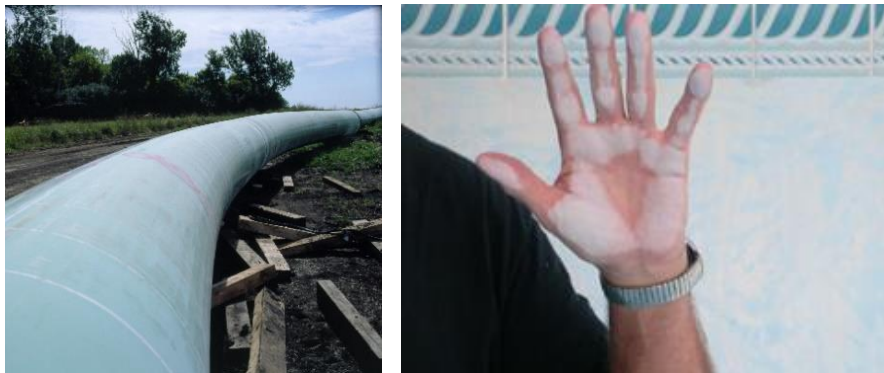
This paper is an overview of FBE compositional testing protocol of qualification testing with regards to the mechanism of chalking, compositional analysis of chalk and impact of chalk on safety, coating performance and film loss. Examples of which can be seen below:
