## **Review on the Determination of Sulfate Ion Concentrations in Deficient Post-Tensioned Grouts**

Rutambara Sonawane,  
Samanbar Permeh,  
and Kingsley Lau  
Florida International University  
10555 W. Flagler St., Miami, FL 33174

Ron Simmons  
and Matthew Duncan  
State Material Office  
Florida Department of Transportation  
5007 N.E 39th Ave. Gainesville, FL 32609

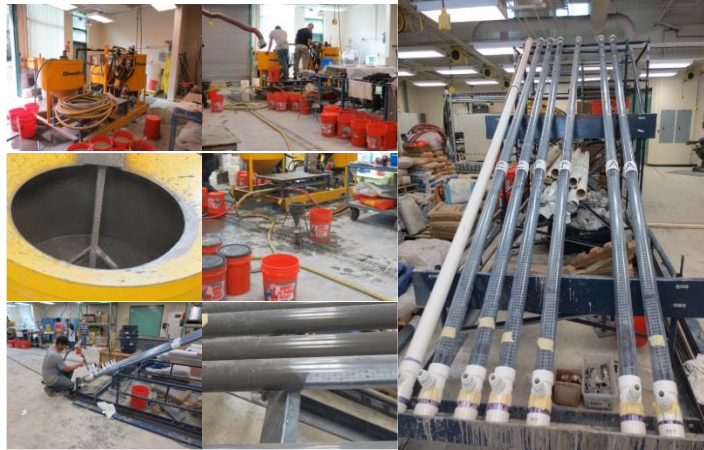
**Figure 2: Example of the modified incline tube test.**

The modified inclined tube test (MIT) is a large-scale laboratory mockup test that includes pumping grout within a duct with a vertical incline to assess grout bleeding and segregation. A 4-inch diameter, 15-ft long PVC pipe (tube) is placed at a 30-degree incline. Grout is pumped upwards from the lower elevation into the tube. During the pumping, the valves at the outlet and inlet are closed sequentially to prevent material loss and to ensure full encapsulation. An example of the MIT is shown in Figure 2. Testing by Hamilton<sup>19</sup> introduced 15% excess mix water and assessed the level of grout deficiency by measuring the moisture content of the grout sampled from locations at the top of the tube. Testing by Perme et al.<sup>16</sup> also introduced 15% excess water but compared the chloride and sulfate levels of the grout from the upper and lower elevations. It also monitored corrosion of steel corrosion probes placed along the length of the tube. Those research efforts showed that this test setup can promote the formation of a deficient grout (>20% moisture and >0.001g/g sulfate) at the upper elevation of the tendon.

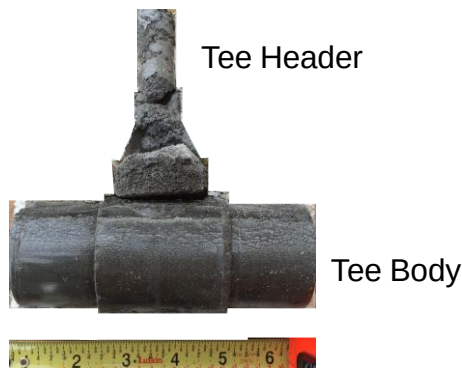
**Figure 3: Example of deficient grout in the INT.**

The inverted tee test was developed by Permeh et al.<sup>14, 20-21</sup> as a small laboratory test to promote water displacement such as in the MIT. The test specimens consisted of a PVC tee ( $2 \times 2 \times 1\frac{1}{2}$  "  $\phi$ , 4  $\frac{3}{4}$  "length) filled with grout, mixed with 20% excess water and varying concentration of chloride and sulfate additions. The large change in surface area from the tee body to the tee header allowed for a compact accumulation of moisture where the grout material could be differentiated. The chloride and sulfate levels were found to be transported with the displaced water to the deficient grout in the tee header. The corrosion activity of steel probes in the tee header was differentiated from steel probes in the tee body<sup>16</sup>.
