## **Surface Hard Zone Phenomenon in TMCP Line pipes for Sour Service: A State of the Art Review**

Ali Smith  
Rina Consulting-CSM  
Via Di Castel Romano 100  
Rome, 00128  
Italy

Carlo Spinelli  
ENI  
Piazza Ezio Vanoni 1  
San Donato Milanese  
Italy

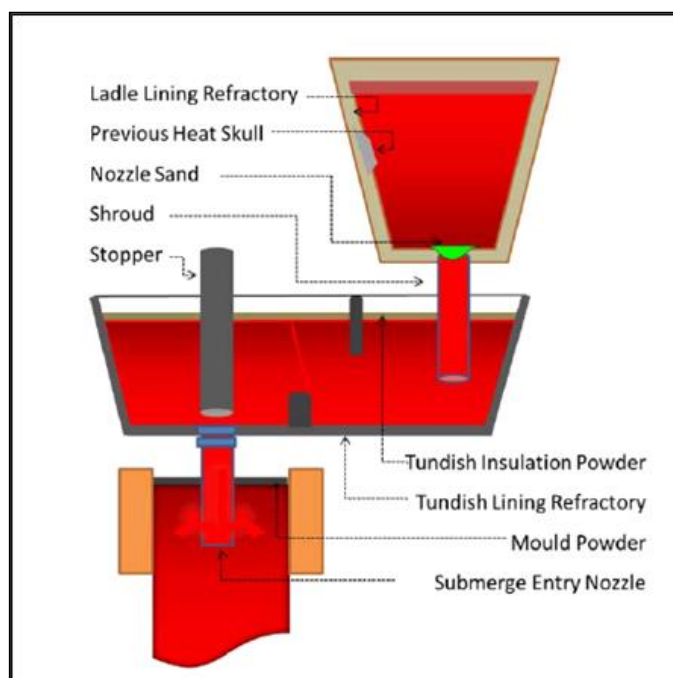
**Figure 1: Potential sources of carbon pick-up during continuous casting of steel slabs.<sup>9</sup>**

This section deals with possible surface chemical changes occurring during TMCP plate manufacture (which may eventually cause hard zones in the pipe). From the review exercise, segregation phenomena were first analysed and then excluded, leaving carbon pick-up during continuous casting as the most likely candidate. The steel may pick-up carbon from a number of external sources as illustrated by figure 1.

These sources of contamination include refractories, ladle nozzle sand, tundish insulation powder, and the mould powder.<sup>9</sup> Table 2 summarises these sources and the amount of carbon that can be picked-up into the steel, as obtained from literature references.

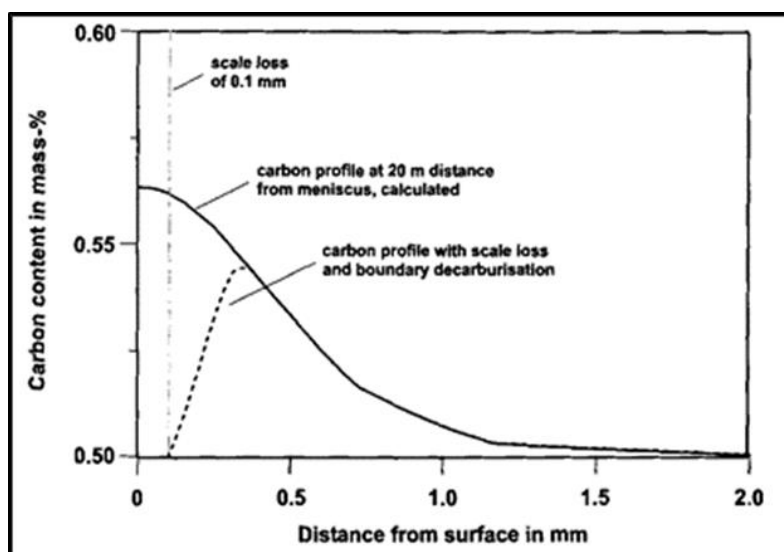
**Figure 2: Predicted carbon content picked up in solid steel versus depth (in wt%) at 20 metres from the meniscus (i.e. after final cooling) during continuous casting.<sup>11</sup>**

As can be seen from table 2 the largest potential increase in carbon level in the steel during casting is due to the mould powder. For the case of the solid steel shell that forms in the mould, the process of carbon entry occurs in the following way. First the mould powder melts and a slag is formed. A carbon particle may then be picked up in the solid steel shell, either by contact with molten slag at the meniscus, or at the zone between mould wall and steel solid shell.<sup>11</sup> Also, subtle variations in casting speed and caster alignment can result in disruption within the meniscus, and a wave forming, which can result in mould powder being transported further down the side of the mould to interact with the solid steel. Finally, the carbon in contact with the solid steel then diffuses into the steel surface causing recarburization.<sup>11</sup> From table 2, resulting enrichment levels in the solid steel surface range from 0.04-0.13 wt% of carbon. Moreover, the enrichment occurs in surface of the solid steel cast slab to a depth of about 1 mm. An example of such enrichment based on experimental and modelling work in the literature applied to a 0.5 wt% carbon steel is shown in figure 2.<sup>11</sup>

From figure 2, the final carbon content after slab cooling reaches a predicted maximum at around 0.3 mm depth, when scale loss and decarburization are considered. Moreover, this peak carbon content is 0.54 wt% versus a nominal level of 0.5 wt%. In addition, it can be seen that the maximum intrusion depth is about 1 mm.

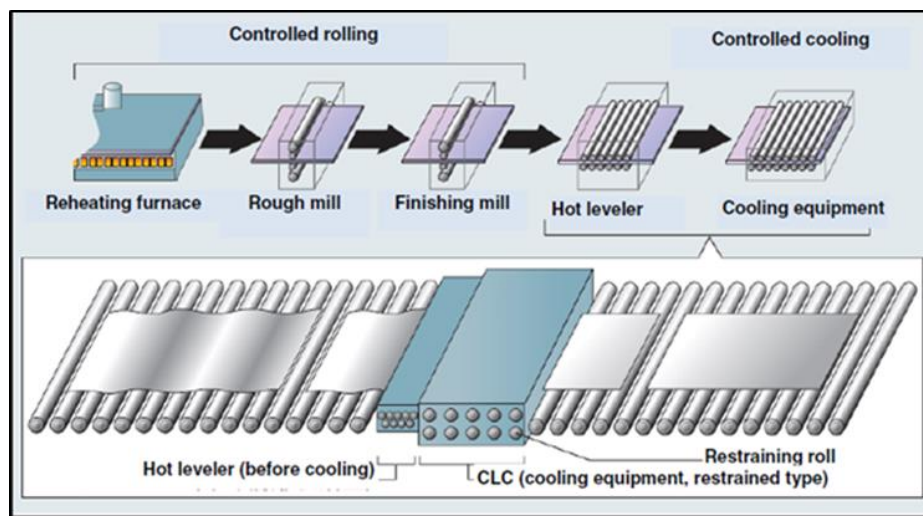
**Figure 3: Generic hot rolling mill layout for TMCP production of steel plates.<sup>12</sup>**

This part of the review focuses on the potential role of the accelerated cooling step on hard zone formation in TMCP plates. Figure 3 shows the TMCP process where steel plates are subjected to accelerated cooling after hot rolling.

As can be seen, the slab is reheated, then subjected to roughing followed by finish rolling. After going through the hot leveler the steel plate is subjected to water spray cooling (accelerated cooling) which transforms the refined austenite structure into a microstructure desirable for the final application e.g. fine ferrite with bainite for linepipe applications, depending on the grade. During accelerated cooling there is the possibility of inhomogeneous cooling in different directions. Over cooling the plate from the top or bottom (the thickness direction) can occur if the water flow rates are not properly controlled. This can lead to top or bottom surface distortion and a higher surface hardness. Over cooling of the ends and edges (longitudinal and transverse directions) due to water accumulation at plate edges or due to splashing, can lead to distortions and hardness increases.<sup>13</sup> These over cooling problems are well known and are avoided by careful design or optimization in the steel mill commissioning phase.<sup>12,13</sup> Accelerated cooling systems have developed over the years leading to the introduction of advanced cooling systems which give reduced temperature variation over the plates surfaces during accelerated cooling.<sup>12</sup> This allows production of plates guaranteeing minimal strength variations, as well as reduced problems with flatness. Such advanced cooling systems achieve better temperature homogeneity, for example by promoting higher heat transfer over a wider temperature range compared to conventional systems. For the ordinary systems, at high temperatures the heat transfer occurs through a film of steam on the plate surface. As the temperature is lowered an unstable transition zone is reached where
