## **CATHODIC PROTECTION ON AN ICONIC BUILDING OF THE MODERN MOVEMENT ARCHITECTURE**

Xavier Hallopeau, Arnaud Meillier, Olivier Lesieutre  
Freyssinet International & Cie  
280 Ave Napoléon Bonaparte  
Rueil Malmaison, 92506  
France

Elisabeth Marie-Victoire, Myriam Bouichou  
Laboratoire de Recherche des Monuments Historiques  
29, rue de Paris  
Champs-sur-Marne, 77420  
France

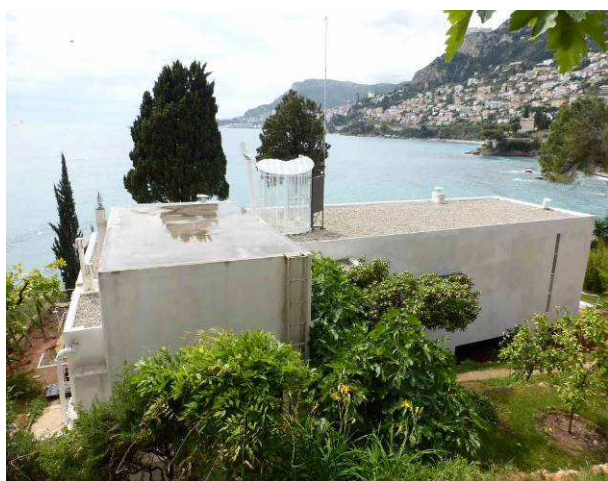
**Figure 1: Back facade**

Built between 1926 and 1929 by Eileen Gray and Jean Badovici in Roquebrune-Cap-Martin near Nice, Villa E-1027 faces the Mediterranean Sea, Figure 1 and 2. Its structural elements and floors are made of concrete, while the non-structural components are more heterogeneous (bricks...). It was partially rendered and totally covered with a lime wash.
