**Paper No.**  
**16914**

## **CUI Management Through Moisture Barrier System and Field Assessment**

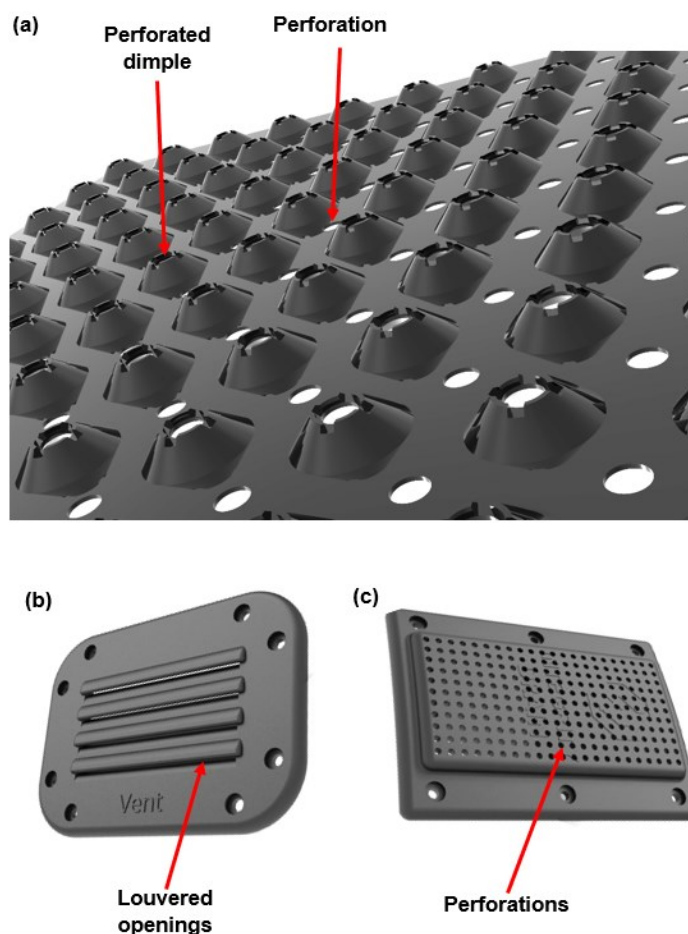
**Figure 1: Candidate moisture barrier devices namely (a) perforated dimple wrap (b) ventilation window (c) low-point drain**

The field assessment was aimed at the moisture trapping and drying behavior of stone wool insulations with and without combination of moisture barrier devices. For this, the perforated dimpled wrap was used as breathable moisture barrier and was installed in between insulation and jacketing. The perforated dimpled wrap contained equidistant 900 Nos through-holes (diameter: 4.6 mm) per square ft. which equates to 16.6 % open area over 1 square ft surface. Perforated dimpled wrap also contained 25 Nos. equidistant dimples per square ft. to achieve a consistent stand-off between the outer periphery of insulation and inner surface of metal jacketing. Figure 1 (a) shows typical perforated dimple wrap revealing the morphology and pattern of dimples and perforations. For the sake of installation, the jacketing was stripped off from the pipeline. Perforated dimple wraps were installed on the outside of soaked insulation via banding, followed by re-installation of jacketing over the perforated dimpled sheets.

To achieve air-circulation (for drying), the rectangular shaped ventilation windows (dimension: 165 mm x 118 mm) were installed in an alternating manner on the sideways (i.e., at 9'o'clock & 3'o'clock) of jacketing. Ventilation windows were installed in the cut-out rectangular slot(s) in the jacketing which were equi-spaced (i.e. after every 6 meters) along the entire length of pipeline segment. Ventilation windows were placed in those rectangular slots, followed by securing via silicon adhesive and metallic screws. Each ventilation window had horizontal and louvered openings (Length: 108 mm, Qty: 04 Nos) which were meant to aid the air circulation alongside the outer periphery of insulation without introducing the liquid moisture from rain, snow falls. Figure 1 (b) shows ventilation window with louvered slots. In addition to ventilation windows, rectangular tray-shaped perforated drains (dimensions: 137 mm x 67 mm) were installed in an equidistant manner after every 6 meters alongside 6'o'clock position of the pipeline segment. Rectangular tray-shaped perforated drains contained equi-spaced 18 holes (diameter: 3.2 mm) per square inch to allow for the drainage of trapped moisture. Figure 1 (c) shows the arrangement for perforated drain. Unlike drain plugs and drain holes which are generally installed/ made via coring out insulations, the rectangular tray-shaped perforated drains were rather mounted along the surface of jacketing. Perforated drains were also installed via cutting rectangular slots in metal jacketing (without insulation removal) and secured in place via silicon adhesive and metallic screws. This placement of ventilation windows and low-point drains allowed linear offset of 3.0 meter between low point drain and adjacent ventilation window. Various candidate configurations were prepared with and without these moisture barrier devices. Table 1 summarizes the configuration of each candidate insulated system, whereas Figure 2 is the visual elaboration of each candidate configuration(s) mentioned in Table 1.
