## **IMPACT OF MAINTENANCE ACTIVITIES ON FUTURE INTEGRITY OF TRANSMISSION PIPELINES**

### **ABSTRACT**

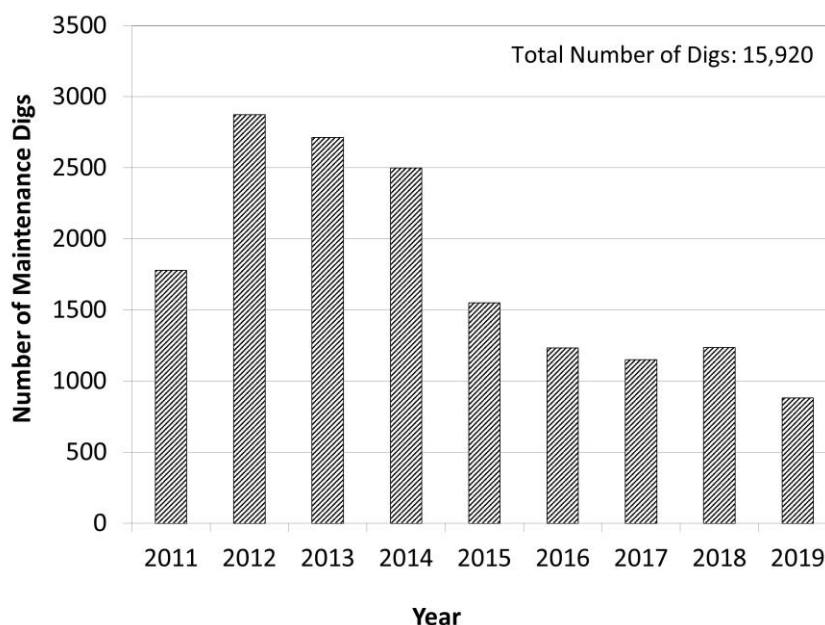
Since 2011, 15,920 digs on 13 transmission pipelines totaling over 12,500 km in Canada and the United States of America (USA) were completed as shown in Figure 2. These digs were analyzed to determine the impact of maintenance activities on the future integrity features.
