## **Characterizing Corrosion on AA-7075 Through Alternative Cleaning Methods and Optical Profilometry**

Steven Kopitzke  
Naval Air Warfare Center – Aircraft Division  
48066 Shaw Rd  
Patuxent River, MD 20670  
United States of America

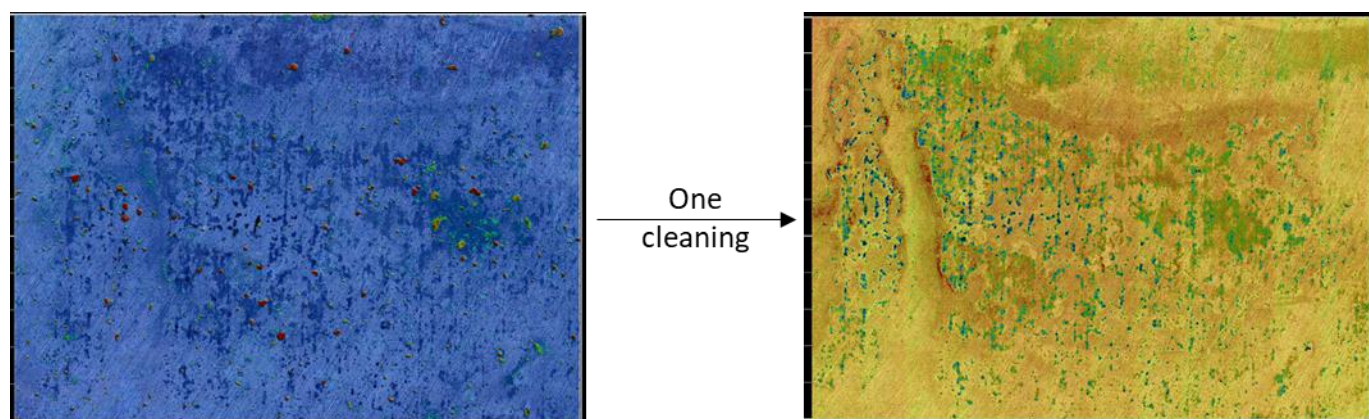
**Figure 1. All corrosion products (red areas in left image) are removed after one cleaning cycle**

Coupon cleaning was accomplished by sonication in nitric acid, according to the published work by Ferrer & Kelly.<sup>3</sup> The application of four cleaning cycles was chosen based on the desire to maintain the curve fitting data analysis techniques listed in ASTM G-1. Based on the mass loss after each cleaning cycle it appears that most of the corrosion product was removed after the first cleaning cycle. However, to develop the equation for the intersecting line to calculate mass loss, the second, third, and fourth cleaning were completed to establish the equation of the second line. In addition, profilometry analysis during the cleaning process confirmed that most of the corrosion product was removed after one 15-minute cleaning

cycle (Fig. 1) but more heavily corroded coupons could have strongly adhered corrosion product remaining through one or two more cleaning cycles. There was no evidence of corrosion product on the surface after four cleaning cycles.
