## **BRIDGE COATING MAINTENANCE STRATEGIES**

**Eric Shoyer, Nick Fabritiis, and Pete Ault**  
Elzly Technology Corporation  
Vineland, NJ, USA

### **Abstract**

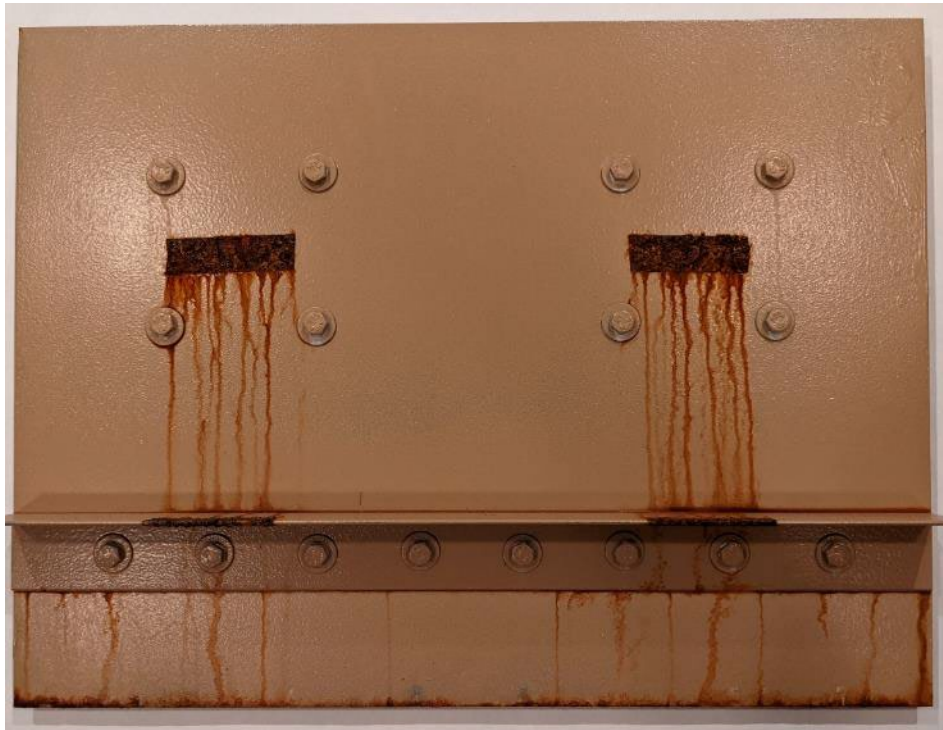
Figure 2. Large 18"x18" after Weathering

Additionally, for systems 1 through 5, one unexposed 18" x 18" x 1/8" panel was prepared by Aluminum Oxide media blast to an SP-10 (5 total). These panels were coated with an OZ/E system and exposed to accelerated weathering in 40 cycles of GMW14872 Cyclical Corrosion Laboratory Testing, Figure 2 shows a panel after exposure.
