# COOLING TOWER INSTITUTE

## CTI CODE TOWER Standard Specifications

### Wood Maintenance for Water-Cooling Towers

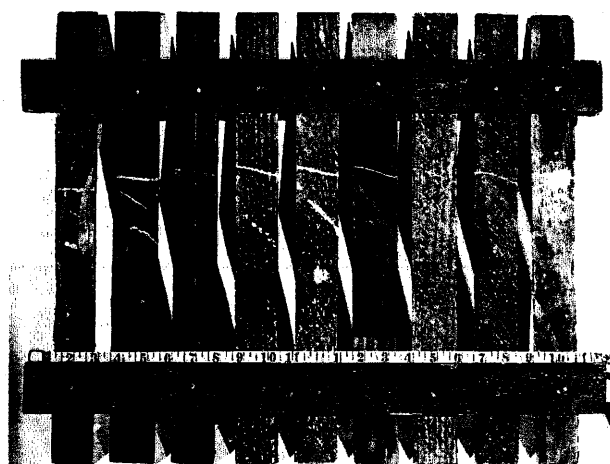
Fig. 1 Treated wood test panel.

The slats were nailed into grids using untreated redwood binder cleats with approximately  $\frac{5}{16}$  inch clearance between slats. Nails were  $1\frac{1}{2}$  inch brass, clinched over on the back side of the panel. Over-all nominal dimensions of the average panel, including the binder cleats, were  $1 \times 18 \times 24$  inches (see Figure 1).

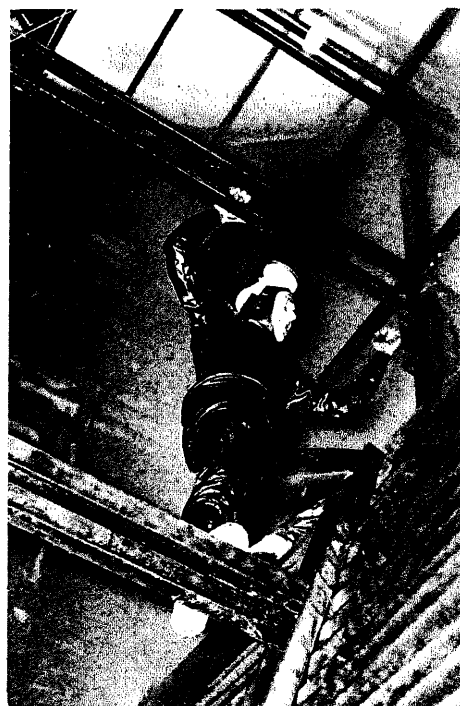
**Fig. 3**

Inspection of framing in plenum area of crossflow tower.

First, the louvers were examined and then entrance made through the louvers to the bottom of the filling, and fill test panels (Figure 2). Then from the stairs the outside casing was examined. Entrance was then gained through the trap door in the fan deck to the plenum chamber which was examined closely with special attention given to framing joints and exposed end-grain material (Figure 3). Next, the drift eliminators, drift eliminator supports, and eliminator panels were inspected (Figure 4). Then entrance was made through the drift eliminators to the distribution system and the top sections of the filling. The fan deck, from the underside, the inside casing, and the partition walls in the plenum area and below were then graded.
