## SMITH-EMERY LABORATORIES

Subject: Transverse Load Test on Stucco Panels

**SUBJECT REPORT: TRANSVERSE LOAD TEST ON STUCCO PANELS**

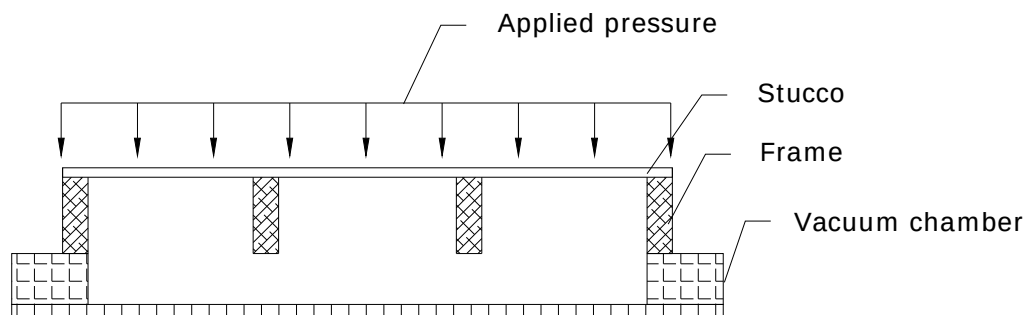
**Figure 1 – Test Setup**

Positive pressure Test

Each specimen was subjected to either a positive or negative uniform pressure until failure. The sample was installed horizontally on a vacuum chamber. For a positive pressure test, the sample was placed with the stucco panel facing up and supported continuously under the two outer studs. For a negative pressure test, the sample was installed with the stucco panel facing down. To avoid direct support under the stucco, angle brackets were used to attach the two outer studs. Refer to Figure 1 for clarification.

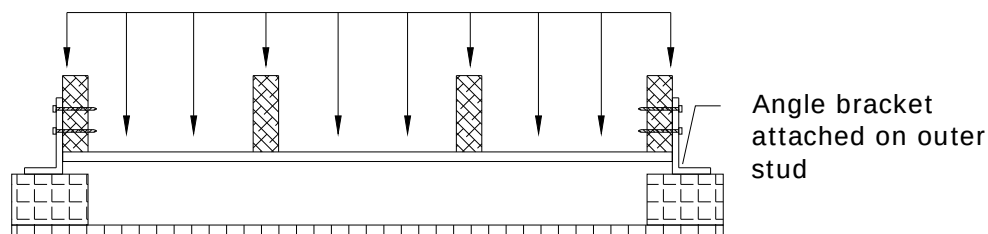
Negative Pressure Test
