## S&C – Detailed inspection of Switches

- Scope**
- Includes: Switches identified as requiring inspection in accordance with NR/L2/TRK/053
- Excludes: Catch points, unless used in a facing direction, half-sets of trap points which are in the open position for ordinary running, switch diamonds, visual inspection of switches during supervisors visual track inspections.

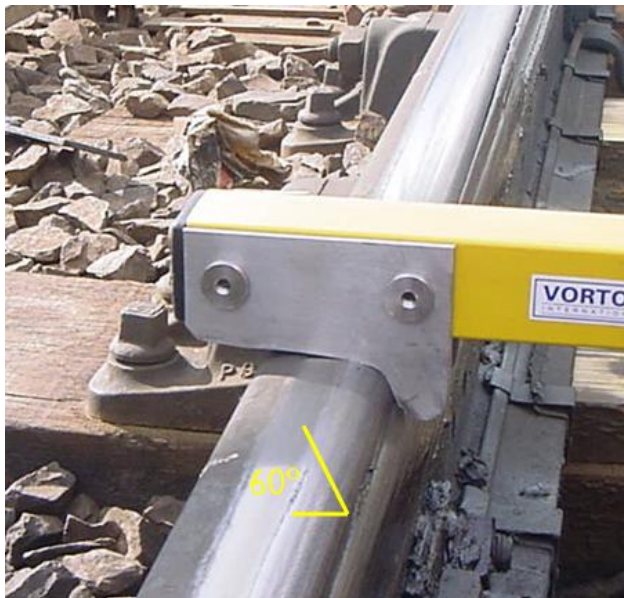
6. Check and record the sidewear on the stock rail front using the NR4 stepped sidewear gauge for a distance of 1m from the switch toe if a reading of 12 or less is recorded then apply actions in accordance with NR/L2/TRK/053.
7. Check that the switch within the first 200mm from the toe is not level nor does it project above the top of the bottom of the sidewear scar on the stock rail.

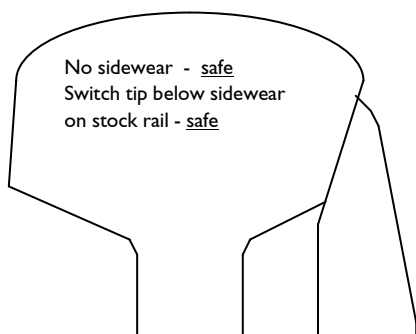
8. Check that the switch tip has not been struck or deformed by wheels onto the stock rail.
