# Corrosion Evaluation of Army and Automotive Materials in the Hawaiian Islands – 3-Year Update

**John Repp**

**I. Carl Handsy**

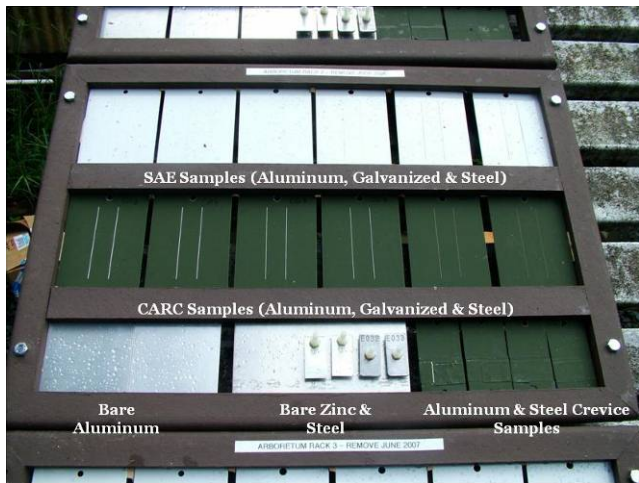
**Figure 3. Representative Exposure Rack.**

Figure 1 shows a sketch of the modular racks. Figure 2 shows photos of the general areas where test racks are located. Figure 3 shows a representative exposure rack. Three such racks were exposed at Coconut Island, Lyon Arboretum and Mona Loa. Due to space limitations only one rack could be accommodated at Volcanoes National Park.
