## Dynamic Response of Vehicle Roof Structure and ATD Neck Loading During Dolly Rollover Tests

2010-01-0515

Published  
04/12/2010Jeffrey Croteau, John Zolock, Robert Larson, Cleve Bare, Daniel Peterson and Donald Parker  
Exponent Inc.

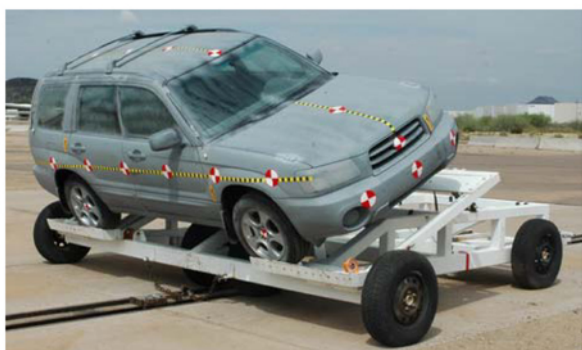
**Figure 3. Subaru Forester on Exponent's FMVSS 208 dolly.**

Each test vehicle was placed in a passenger-side leading configuration on an FMVSS 208 rollover dolly as shown in [Figure 3](#). Per the FMVSS 208 test protocol and SAE J2114 recommended practice, the dolly was oriented on the crash rail such that the Forester's longitudinal axis was perpendicular to its velocity vector at the point of release from the dolly. The vehicle was placed on the inclined dolly at a roll angle of 23 degrees measured from horizontal. The vehicles' passenger side tires rested against a 4-inch-tall (10 cm) steel edge that was attached to the dolly platform. For each test, the height of the dolly was adjusted so that the contact surface of the Forester's passenger-side tires was located 9 inches (23 cm) above the rollout surface. The rollover dolly with test vehicle was accelerated to a target speed of 44 mph (71 kph). The dolly struck honeycomb-filled snubber tubes, which decelerated the dolly, but allowed the vehicle to translate and roll onto the test surface.

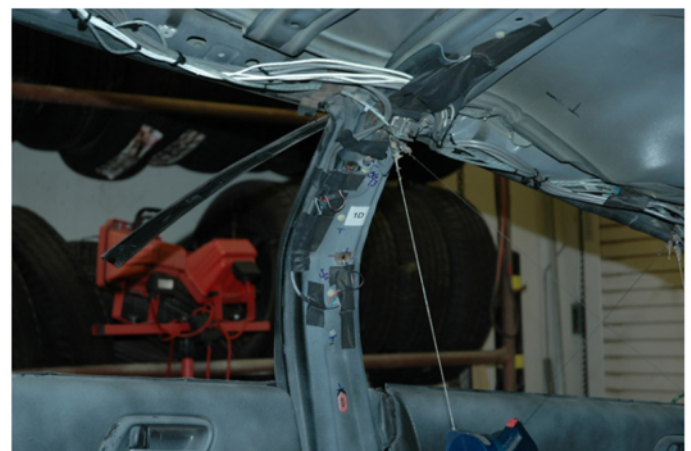
**Figure 13. Interior of left B-pillar post-test on dirt without ATDs.**

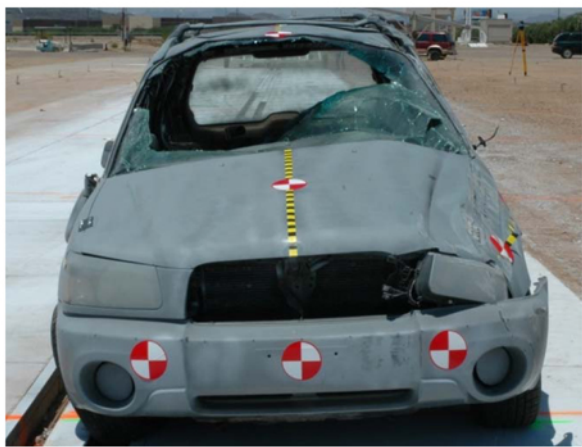
**Figure 19. Roof deformation to Subaru Forester after the test on concrete.**

The post-test condition of the vehicle's roof after the concrete test was similar in appearance to the undeformed vehicle roof, despite having undergone a series of impacts and corresponding lateral deformations (Figure 19). There was however enough roof deformation to fracture the windshield and tear the PVB layer from the perimeter at the roof header. The real-time measurements of the roof structure at the top of the A- and B-pillars (Figure 20) indicated that there was minimal residual deformation at the completion of the overall roll sequence. The vertical and transverse displacements measured during the concrete test exhibited a similar trend when compared to the deformation during the first roll in the dirt test. The deformation to the near-side roof rail (passenger) followed a path from upper right to lower left and the deformation to the far-side roof rail shifted from upper left to lower right. The absence of plastic vertical permanent deformation in the roof structure is attributed to the random nature of a rollover resulting in no significant impact events near the inverted roll position (6 o'clock position in Figure 18). Rather, the loading to the roof structure occurred while the vehicle was oriented more on its side and thus the vehicle was not exposed to forces in a vertical direction that would tend to cause plastic deformation to the roof structure.
