# Analysis of Residual Strain Profiles in Distorted Aluminum Engine Blocks by Neutron Diffraction

Anthony Lombardi and Comondore (Ravi) Ravindran  
Ryerson University

**CITATION:** Lombardi, A., Ravindran, C., Sediako, D. and Mackay, R., "Analysis of Residual Strain Profiles in Distorted Aluminum Engine Blocks by Neutron Diffraction," *SAE Int. J. Mater. Manf.* 6(2):2013, doi:10.4271/2013-01-0171.

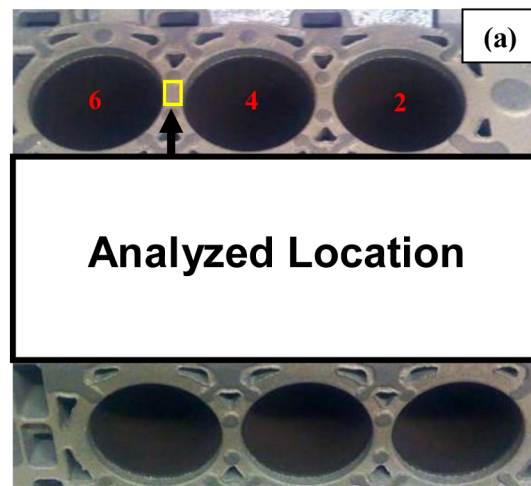
**Figure 1. Images of: (a) top view of engine block, indicating analyzed sections, (b) cross-section of the cylinder bridge showing sections analysed along the cylinder depth.**

Residual strain mapping was carried out from top to bottom along the bridge between cylinders 4 and 6 of the engine blocks as indicated by the rectangles in Figures 1 (a) and (b). Residual strain was measured along the aluminum cylinder bridge and the gray cast iron cylinder liners in the hoop, radial and axial directions using neutron diffraction. Neutron diffraction was carried out at the Canadian Neutron Beam Centre in Chalk River, Ontario, Canada.
