# Analysis of Damage Caused to Vehicle Body Panels by Impacting Hail and Various Tools and Objects

Nikola Josevski, Andreas Sandvik, Chris Jones, Tandy Pok, Tia Orton and Shane Richardson  
Delta-V Experts

## ABSTRACT

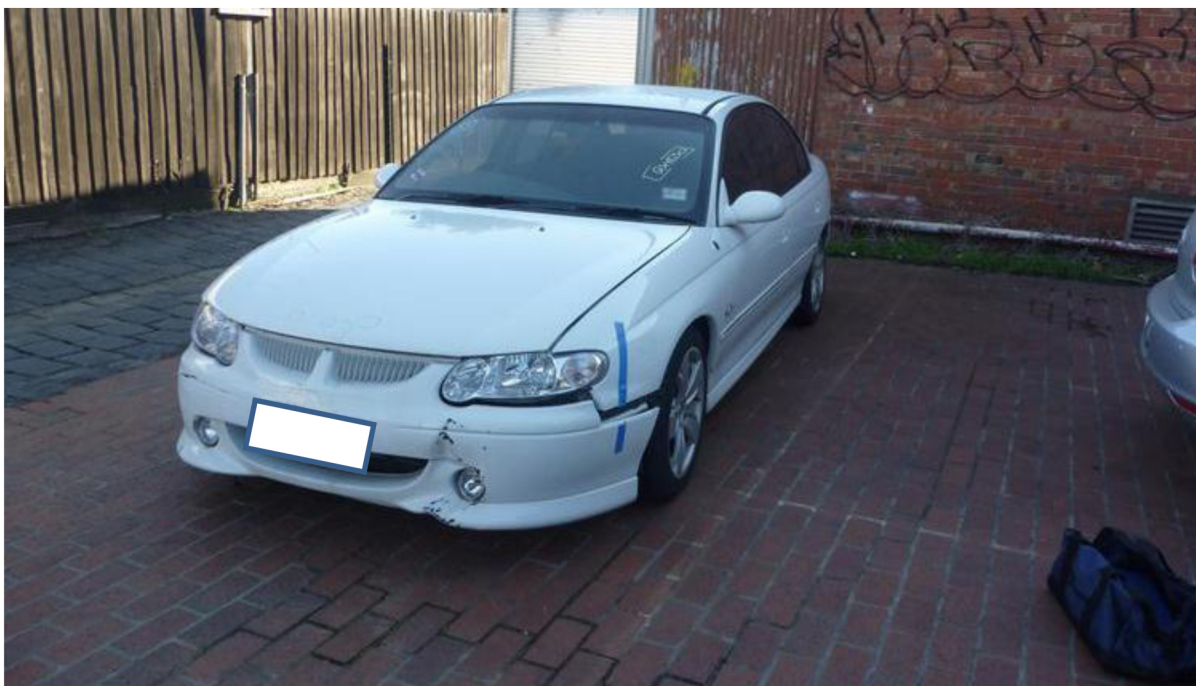
**Figure 11. Test vehicle.**

Figure 11 and Figure 12 show the test vehicle prior to commencing tests.

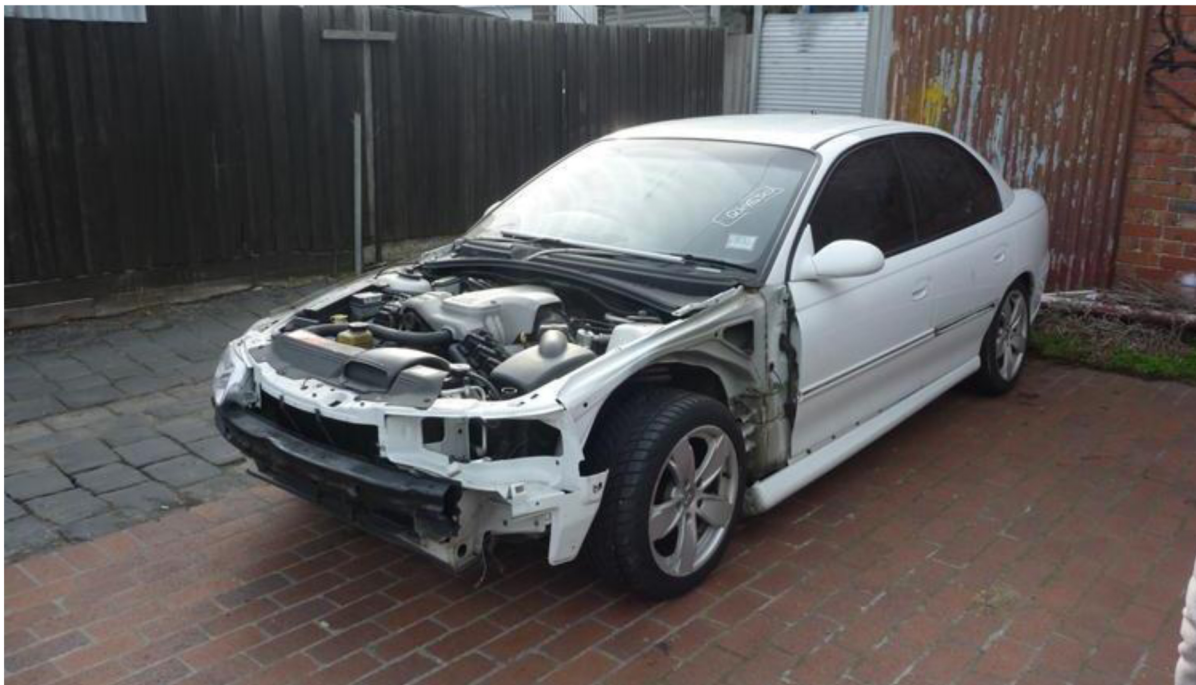
**Figure 12. Test vehicle when dismantled for testing.**

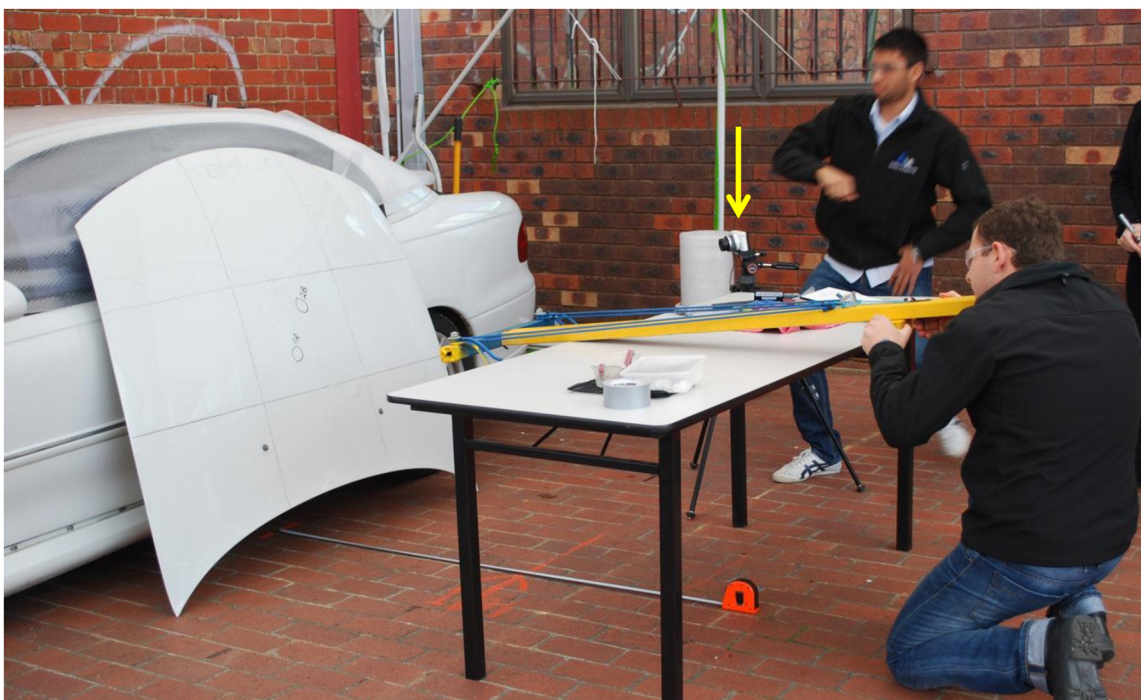
**Figure 13. A view of the projectile launching device (yellow). Tape measure on the ground under the table. High speed camera indicated with arrow. In this test, the target body panel was the vehicle's bonnet.**

developed to project hail stones in a horizontal direction (Figure 13 and Figure 14).
