# A New Method for Monitoring Gears Surface Failures Using Enhanced Image Registration Approach

## ABSTRACT

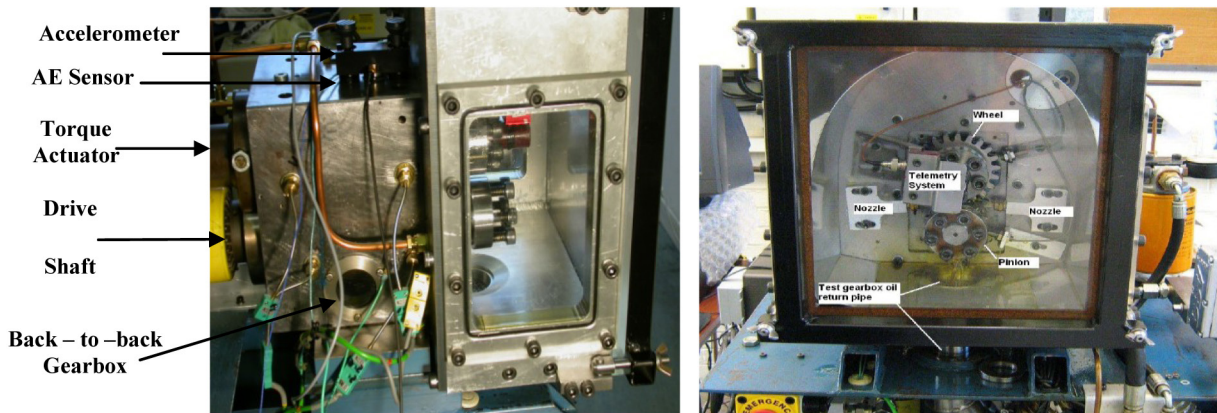
Figure 1. Newcastle University 75 mm centre distance back-to-back gear test rig

gauges installed on the wheel shaft and the measured torque values are transmitted to the control program by telemetry in order to provide closed loop torque control of the actual load on the gear itself. The test rig, as shown in Figure 1, is controlled using National Instruments (NI) LabVIEW which consists of a PCI-MIO-16E-4 E series data acquisition card (NI) and 250kps sampling rate. Temperature is monitored using a USB-9211A temperature data acquisition card (NI). Three oil heaters and a water cooler are used to ensure that the running oil is maintained at a constant temperature during the tests. Temperatures were measured at three locations: rig oil tank, test gear bearing and slave gear bearing. Oil pressure and flow rates were also measured. A gear tooth trigger sensor was installed adjacent to the pinion test gear to ensure that tooth failure could be recorded. The input shaft speed and motor current were also monitored as a precaution. The test rig software provided the flexibility to change the control algorithm of the parameters measured according to the test conditions using LabVIEW's scalable architecture features. The test rig sensor-actuation system layout is shown in Figure 2. A pair of

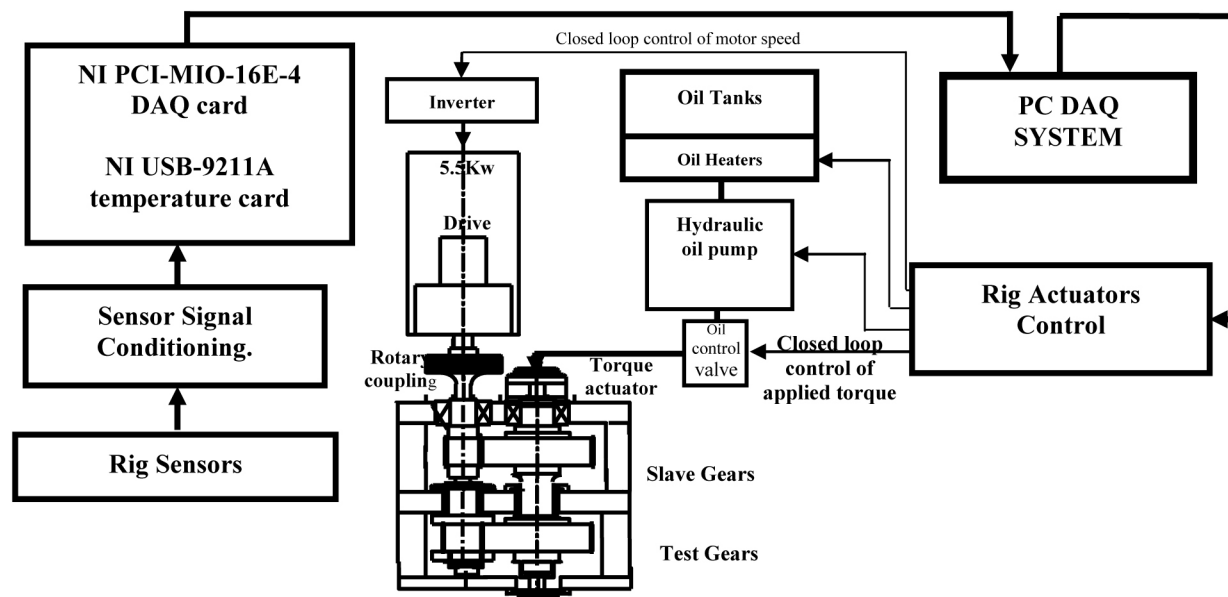
Figure 2. 75 mm test rig sensor-actuation system layout.
