ARP6824™

## Guidelines for the Use and Installation of Large Size Wire/Cable Jacket Damage Repair Sleeve

This SAE Aerospace Recommended Practice (ARP) provides users a means to correctly install a repair sleeve designed for large size wire or cable jacket damage repair.

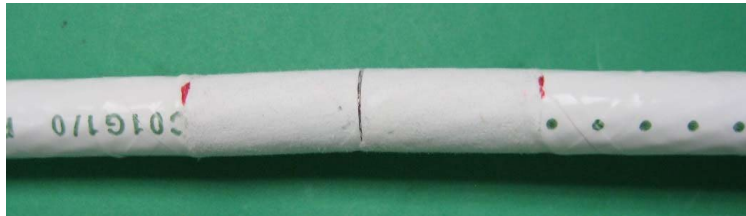
- 3.2.1 Examine damage to ensure the conductor is free of damage (e.g., nicks). The Figure 1 damage shown is for example only. Measure the damaged area to ensure compliance to the applicable detail specification.
- 3.2.2 Abrade the periphery of the outer jacket repair area using 240 grit or finer abrasive paper or general purpose scouring pad. Clean the outer jacket repair area with a cleaning cloth per AMS3819 Class 1 Grade A Form 1 moistened with isopropyl alcohol or appropriate cleaning solution for the wire insulation as in Figure 1. Take foreign object debris precaution with the cable preparation materials.

**Figure 1 - Abraded cable**

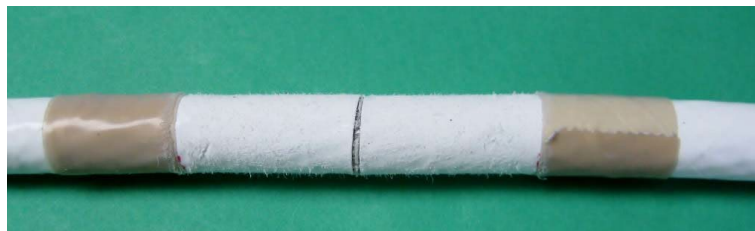
- 3.2.3 Install PTFE or masking tape on each side of the damaged area to protect the outer jacket outside of the repair area. The damage area should be located approximately in the center between the two taped area which is approximately 1.5 inches (38.1 mm) apart. See Figure 2. It is acceptable to use an ink marking to mark the edges of the repair area.

**Figure 2 - Application of PTFE protective tape**

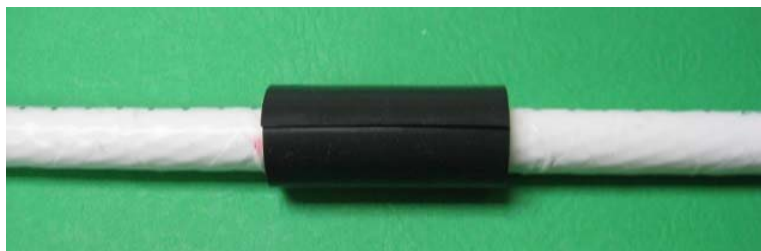
- 3.2.4 Place the split repair sleeve around the wire/cable over the damaged area between the ink markings. The split edges should meet or overlap approximately 1-1/2 times around the wire/cable prior to shrinking. See Figure 3. Note that the split edges of the sleeve should touch or overlap after shrinking into place.

**Figure 3 - Sleeve placement**
