## SSC limits of TMCP line pipes

### ABSTRACT

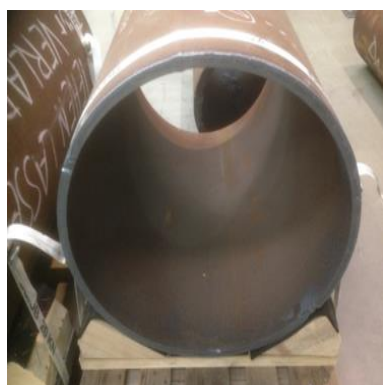
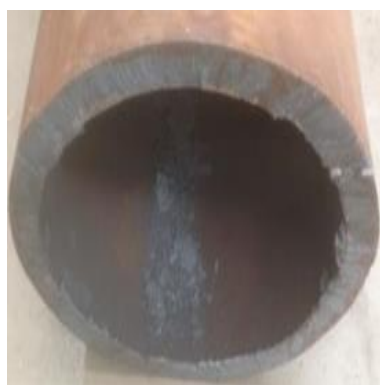
**Figure 1: X52 and X65 line pipe rings received from industry**

The X52 pipe is 1000 mm x 720 mm OD x 20.6 mm WT and the X65 pipe is 980 mm x 510 mm OD x 38.1 mm WT (see Figure 1).

X52

X65

The tensile properties of the materials have been checked in order to know the accurate yield strength. Table 1 below shows the data for the two pipes. Both materials are close to the mid-range of the grade as per API 5L/ISO 3183 standard<sup>9</sup>. A set of three uniaxial specimens were extracted from both sample grades and the test resulted in average YS of X52 was 421 MPa (61 ksi) for the X 52 grade and average YS of 544 MPa (79 ksi) for X65.
