## Aluminum Mold Corrosion and Protection

Zhangzhang Yin, Bingzhi Wang, Xuejun Wang, Anthony Kouba

Nalco Water Company

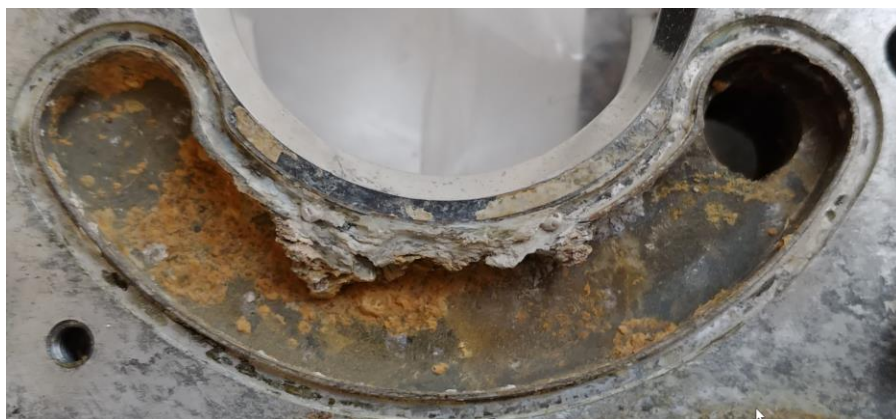
**Figure 1.** Corroded aluminum mold from plastic molding production. The metal is Al7075.

With the emerging of using high strength alloys, such as Al 7075 and Al 2024, in the mold manufacturing the challenges of corrosion control have increased. A series of failure analysis found that the corrosion seemed to be a widely existing problem for aluminum molds [8]. Figure 1 shows a typical corrosion on aluminum mold. The areas exposed to cooling water has heavy corrosion, including localized corrosion and exfoliation corrosion. The water channels appear to be covered by iron corrosion product transferred from elsewhere. Areas outside of the water channels also have slight corrosion, likely caused by leaked or spilled water.

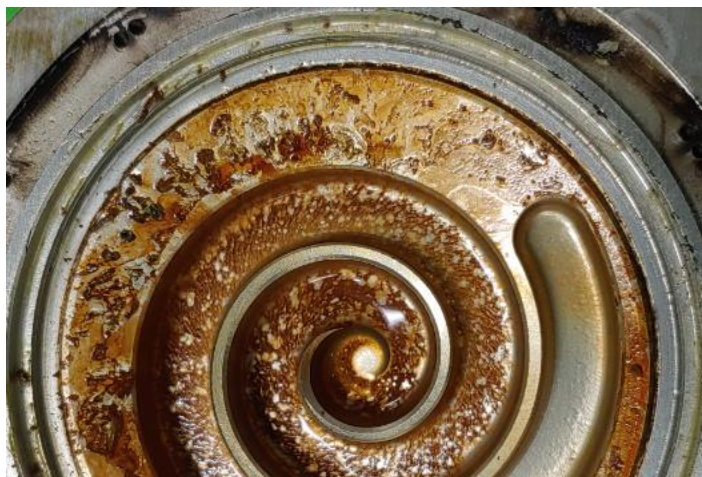
**Figure 2.** Aluminum mold from a bottling plant. The mold is made with aluminum alloy 6063.

In the closed loops that contain parts made with various metals, protection of all metal is crucial for corrosion protection of the system. The corrosion product can be transferred from one place to another and adhere on a different metal, as shown in Figure 2. Under-deposit corrosion may happen in such case, and if the metal is more active than the corrosion product (for instance, aluminum and iron oxide as in Figure 2), replacement reaction can happen, causing the more active metal to corrode faster.
