## **Study on Elemental Sulfur Formation from Black Powder Deposits**

Yousef Khuraibut  
Inspection & Corrosion Team  
Kuwait Oil Company  
Ahmadi, Kuwait

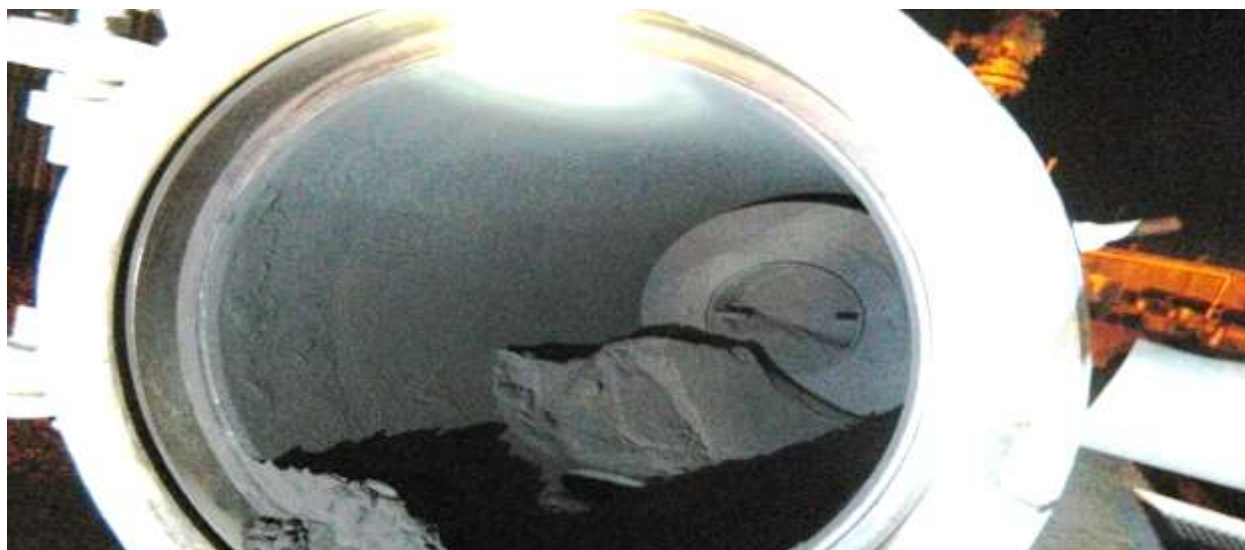
**Figure 1: Black Powder Accumulation in Fuel Gas Pipeline FG-098**

Pipeline FG-098, which carries fuel gas from the refinery to the gathering centers for equipment and for blanketing purposes, suddenly exhibited high amounts of black powder accumulation during cleaning pigging operations. The asset owner did not have the sample bottles to collect the deposits immediately from the pig receiver and; therefore, planned to contact the inspection and corrosion team for deposit collection the next day. However, due to shift changes and gaps in communication, the actual deposits collection was delayed for a few days. As a result, the deposits were left exposed to the environment for that period (Figure 1 and Figure 2).

After the deposits collection, wet chemistry and X-ray diffraction (XRD) analysis confirmed the presence of iron sulfides (FeS), Iron oxides and elemental sulfur (S<sub>8</sub>), being the common factor in the deposits. This was concerning, since it suggests the involvement of H<sub>2</sub>S and oxygen in the process and the incoming fuel gas from the refinery, which as per the specification, should be free of acid gases.

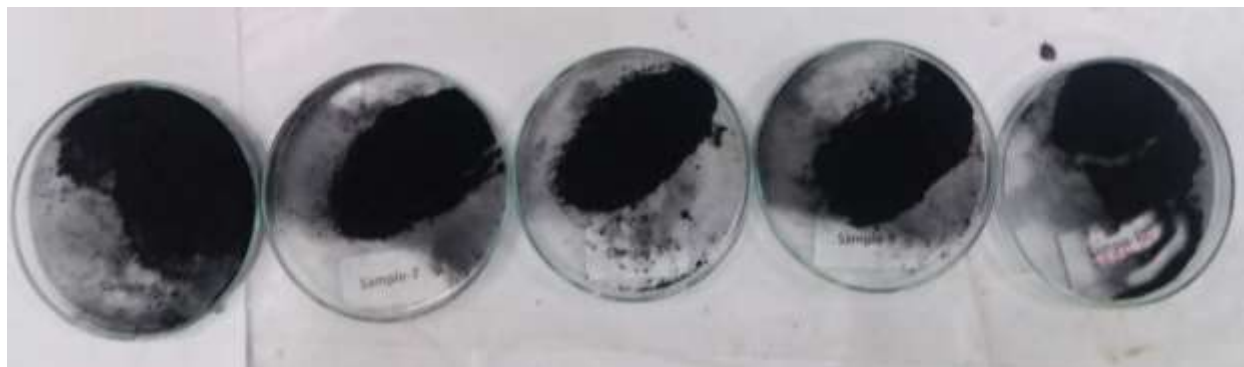
**Figure 3: Experiment Samples in Petri Dish for Oxidation of Iron Sulfides (FeS) from Black Powder Deposits**

Five set of samples were collected from HP-116 and kept for analysis at different durations for 6 hours, one day, one week, two week and three weeks at room temperature (Figure 3). The same samples were kept at the same length of time, but under constant temperature-controlled oven at 50°C, to simulate the environmental condition for exposed deposits in Kuwait.
